The REMR Bulletin

VOL 2, NO. 3

New Technique for Waterstop Replacement Used at Pine Flat Dam

Performance of Repairs to Stop Leakage in Intake Structures

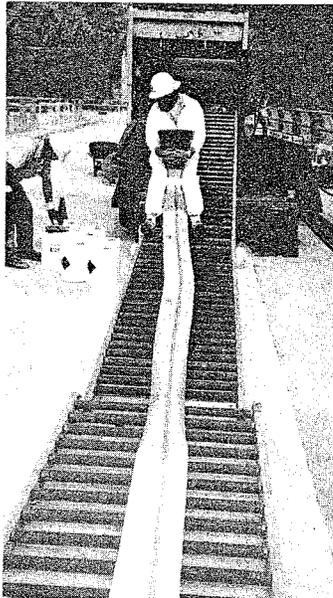
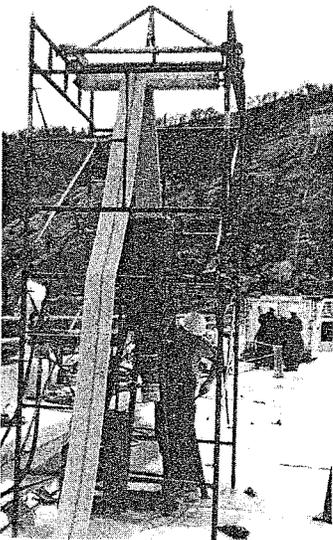
Felt-lined tube used by Sacramento District in its waterstop replacement project at Pine Flat Dam, Kings River, California, has been stretched out along the top of the dam and is being filled with water-activated polyurethane resin.

Workers prepare to couple the resin-impregnated tube to a pipe connected to a drill hole running the length of one of Pine Flat's leaking joints.

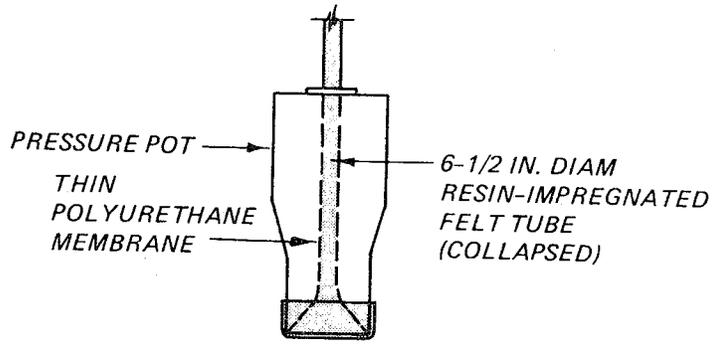
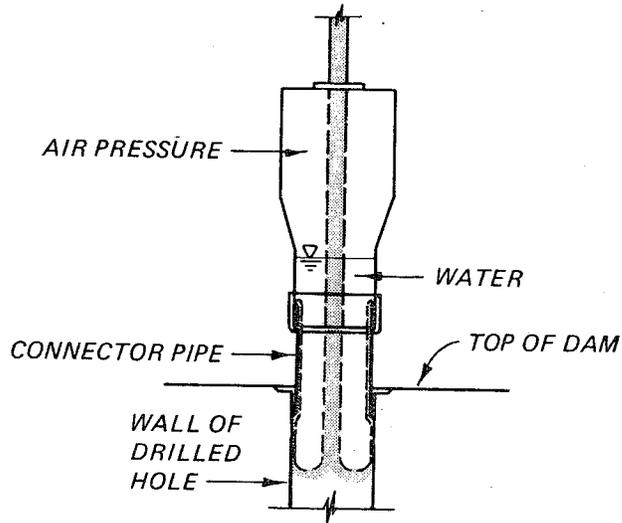
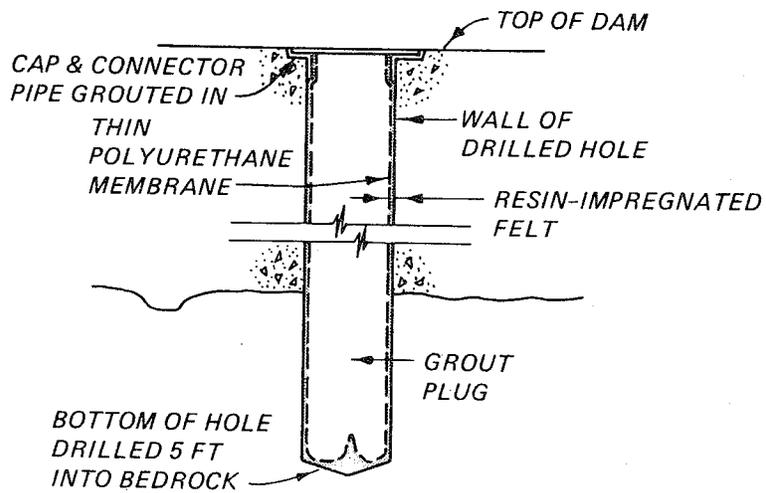
Construction of replacement waterstop by inversion process

a. CONNECTION TO PRESSURE POT

b. PRESSURE FORCES FELT TUBE TO INVERT

c. COMPLETED WATER STOP

The tube was then inserted into the drill hole using water pressure to turn the tube inside-out as it was being forced down the hole. Internal air and water pressure pressed the resin-impregnated felt tightly against the concrete surface, and water inside the drill hole activated the resin creating a bond between the liner and the drill hole. After the resin had cured, the center of the tube was filled with grout to form a strong yet flexible core.

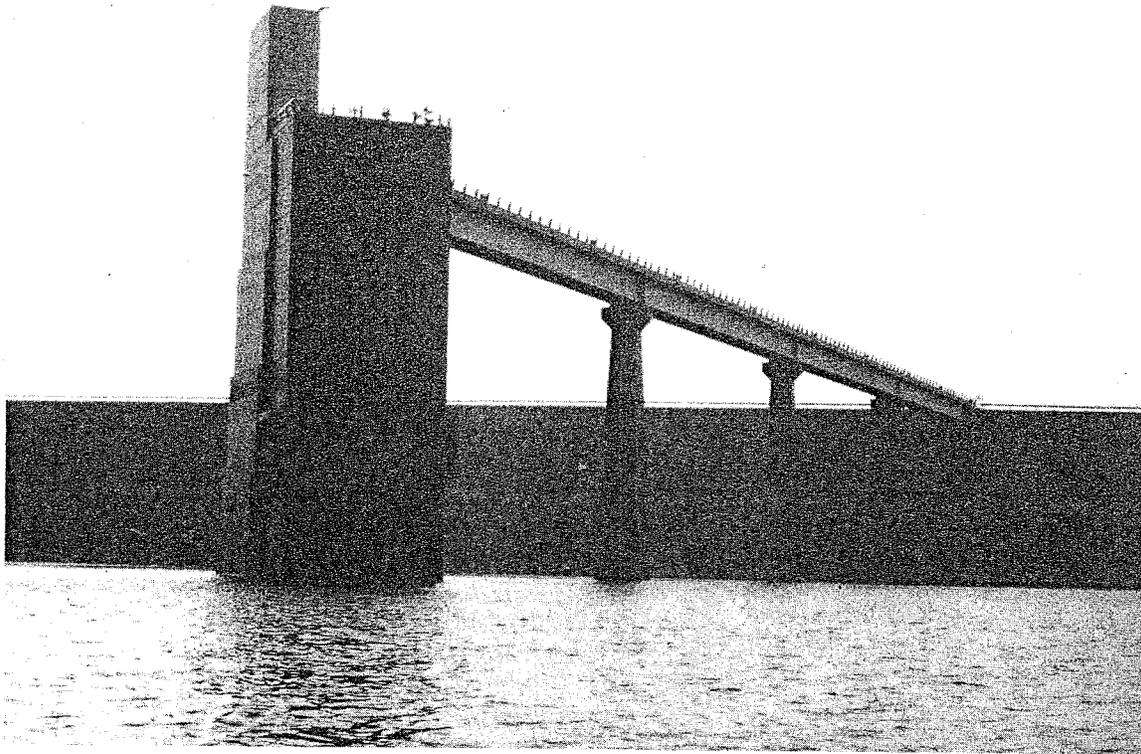
A typical example of repair performance can be seen in the history of repairs to the intake tower of Beltzville Dam in Philadelphia District. Water seepage in the intake tower at Beltzville was first noted during the third periodic inspection of the project in September 1972. Water was observed in electrical conduits and boxes, and minor leakage was seen at the joints and form tie locations below pool level. This condition worsened over the next few years, being manifested by numerous instances of minor leakage, extensive calcite formation, and corrosion of imbedded connection plates that support interior framing.

Intake tower of Beltzville Dam (completed 1972), located on Pohopoco Creek near Parryville, Pennsylvania
