# The REMR Bulletin

News from the Repair, Evaluation, Maintenance,  
and Rehabilitation Research Program

VOL 3, NO. 1

## Current Methods for Repairing Scoured Areas Downstream from Stilling Basins

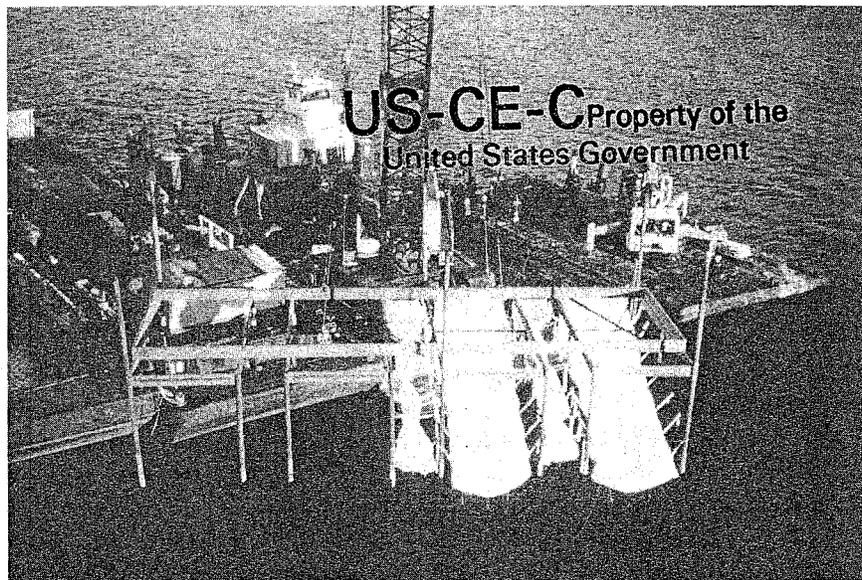
Lowering large fabric bags into place prior to filling them with grout as a substitute for large riprap, Emsworth Dam, Ohio River

Model studies of scour protection for Emsworth Dam, Ohio River, revealed that the bags would be more stable than stone 4 to 5 feet in diameter. Subsequently, grout-filled bags were placed behind one of the gate bays at Emsworth after large riprap failed to remain in place. A frame with empty bags attached was lowered into place behind the gate bay (see cover photo), and the bags were then filled with grout pumped through a hose. This repair has been successful and offers encouragement for those instances in which large enough stone either is not available or is uneconomical.

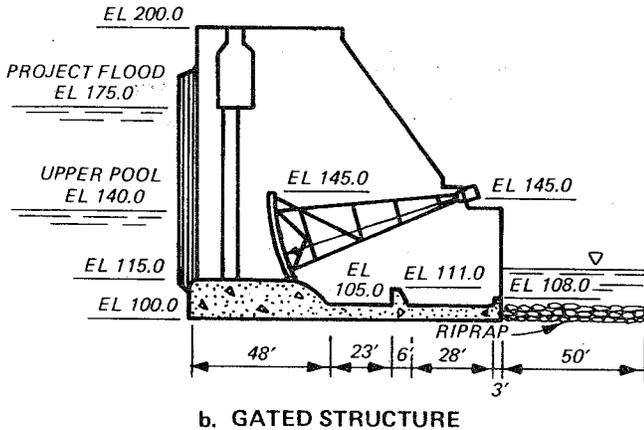
Figure 1. Cross sections of typical structures showing downstream protection

dams (Figure 1), many of which do not have a true stilling basin but rather a short spillway apron for energy dissipation. Most of the projects with stilling basins are gated structures.

From the model studies, it is apparent that scour below uncontrolled fixed-crest dams is caused by jet flow that plunges down the face of the spillway and exits the spillway apron with velocities often greater than 20 fps. This plunging jet flow (Figure 1a) probably causes piping of the material beneath the original rock protection permitting the rock to sink. Under certain conditions, this type of flow is strong enough to actually displace the rock protection.

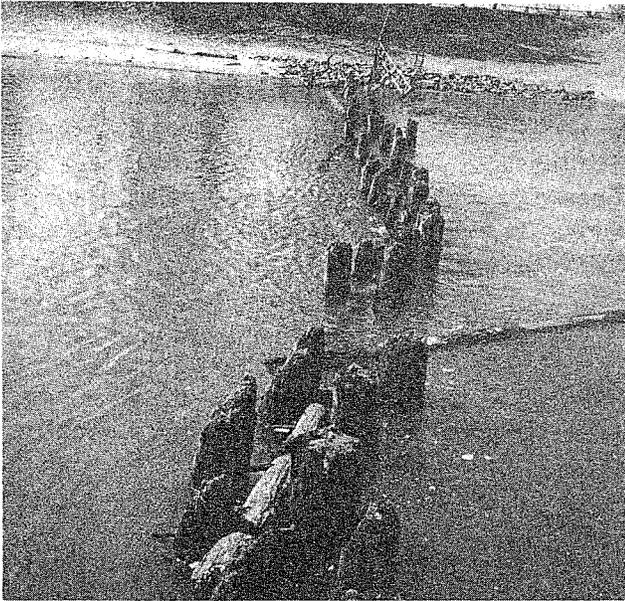
Spur dike constructed from untreated Douglas fir and suffering from age deterioration. At the landward end of the structure, a landowner has placed stone in an effort to control sloughing of the riverbank.

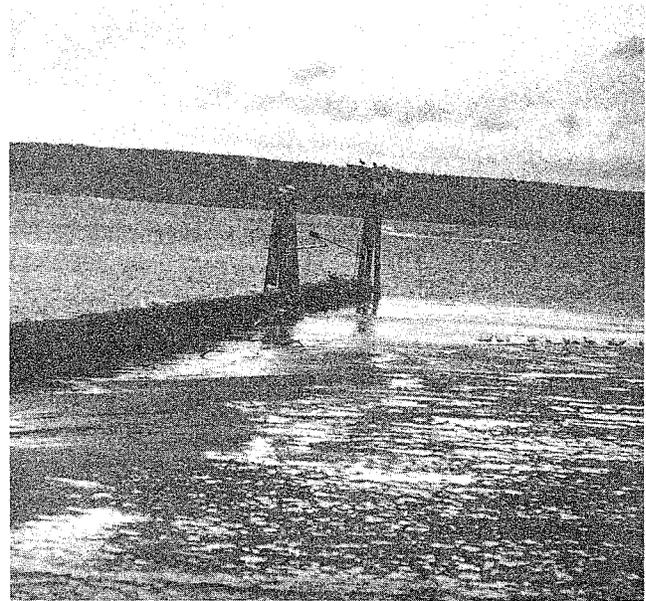
Training structure constructed to control shoaling near a river mouth. Slope failure of the outer end several years ago resulted in the loss of several hundred feet of the structure.
