The REMR Bulletin

News from the Repair, Evaluation, Maintenance,
and Rehabilitation Research Program

DEC 1987

Concrete Rehabilitation at Lock and Dam No. 20, Mississippi River

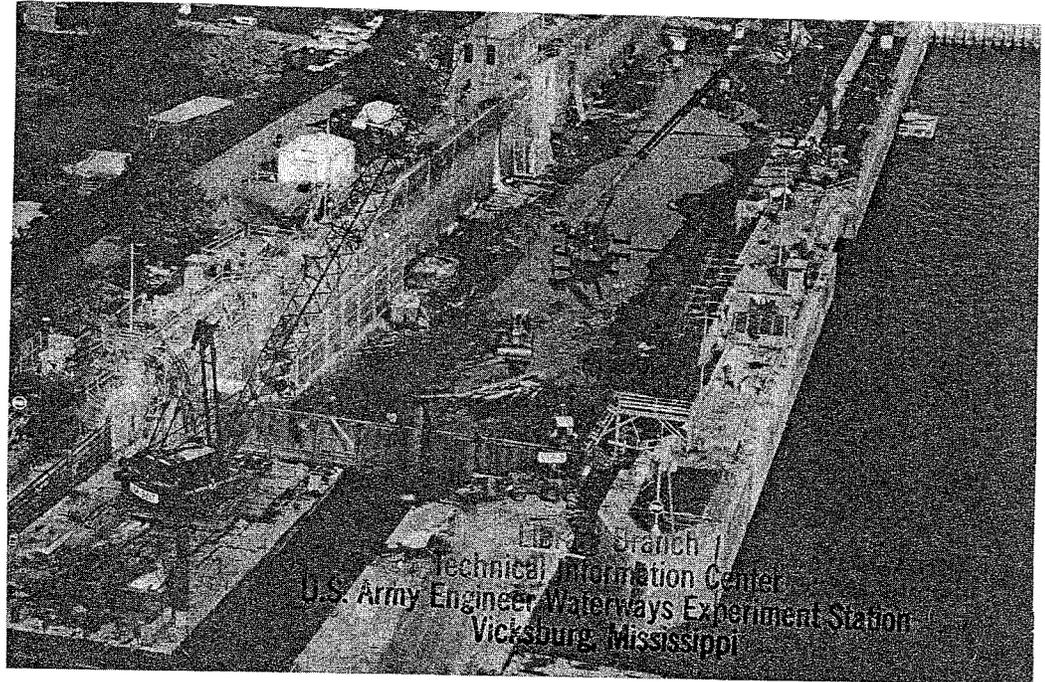
Lock and Dam No. 20 dewatered for rehabilitation

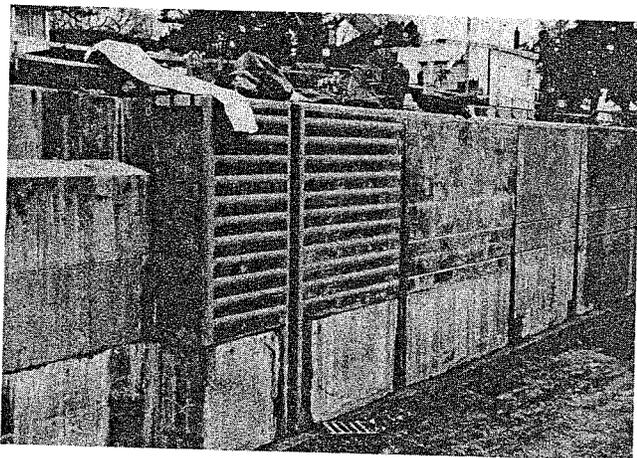
During the approximately 50 years of the structure's existence, severe climatic conditions plus impact and abrasion

from barges and boats deteriorated the surface of the nonair-entrained concrete lock walls. Cores taken during a condition survey in 1985, however, showed the average compressive strength of the underlying sound concrete to be 6,974 psi.

Figure 1. Wall armor embedded in lock wall to minimize the effects of abrasion and impact

Major rehabilitation of the lock wall surface was begun in 1986. The deteriorated concrete was replaced with conventional air-entrained concrete. Wall armor was embedded in areas susceptible to abrasion and impact (Figure 1). The cost of the concrete rehabilitation was approximately \$2 million.

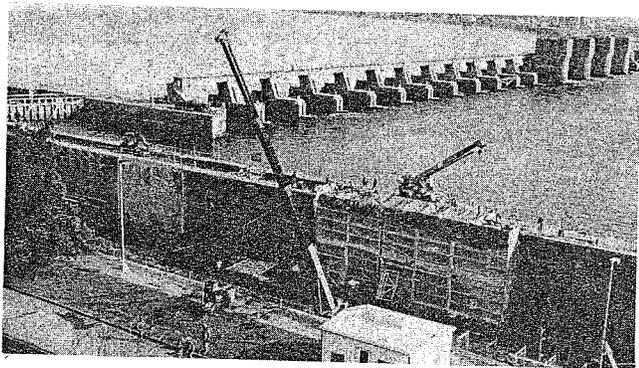
Figure 2. Heated enclosure used during winter repair of Lock and Dam No. 20

Because the work was done during the winter months when the ambient temperature ranged from 20 to 30 degrees Fahrenheit, heated enclosures were provided at each monolith (Figure 2).

After placement, temperature in the enclosure was maintained at a minimum of 50 degrees Fahrenheit for seven days. A curing compound was used for most of the curing. However, moist curing (wet burlap covered with plastic sheeting) and forms left in place were also used.

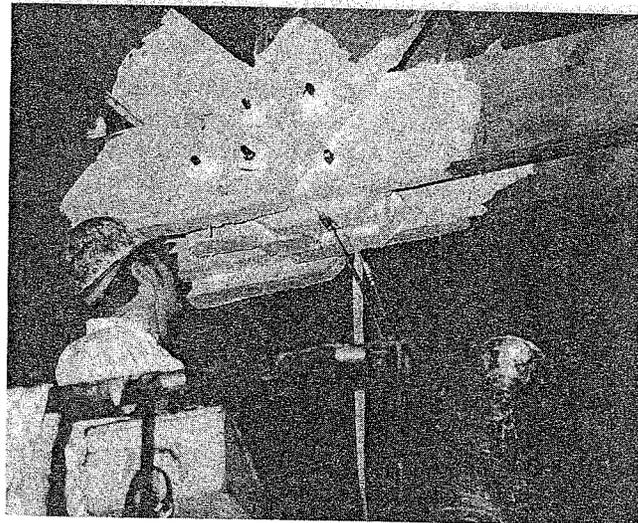
In the spring of 1982, following a partial collapse of one roof, the St. Louis District inspected roof truss members and columns in the warehouses. Many of the horizontal, vertical, and diagonal truss members were severely damaged, probably as a result of the heavy snow loads of the previous winter. Some of the 10- by 14-inch timber support columns had failed, and many had severely split. Repair of wooden columns using epoxy was not attempted because a large amount of epoxy would be needed to fill the many cracks and a large amount of sealer would have been needed to completely seal the surfaces of entire columns. Failed columns were replaced, and columns with very large cracks were shored with timber members. All columns were banded to ensure a margin of safety against column failure.

Figure 2. Injecting low-viscosity epoxy into a cracked roof truss

The next step was to inject low-viscosity (LV) epoxy into the cracks. Using an injection pump about the size of a large briefcase, the two-part LV epoxy, Sicadur Hi Mod LV, was mixed and pumped through the lowest central injection port. As it penetrated the crack, it was forced out of secondary or breather ports which were promptly closed when the epoxy appeared. These breather ports verified that the epoxy was penetrating the cracks as desired. The injection continued until the epoxy emerged from the last breather port, which was then crimped closed, along with the injection port. Within an hour the LV epoxy began to set, and after 24 to 48 hours, it exceeded the strength of the wood it bonded.

Injection pressure was limited to a maximum of 40 psi, thus providing time for the epoxy to penetrate wood fibers before being forced from the breather ports. By controlling injection pressure, blowouts of the LV epoxy through the CS epoxy were kept to a minimum.

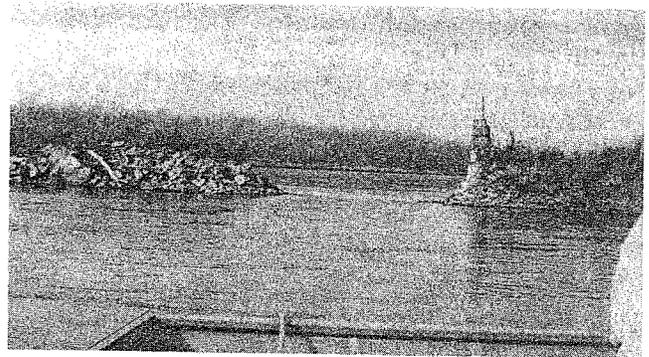
Figure 1. Gaps or notches in dikes which hinder sediment accretion

- Dredging accumulated sediments from dike fields and maintaining connecting channels between backwater pools and the main channel.
- Raising and lowering dike crests and using brush, boulders, stone, or automobile tires to provide artificial fish shelters.
- Allowing crests of training structures to degrade below design elevations if not detrimental to the stabilized channel.
- Constructing gaps or notches in dikes to hinder sediment accretion (Figure 1).
- Constructing dikes with a gap between the dike structure and the river bank.
