# The REMR Bulletin

News from the Repair, Evaluation, Maintenance,  
and Rehabilitation Research Program

VOL 6, NO. 4

## Rehabilitation of Peoria Lock Using Preplaced-Aggregate Concrete

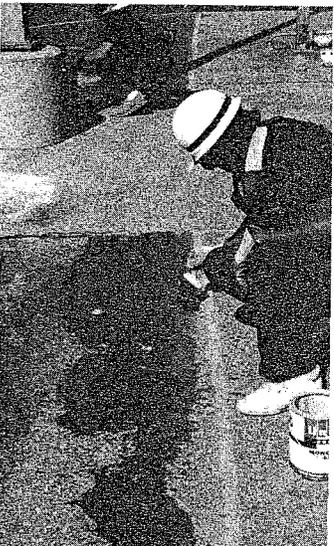
Some defects (vugs) occurred on the concrete surface. Some of the vugs are the result of the method used to vibrate the forms and changing the grout flow requirement from 18 sec to 26 sec. Additionally, in some areas where PAC was to be used,

Vugs on resurfaced lock wall at Peoria Lock and Dam, as concrete is being moist cured.

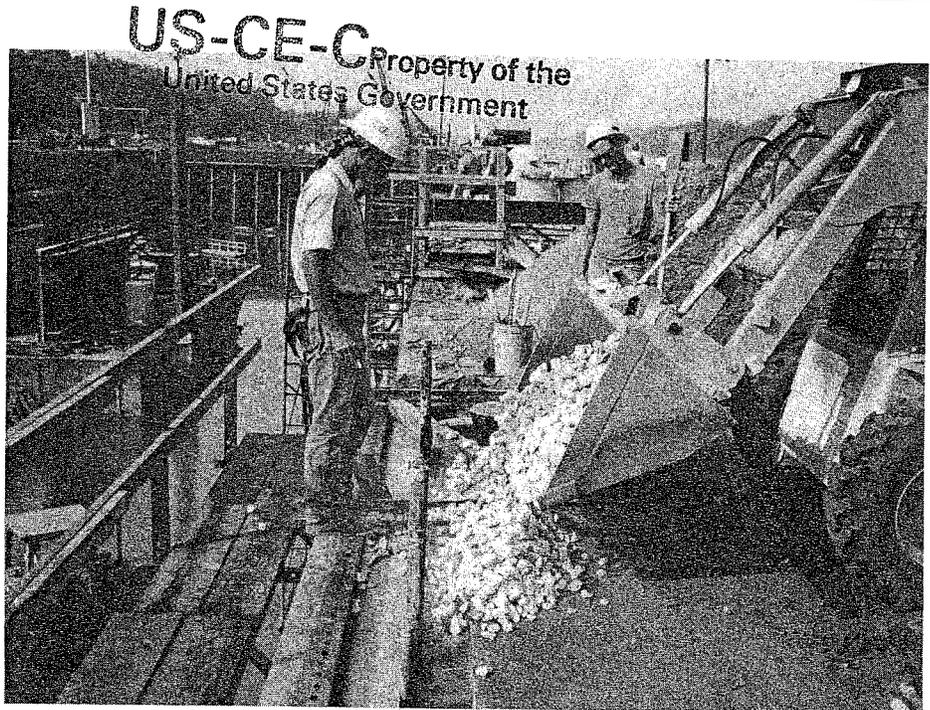
Prewashed, coarse aggregate being placed in water-filled form

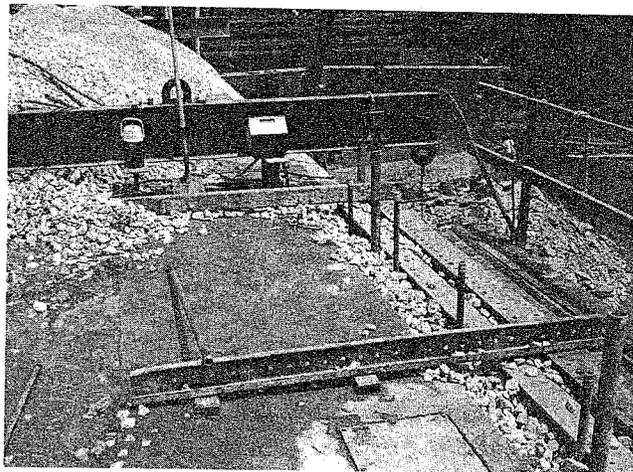
Figure 1. Panel ready for grout injection. Sounding wells, grout injection pipes, and coarse aggregate visible.

Grout injection pipes (10 per monolith) and observation pipes (3 per monolith) were set vertically on 4-ft and 12-ft centers, respectively, in each form (Figure 1). Forms were filled with water to reduce breakage of coarse aggregate as it was placed in the form. As much pre-washed coarse aggregate as possible was placed in the forms to maximize point-to-point contact of aggregate particles and to reduce the amount of grout required to fill voids. It is estimated that the PAC contained 2,700 lb of coarse aggregate in each cu yd.

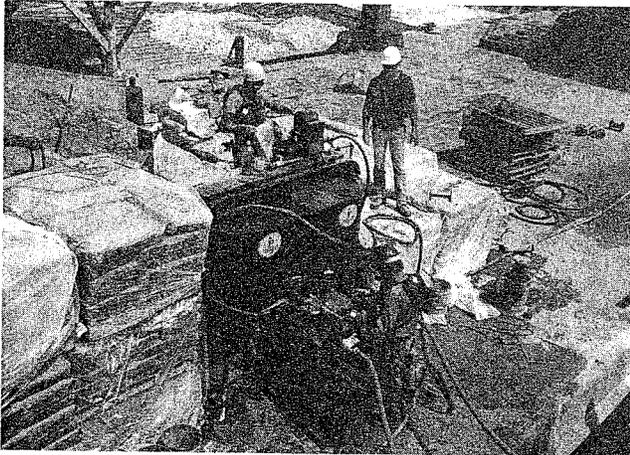
Figure 2. Grout mixer and pump. Grout materials being measured into the mixer

being resurfaced, adjusting pumping requirements as needed (Figure 2).

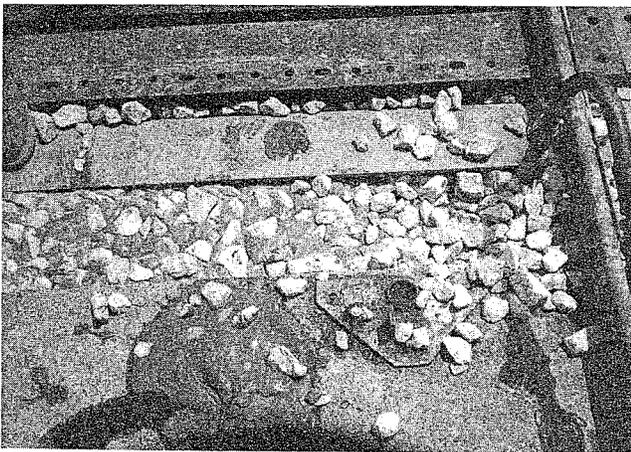
Figure 3. Grout "daylighting" at the top of a form

After approximately 8 to 10 hr of pumping, the grout would "daylight" at the top of the panel (Figure 3). Sufficient additional grout was pumped to ensure no dilution of the grout at the surface. Three-eighths- to one-half-inch aggregate was worked into the top surface, and then the surface was broom finished. The forms were removed 24 to 48 hr after the completion of grouting operations.

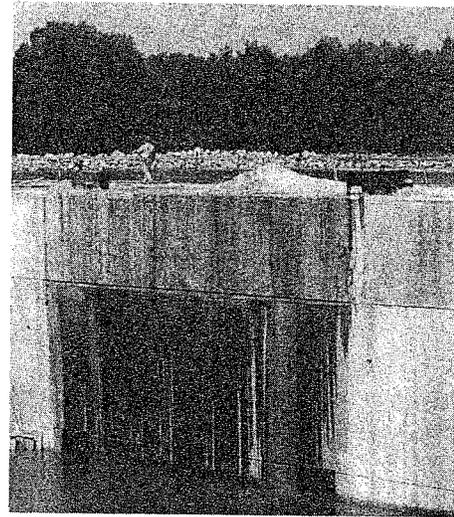
Figure 4. Moist curing of a resurfaced monolith

The PAC was moist-cured for 7 days. The contractors set up a soaker system on top of the lock wall which allowed water to flow down the resurfaced face of the lock wall (Figure 4).

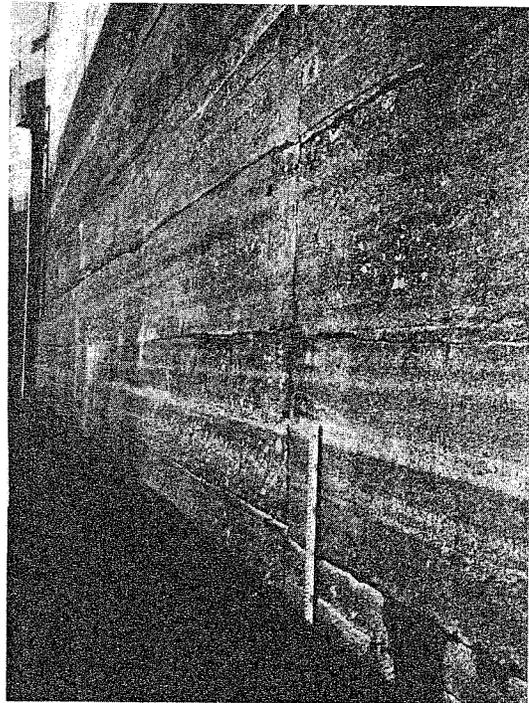
Figure 1. Upstream face of dam showing horizontal lift joints and vertical construction joints between blocks

joints, the situation continued to deteriorate. By mid-1987, leakage in the left side alone had reached over 4,000 L/min and was entering the lower drainage gallery at higher pressures and over larger areas than before. Seepages on the downstream side of the gallery were also noted. Following the structured analytical approach as outlined above, treatment was concentrated on a 23-m-long section in the most critical area and was conducted from within the 2.4- by 2.2-m lower gallery, running about 3 m above the foundation and 4.5 m back from the upstream face (Figure 2). Fans of primary holes, up to 6 m long, were cored at regular intervals upstream from the gallery to investigate the suspect joints. These holes confirmed that the water flows were travelling through the joints: the concrete itself was materially sound. Many holes intercepted flows of up to 400 L/min at full hydrostatic head.

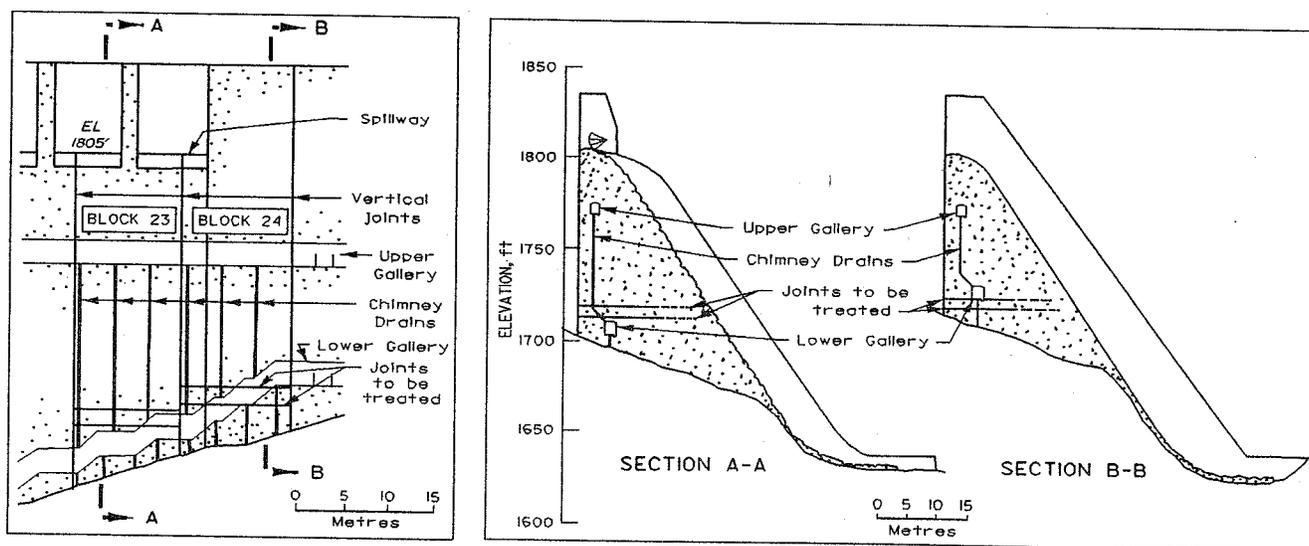
Figure 2. Horizontal joints investigated and treated in Blocks 23 and 24

After all the primary holes had been drilled (Figures 3 and 4) and the data carefully considered, the systematic epoxy resin grouting program was commenced through special packers fixed in each hole. Resin, injected through one packer, would be observed to travel and connect with the next hole, to which injection would then be transferred. In this way, the continuity of the resin filling could be promoted.

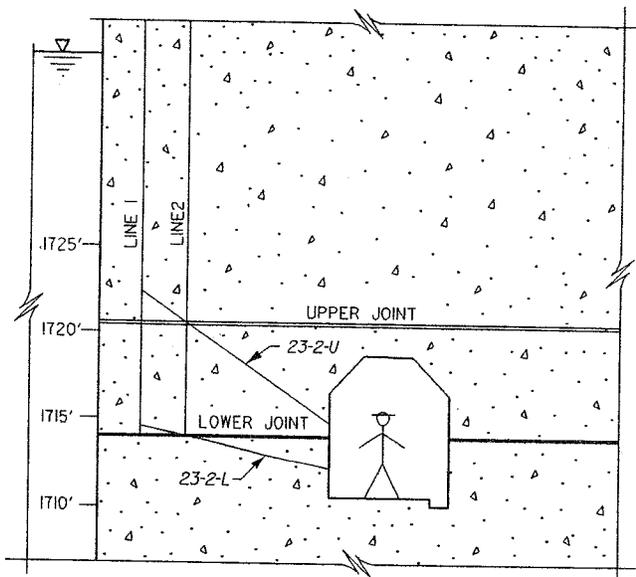
Figure 3. Typical section showing intended joint interception at one station

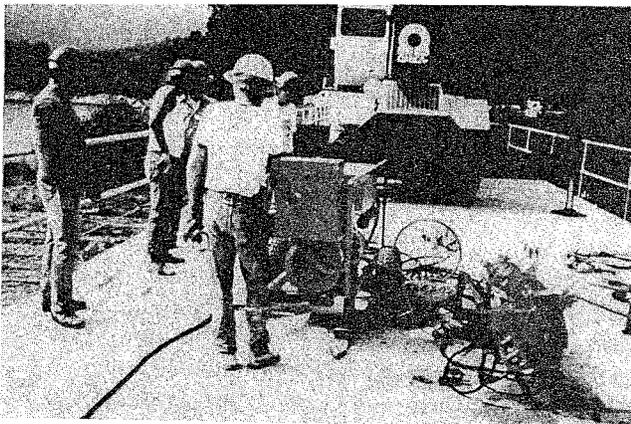
Figure 4. Components of the electrohydraulic coring rig (from right, mast w/head, controls, power pack)

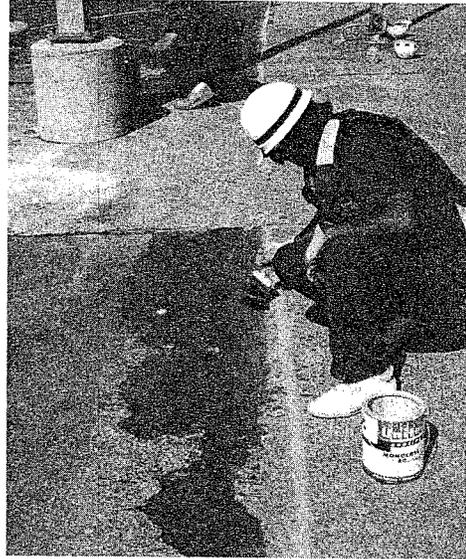
Field testing of a penetrating concrete sealer, Brandon Road Lock & Dam, Rock Island District, Illinois
