The REMR Bulletin

VOL 8, NO. 2 INFORMATION EXCHANGE BULLETIN APR 1991

Hammondsport Flume: A Case History in Rehabilitation and Repair

Effective Underwater Joint Sealing at Chief Joseph Dam

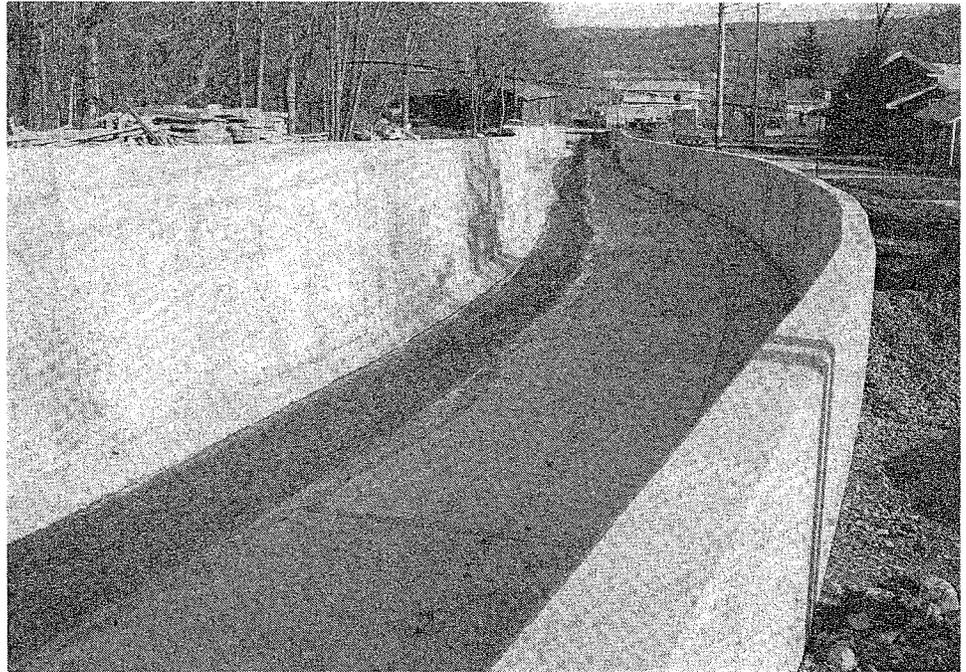
Hammondsport flume, showing replaced section after completion

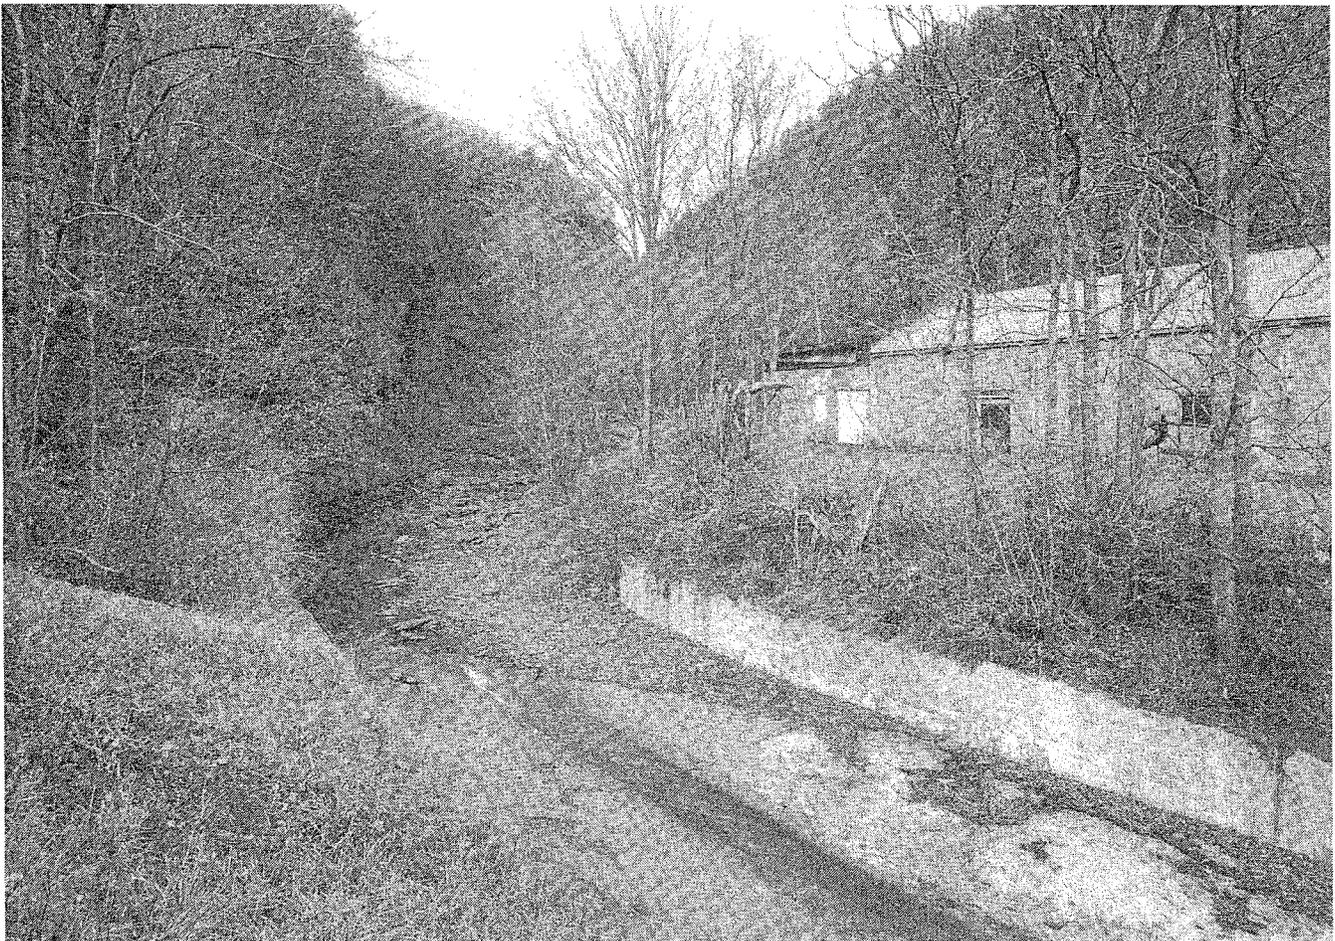
Glen Brook annually produces several hundred cubic yards of gravel (Fig. 1). The gravel moves by high velocity flow and erodes the floor of the flume. In 1950, the State sponsored some repairs through the Buffalo District Corps of Engineers by patching the floor and constructing a low flow channel. The State has been responsible for maintenance since 1950.

Figure 1. The upstream end of the flume before construction, showing gravel deposits

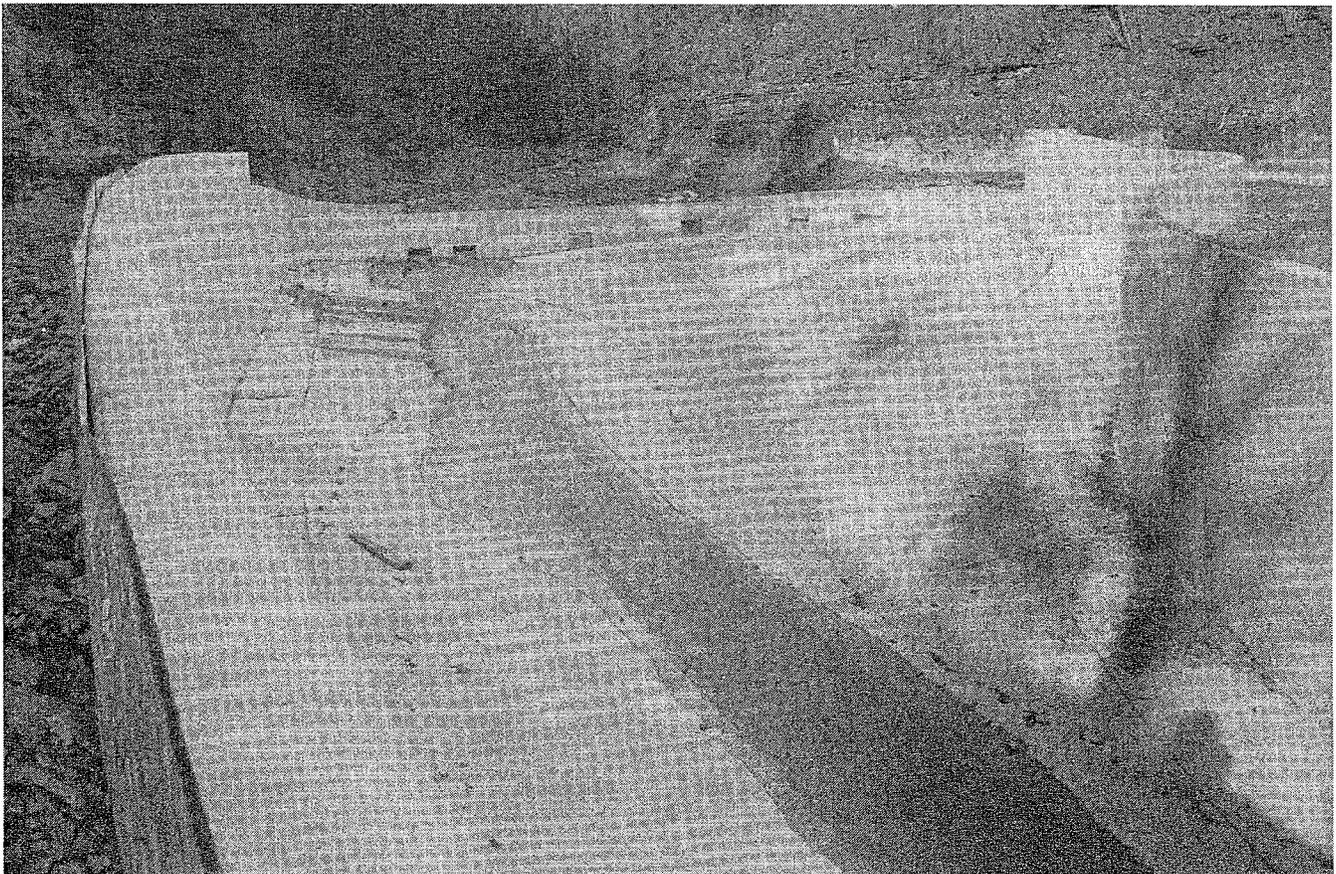
Figure 2. Weir, sediment basin, and access road for maintenance are part of the new intake systems that helps control gravel intake

- Proposing to extend the flume 200 ft upstream and expand the entrance from 32 ft to 85 ft.
- Protecting the flume with a 6 1/2-ft-high weir across its entrance. The weir would form a 1,600 cu yd sediment trap to stop the major portion of moving

gravel. The weir would be constructed with five 2-by 3-ft openings in order to convey low flow through the structure.

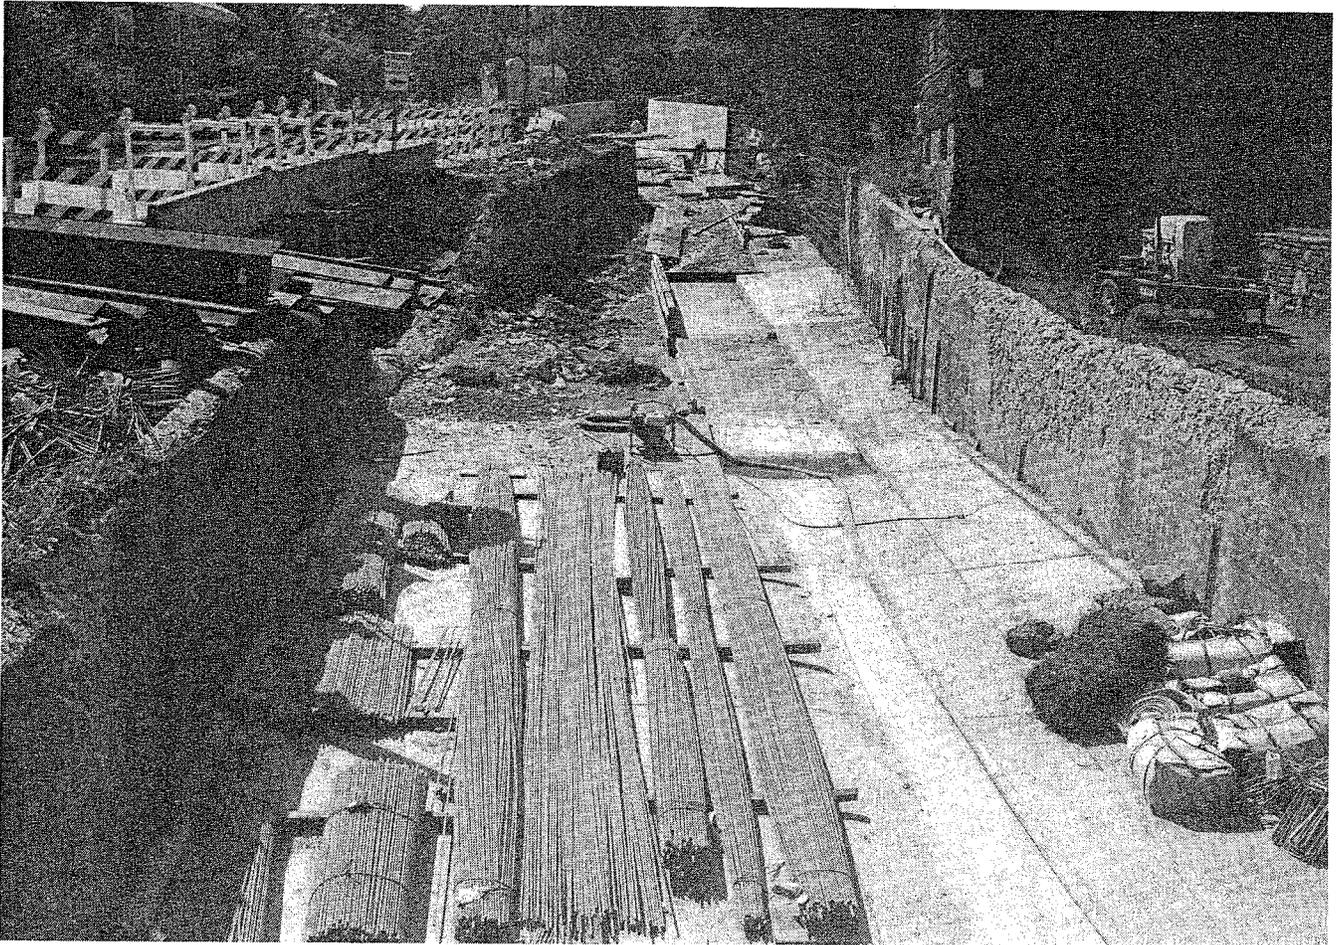
Figure 3. Upstream view, showing end of replacement section and beginning of overlay section during construction

- Replacing the upper 650 ft of the old structure. This would eliminate the hydraulic restriction by deepening the channel and reducing the sharp curve in the structure.
- Proposing to remove all deteriorated concrete in the 1,583-ft remaining section of the flume and by overlaying the floor and walls with a minimum of 6-in. of reinforced concrete. Reinforcing steel would be held in place with drilled and grouted dowels on 2-ft centers into the old concrete. In addition, care would be taken to honor existing construction joints (Fig. 3).

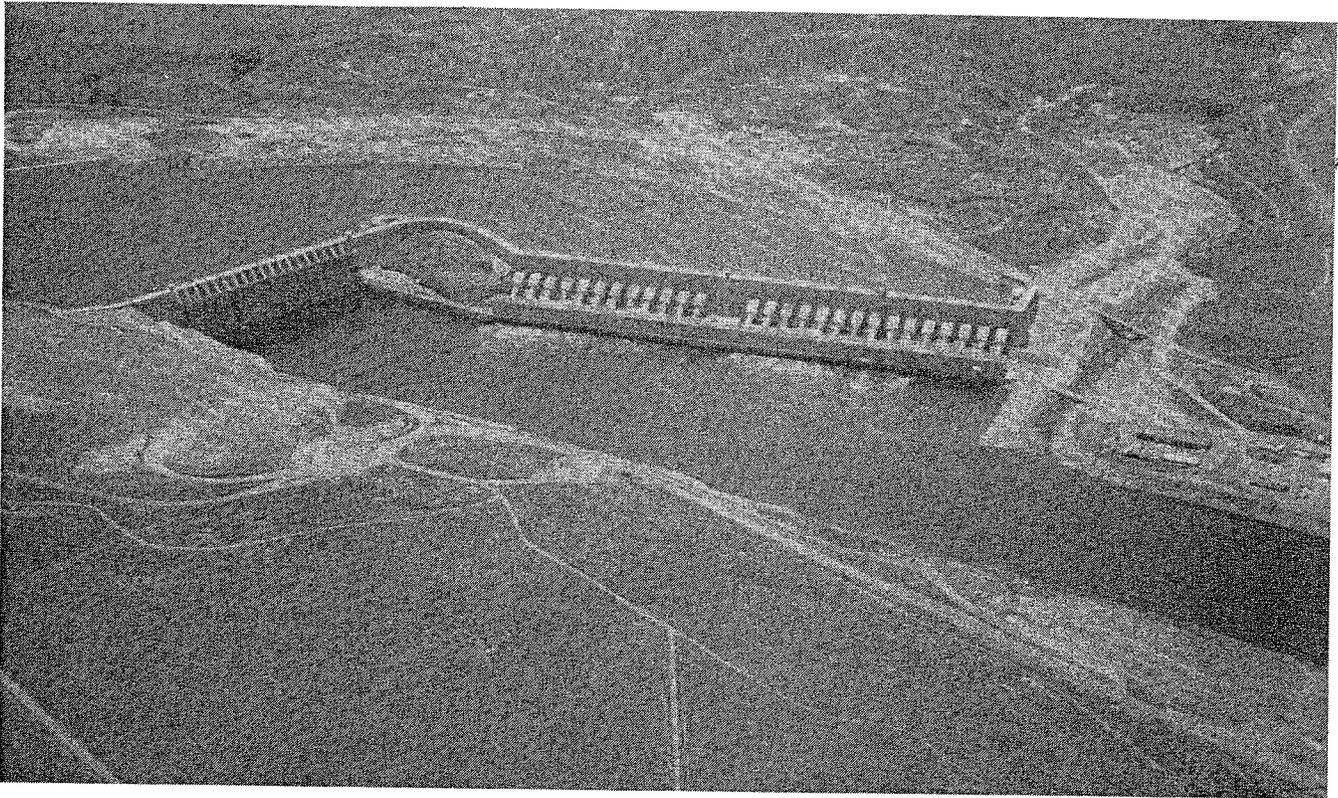
Figure 1. Aerial view of Chief Joseph Dam, Washington

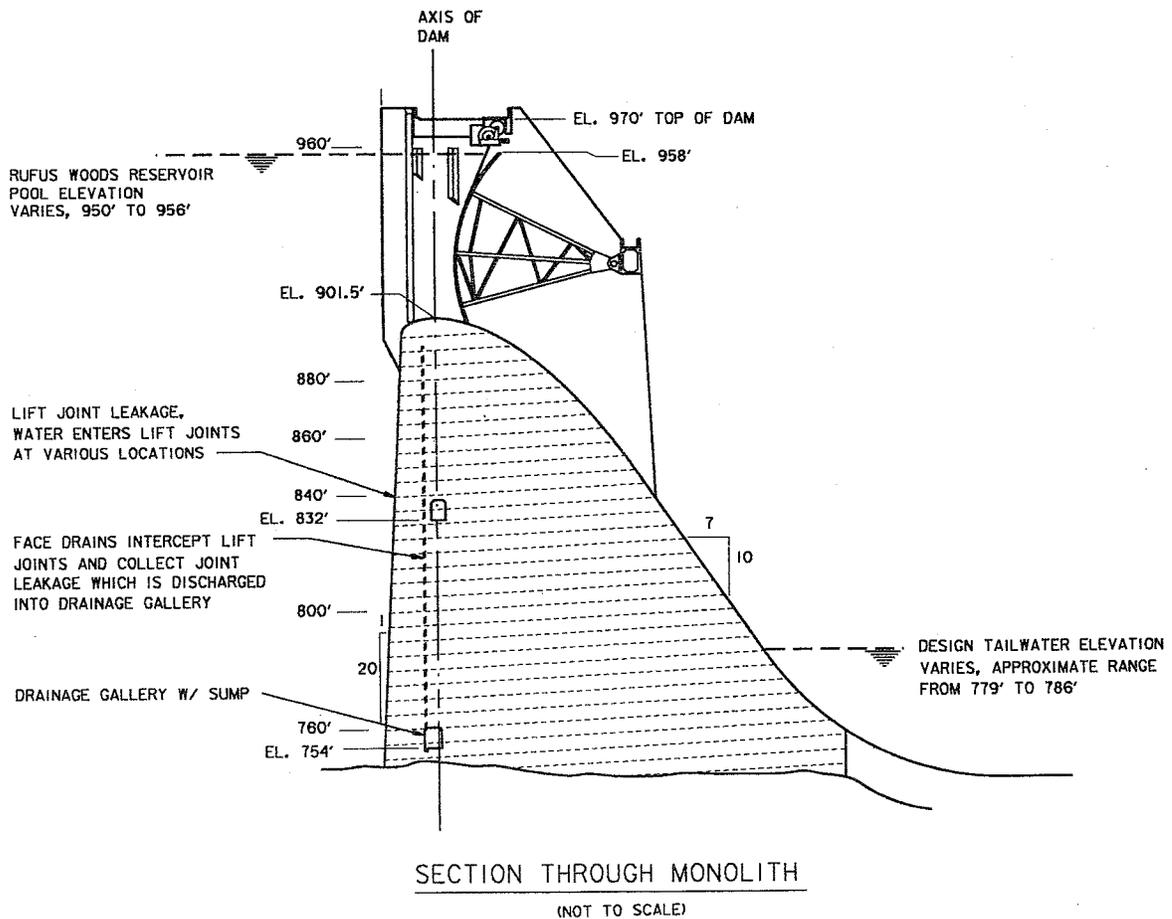
Leakage was the result of the structure's open horizontal lift and vertical monolith joints. Large volumes of water from the upstream reservoir entered the joint lines during the coldest period of the year when the concrete contracted and the joints opened. The annual variation in leakage ranged from less than 100 gpm in summer and early fall to over 5,000 gpm by the end of February to mid-March.

The spillway monoliths (Fig. 2) were constructed with five, equally spaced, vertical face drains, which collect leakage intrusion from the lift joints and discharge it into the drainage gallery. The monolith joints were constructed with two vertical, copper waterstops, spaced 36 in. apart (upstream/downstream) with an 8-in.-diam joint drain centered between them. This drain collects monolith joint leakage and discharges it into the drainage gallery. The discharge from the face and joint drains in the drainage gallery is collected in the spillway sump.

Figure 2. Monolith section showing leakage

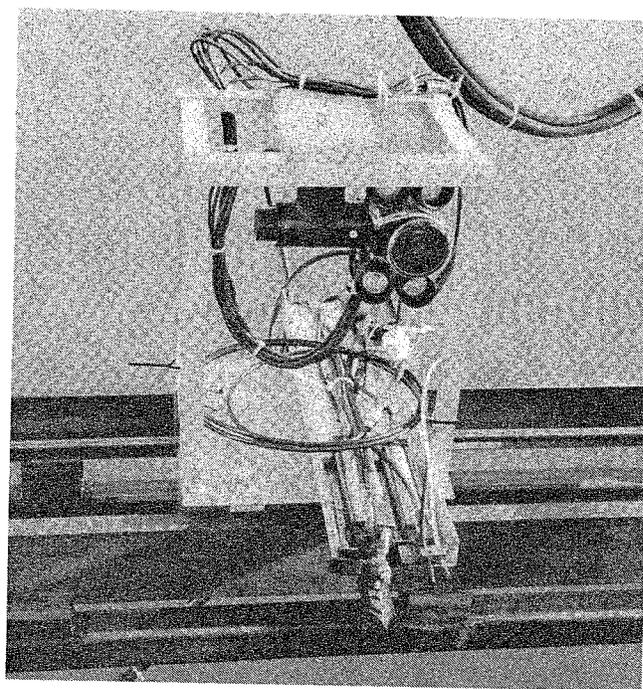
Figure 3. Pan-tilt camera with lights mounted on underwater frame, steel scraper tool with high-pressure water-blasting nozzle, grout hose (black) and dye hose (white)

the cleaning-inspection-grouting equipment along the length of the frame to traverse a lift joint (Fig. 3). All camera systems were color videos with monitors and recorders. A downhole camera was used to inspect the monolith joint drains. A remotely operated vehicle (ROV), self-propelled (swimmer) camera was used for underwater inspections. Results of repairs on individual joints were readily discernible as the work progressed. As soon as a joint was sealed, leakage was reduced significantly as determined by measurement and visual inspection of drain outflows.
