# The REMR Bulletin

News from the Repair, Evaluation, Maintenance,  
and Rehabilitation Research Program

US-CE-C Property of the  
United States Government June 1992

Volume 9, Number 2

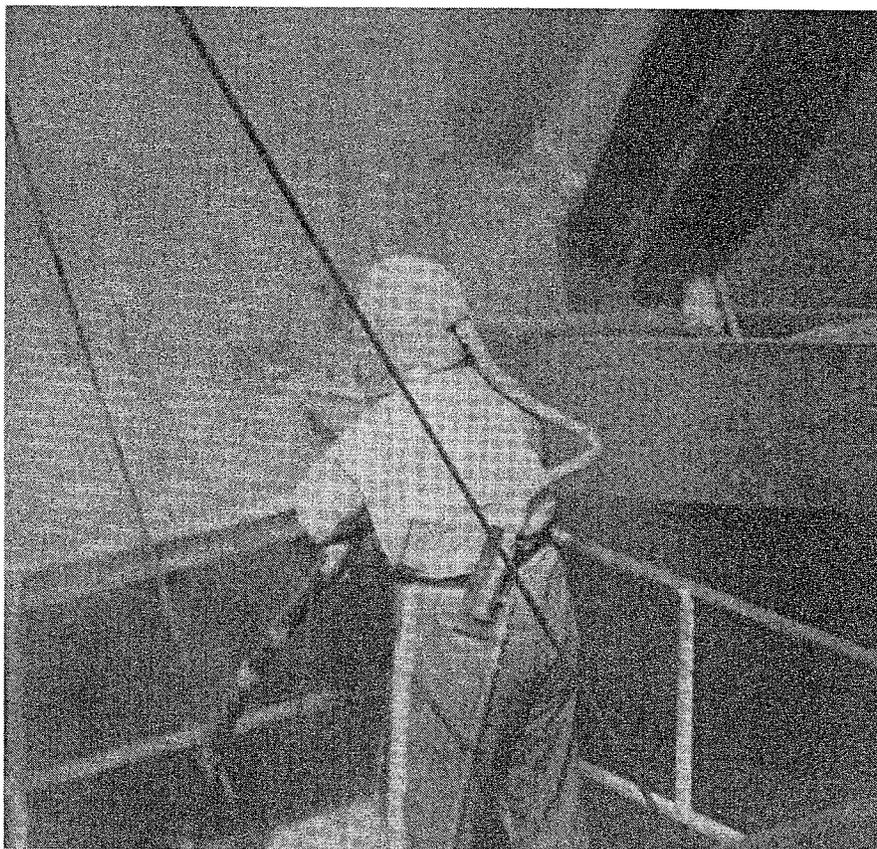
Blaster removing red lead vinyl paint system from tainter gate.

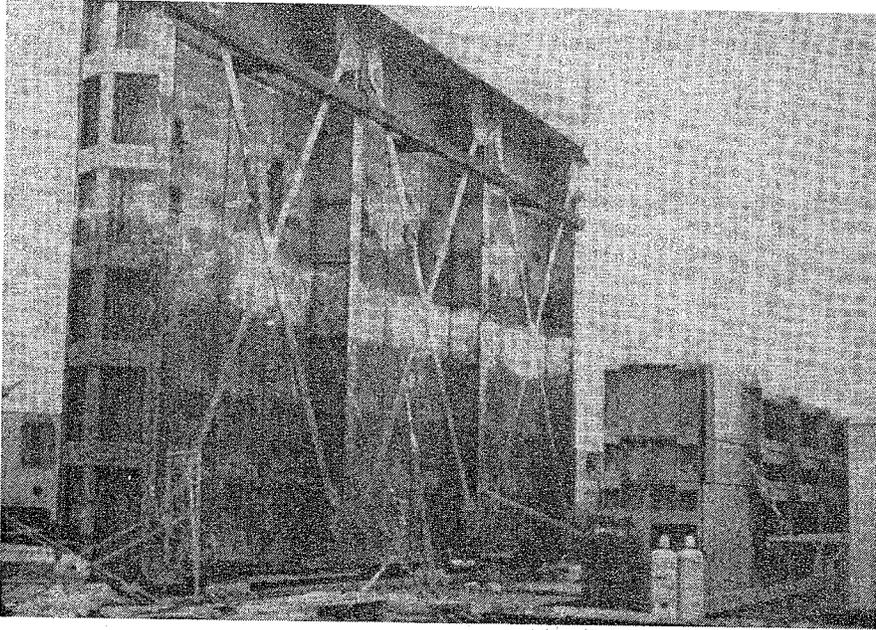
**Miter gate set onto barge in preparation for repainting.**

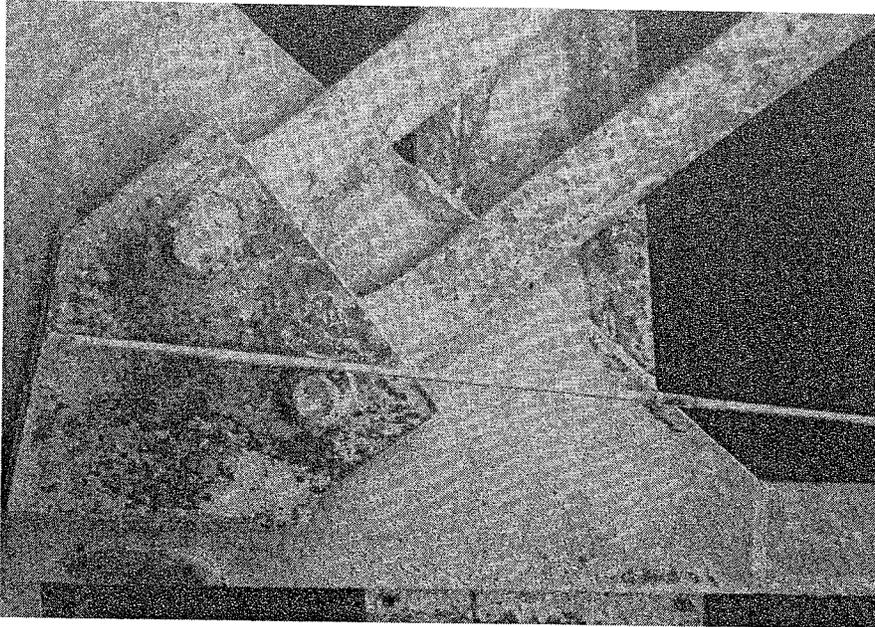
**Close-up of corrosion on miter gate. Repainting will probably be done by contractor.**

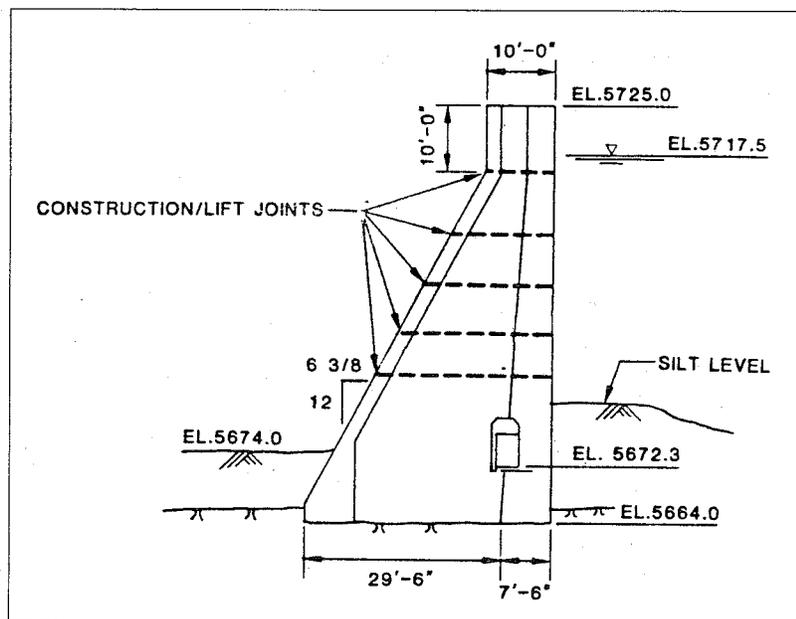
Figure 1. Nonoverflow gravity dam section, Soda Dam, Idaho.

- Advanced deterioration existed in the outer 1 to 2 ft of the downstream face and in the upper 10 ft of the structure.

- The surface concrete on the downstream face contained extensive microcracking with soft, carbonatelike fillings (calcium-alkali-silica gel), indicative of alkali-aggregate reactivity.
- Compressive strengths in the downstream face and upper 10 ft were 1,500 to 3,000 psi versus 3,000 to 4,000 psi within the body of the structure.
- Reactive aggregates were identified as part of the concrete especially (rhyolites and other silica-rich aggregates).
- Cracking was attributed to swelling of the calcium-alkali-silica gel by-product of the alkali-aggregate reaction and subsequent cycles of freezing and thawing.

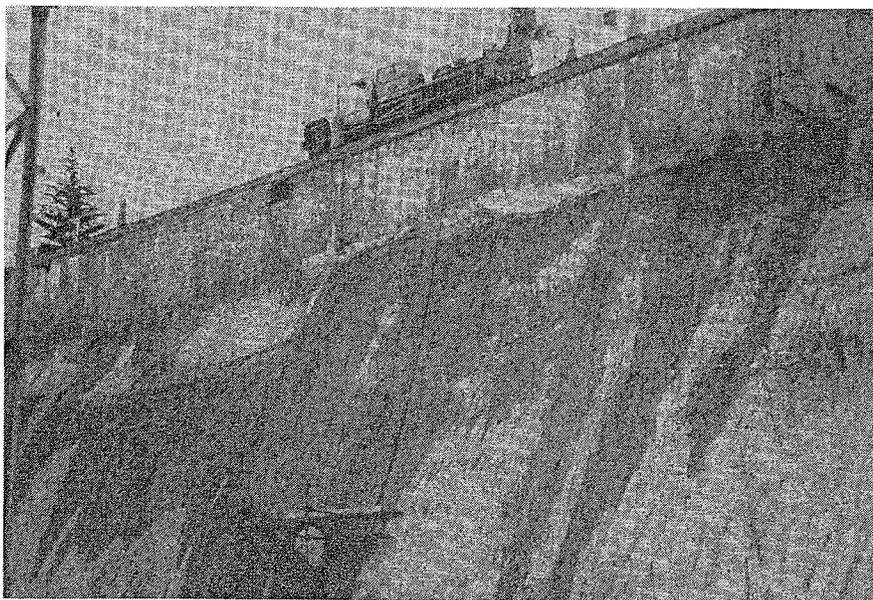
The nonoverflow gravity section was determined to be stable, structurally sound, and strong enough to resist overturning or sliding in its present condition for the normal operating loading condition. However, over time continued seepage of water through cracks and joints could jeopardize this condition by weakening the structure along horizontal construction joints (Figure 2). Once a large enough area was

Figure 2. Seepage on downstream face of gravity section.

weakened, a sliding failure or increased leakage could result. A decision was made to eliminate the leakage through the structure. Remedial techniques considered included: removing and replacing concrete over the upstream face of the dam, covering the upstream face with a two-component membrane (PVC and geotextile lining), and chemical grouting of construction joints.

The actual cost for chemical grouting would be dependent upon the difficulty of localizing and isolating seepage zones. Chemical grouting of joints and cracks was chosen as the most economical and best technical alternative.

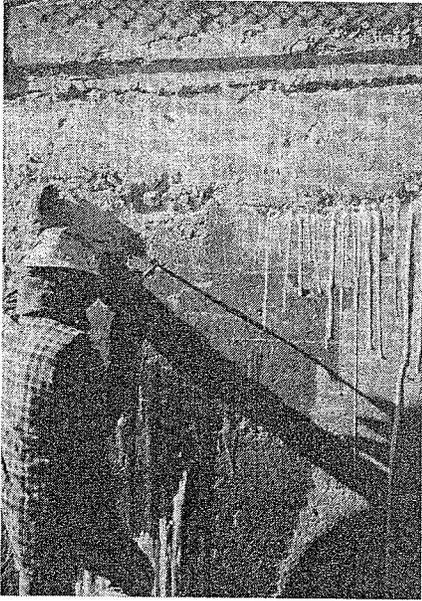
**Figure 3. Chemical grouting of upstream face.**

A total of 290 gal of polyurethane grout was injected into 450 holes for the treatment of 630 lin ft of monolith and lift joints (Figure 3). Grout acceptance varied from 0 to 5.0 gal per hole, with only 1 percent of the holes found to be tight. The overall average grout acceptance per linear foot of joint/crack treated was 0.65 gal per lin ft, with higher acceptance in the upper 10-ft section of the dam (area of normal pool elevation fluctuation), which had more deterioration and microcracks. In this zone, maximum grout penetration along microcracks to a distance of 6 ft was realized.

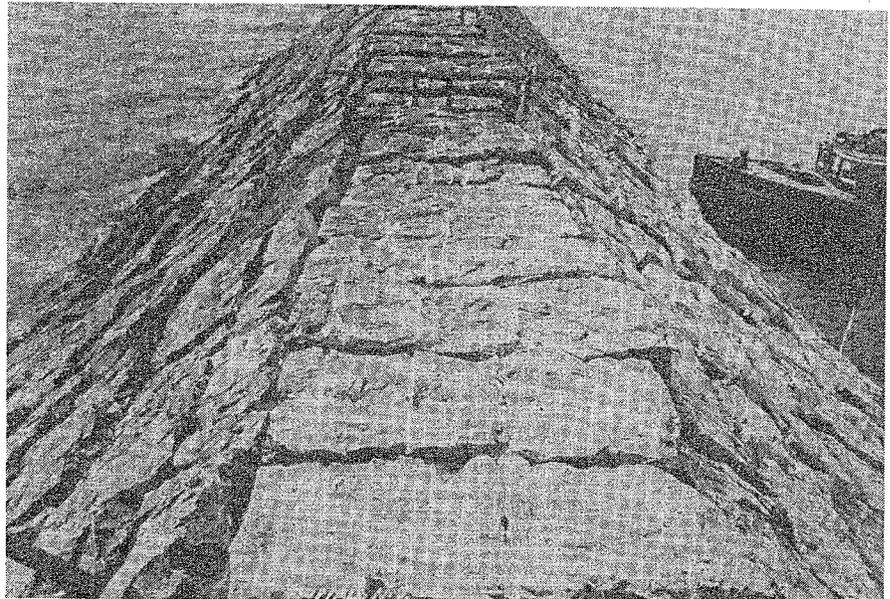
**Buffalo, New York, breakwater. The first rubble-mound breakwater constructed on the Great Lakes (1897-1902). Note the laid-up stone armor over the rubble mound.**

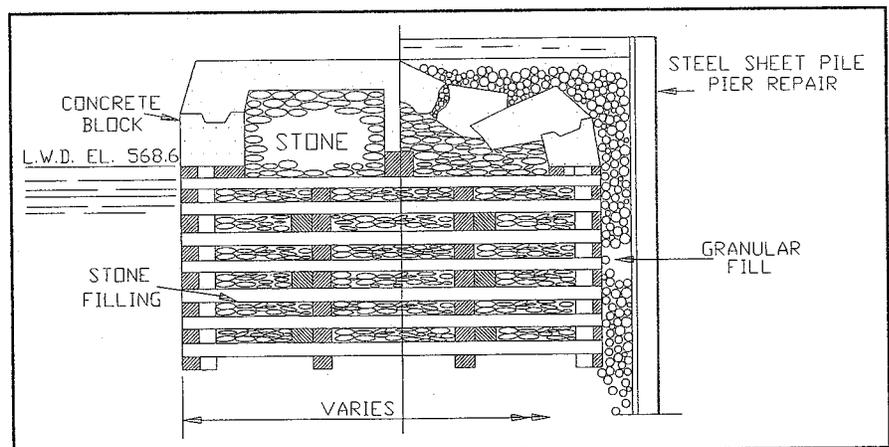
Figure 1. Section of North Pier, Erie, Pennsylvania. Original construction 1825-1900 of vertical-faced, stone-filled timber crib. Later repair included steel sheet-pile facing with granular fill.

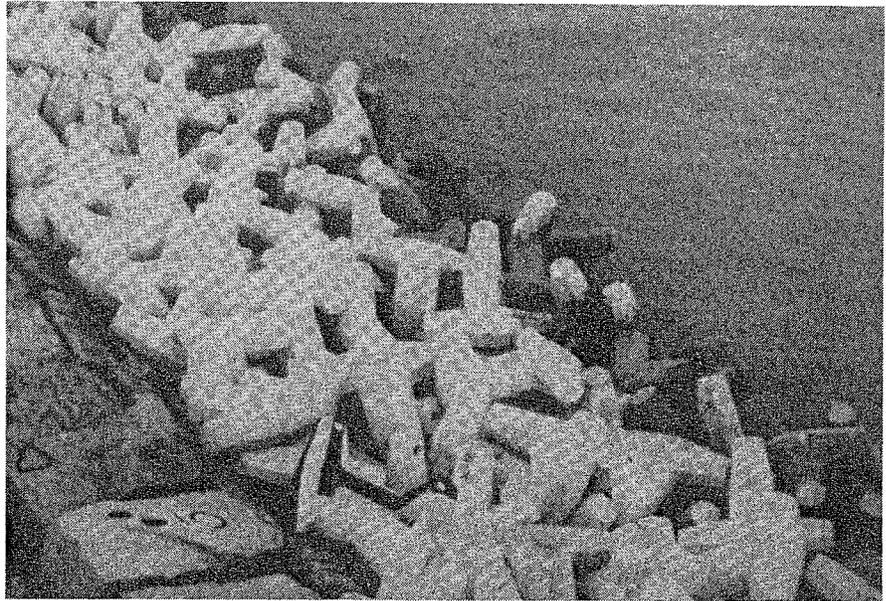
In contrast, continuous breakage of 2-ton dolosse on the Cleveland Harbor, Ohio, East Breakwater as the result of wave-induced rocking and ice impacts is an example of unit aging (Figure 2). The reduced stability caused by this unit breakage was compounded by a significant storm and resulted in a localized failure at the head section in April 1982; this situation has caused concern about the long-term stability of other portions of the armor cover.

**Figure 2. Use of 2-ton dolosse on the Cleveland Harbor, Ohio, East**

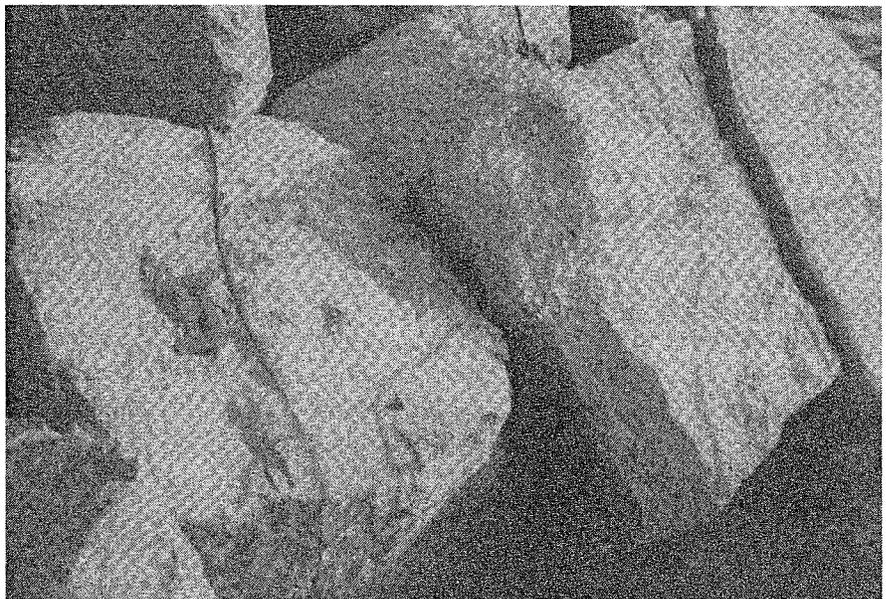
**Figure 3. Adjacent split stones, Cleveland Harbor.**

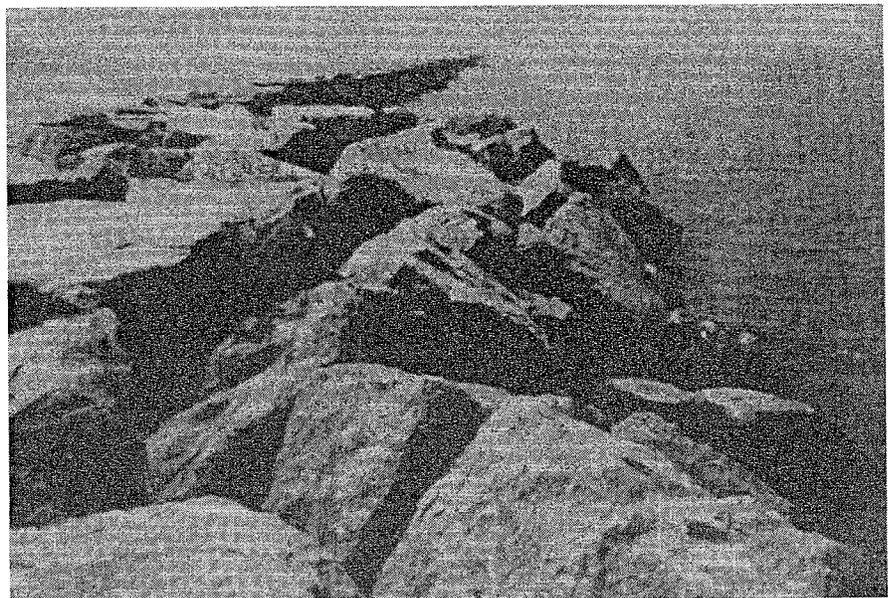
Figure 4. Example of new work, Cleveland Harbor.
