News from the Repair, Evaluation, Maintenance,
and Rehabilitation Research Program

Volume 10, Number 2

June 1993

Coastal structure inspection in wake of Hurricane Iniki

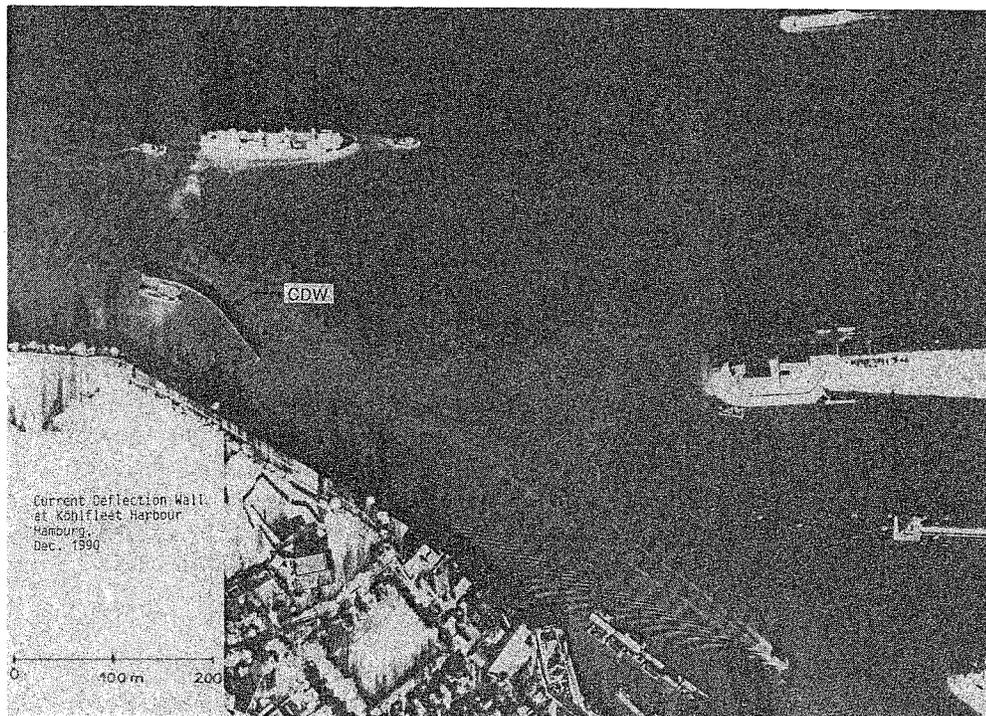
Aerial view of current deflector wall prototype in Kohlfleet Harbor, Port of Hamburg, Germany.

This CDW was built with a 2-year design life so that the operating principle could be demonstrated and verified before a permanent structure was constructed. The pilings and uprights are structurally sound and will remain in place as part of a planned permanent structure. However, the wooden panels are susceptible to ice-flow

damage, and some require replacement following winter icing conditions. The permanent panels will be fabricated from steel sheathing welded to the existing uprights.

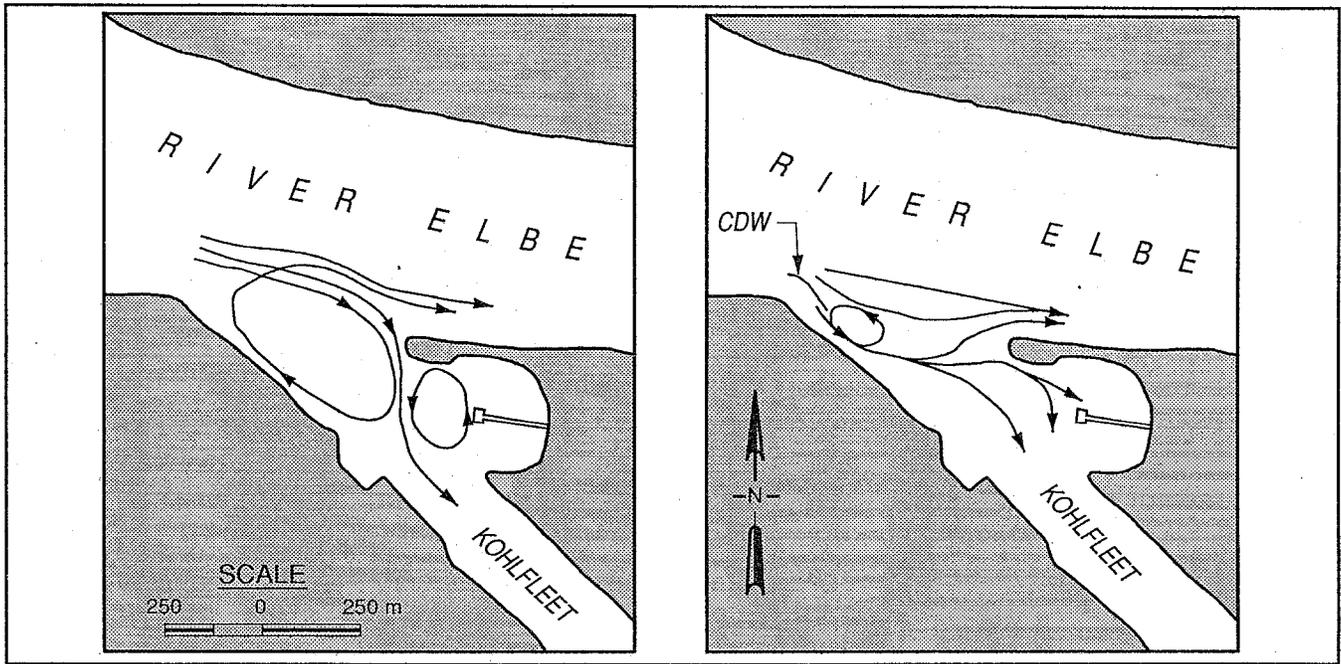
Current pattern studies were repeated at the Kohlfleet Harbor entrance immediately following CDW construction. The same type of field exercise that had identified the eddy was repeated to evaluate the success of the CDW in eliminating the eddy. This exercise involved releasing radar reflectors attached to variable depth drogues. This procedure outlined the surface and middepth current patterns. Postconstruction reflectors were placed in the Elbe River, along the CDW channel, and across the harbor entrance. This evaluation showed that the CDW had successfully eliminated formation of the large, stable eddy in the harbor entrance. Navigation through the harbor entrance was also improved, even though the width of the harbor had been reduced slightly by the construction. Pre- and post-CDW circulation patterns at Kohlfleet Harbor are illustrated in Figure 4.

Figure 4. Pre- (left) and postcirculation (right) patterns, Kohlfleet Harbor.

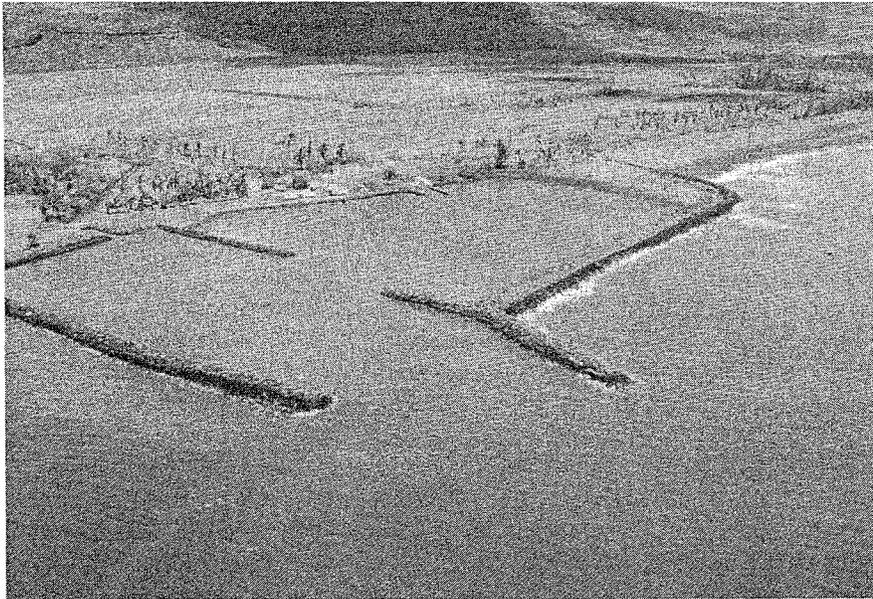
Figure 2. Kikiaola Small Boat Harbor breakwater sustained minor damage.

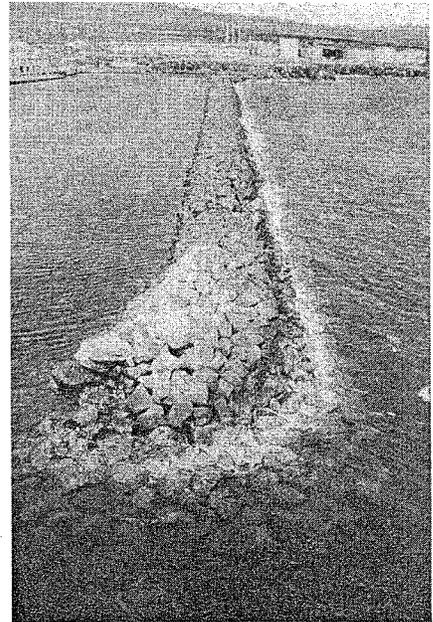
The 1,126-ft-long Port Allen breakwater, constructed on the south side of the island in 1935, suffered extensive damage. Large gaps appeared in the extraordinarily well-constructed keyed-and-fitted stone armor (Figure 3). Many 8- to 12-ton stones were totally displaced. The displacement appeared to be the result of excess internal pressure, evidenced by localized seaside and backside "blowouts" and backside toe stone displacement. While this breakwater was still functional, it was noted that immediate repairs were necessary to maintain the structural integrity. This breakwater had no repair history until severely damaged by Hur-

ricane Iwa in 1982. The breakwater was repaired in 1984 but was shortened by 74 ft.

Figure 3. Port Allen breakwater sustained damage to both head and trunk.

Although Hurricane Iniki damage was extensive, the Corps structures sustained relatively minor damage. This can be primarily attributed to excellent construction techniques. The keyed-and-fitted stone breakwaters are exceptionally stable. But it is difficult to achieve new structure stability when repairing keyed-and-fitted structures because of limited stone selection. This is supported by the fact that the Port Allen breakwater has sustained progressively more damage with each hurricane.

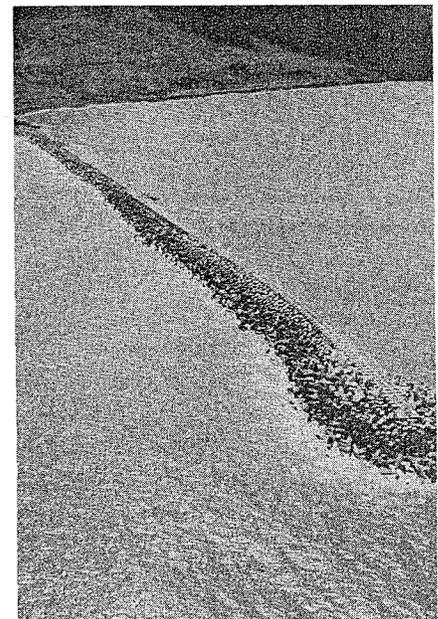
Figure 4. Nawiliwili Harbor breakwater.

At the Nawiliwili Harbor, eyewitness accounts put the wave height at 30 ft outside the harbor and 8 ft inside. The 2,150-ft-long Nawiliwili breakwater was intact with no breaches and no evidence of gross armor movement (Figure 4). Originally constructed in 1926, this structure has been repaired several times with 598 18-ton reinforced tribars placed in 1959 and 934 11-ton lightly reinforced dolosse placed over the tribars in 1977. Recently, 6.5-ton tribars were placed on the harbor side of the breakwater. A detailed inspection of the breakwater revealed seven newly broken dolosse and six newly broken tribars (Figure 5). The total count for broken units observed above the still-water level:

- 11-ton dolosse — 40 out of 934 units broken
- 17.8-ton tribars — 16 out of 598 units broken

- 6.5-ton tribars — 1 break

There were many signs of concrete armor unit movement. Almost uniformly distributed across the face of the breakwater were fresh spall marks where units had rubbed against

units. One dolos was completely displaced, with the fluke resting atop the ribbed concrete cap.

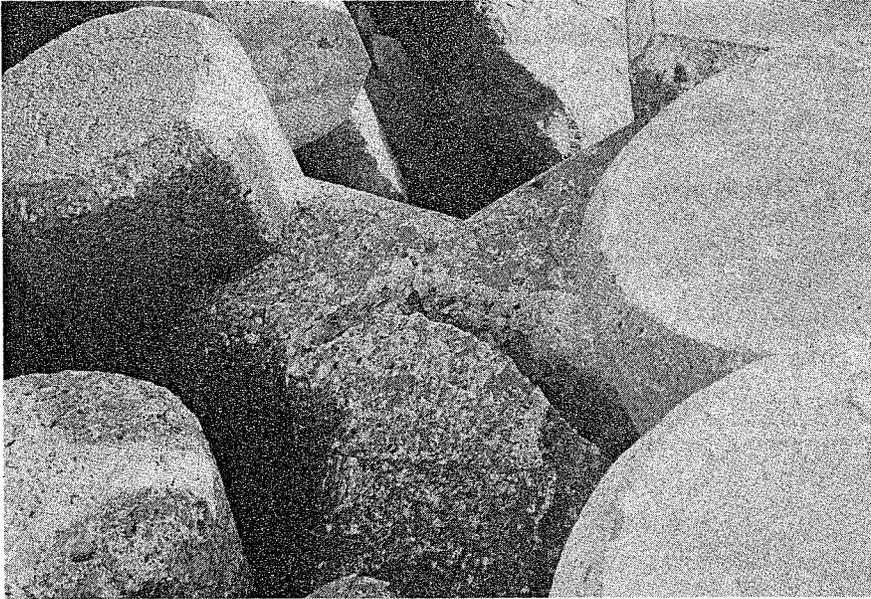
Figure 5. Freshly broken tribar on Nawiliwili breakwater.

The two concrete armored breakwaters, Nawiliwili and Waianae, are aging. The con-

crete armor rehabilitations and construction in the late 1970s show a high percentage of damage, nearing 5 percent. Recently developed stress prediction methods show that the design tensile stress corresponding to 5-percent exceedance is approximately 550 psi in the 11-ton dolosse at Nawiliwili, which is approximately equal to the concrete tensile strength (Melby 1989). This stress was determined using the concrete armor design program called CAUDAID.

A conservative redesign might incorporate fattening of the basic shape, higher strength concrete, or more reinforcement (Melby and Turk 1992). The stress prediction methods developed to date assume stable non-rocking armor units. The small dolosse at Waianae have very low predicted stable stresses but are probably rocking about on the slope, producing high impact stresses. Current investigations in the REMR Research Program are addressing incorporation of impact stresses due to armor unit movement into cur-

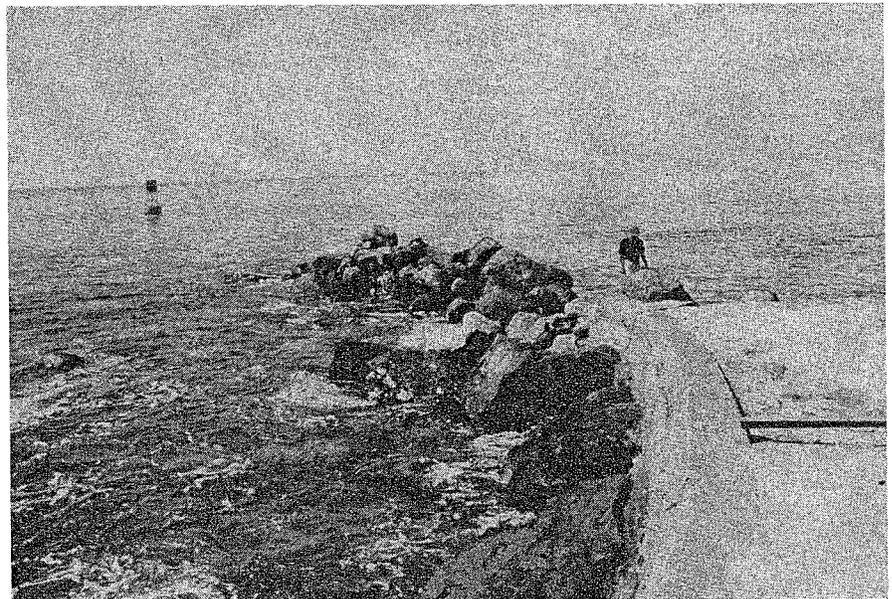
On the island of Lanai, inspection of the Kaumalapau Breakwater was conducted at the request of the State of Hawaii. Approximately 180 ft of the original 270-ft-long rubble-mound structure had been destroyed by estimated 30-ft waves on a surge of approximately 15 ft (Figure 6). This is one of the few breakwaters observed that does not have a fronting reef. The shelf slope is very steep here allowing deepwater waves to the breakwater. The inspection revealed a wide scatter of breakwater remnants,

consisting of stone, a few dolosse, and concrete and metal refuse, strewn into the mouth of Kaumalapau Harbor.

Figure 6. Breakwater destroyed by hurricane at Kaumalapau, Lanai.
