REMR Technical Note CO-RA-1.2

Concrete Armor Unit Performance Survey

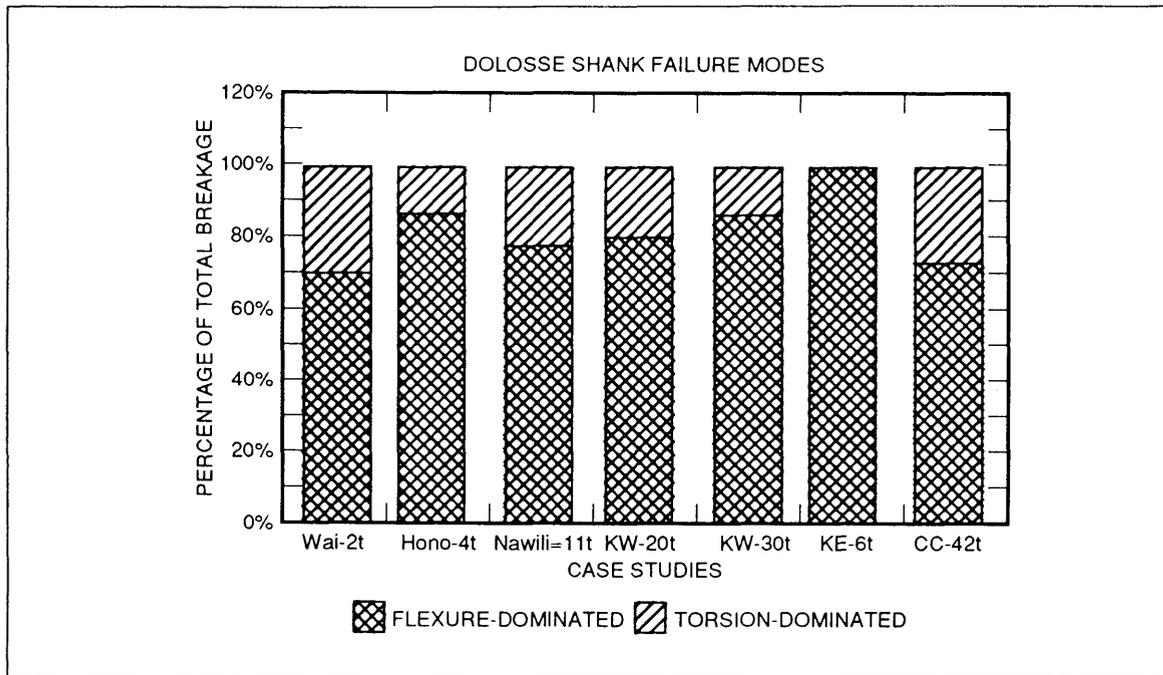
- a. *Dolos failures.* The failure modes for broken dolosse were categorized as either flexure or torsion dominated. Figure 1 shows the percentage of the total failures that were either torsion- or flexure-dominated. As this graph indicates, flexure is the dominant failure mode. Breakage was observed throughout the dolos but occurred predominantly at the shank (Figure 2). Figure 3 shows a typical example of a shank failure that is

Figure 1. Dolosse failure modes

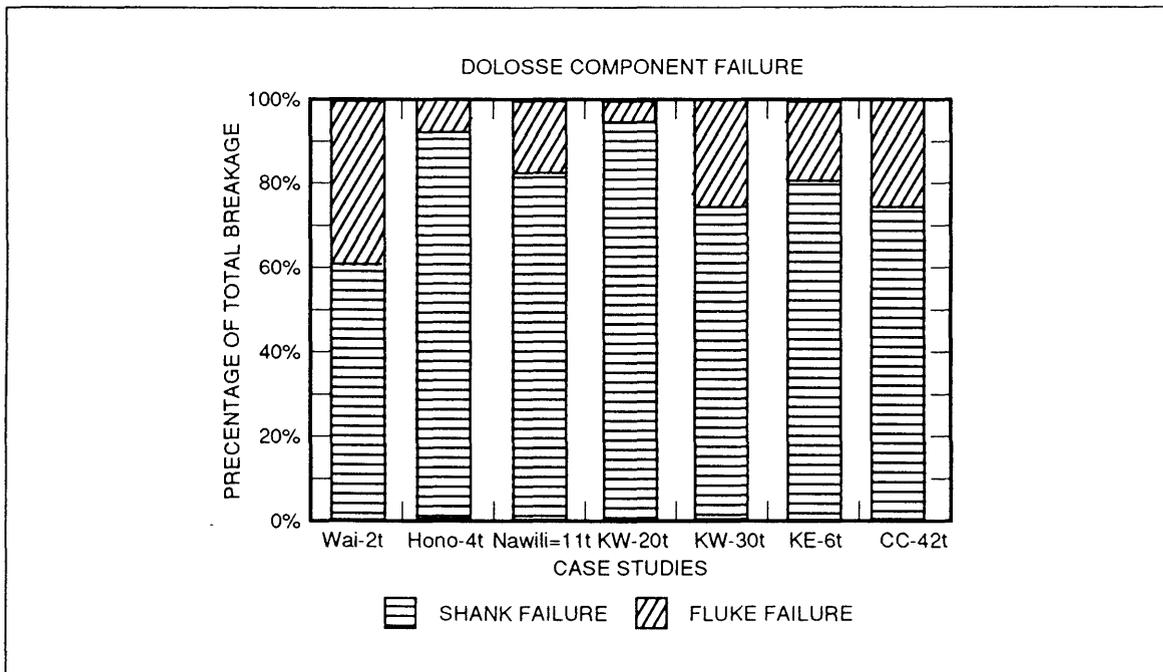
Figure 2. Dolos component failure

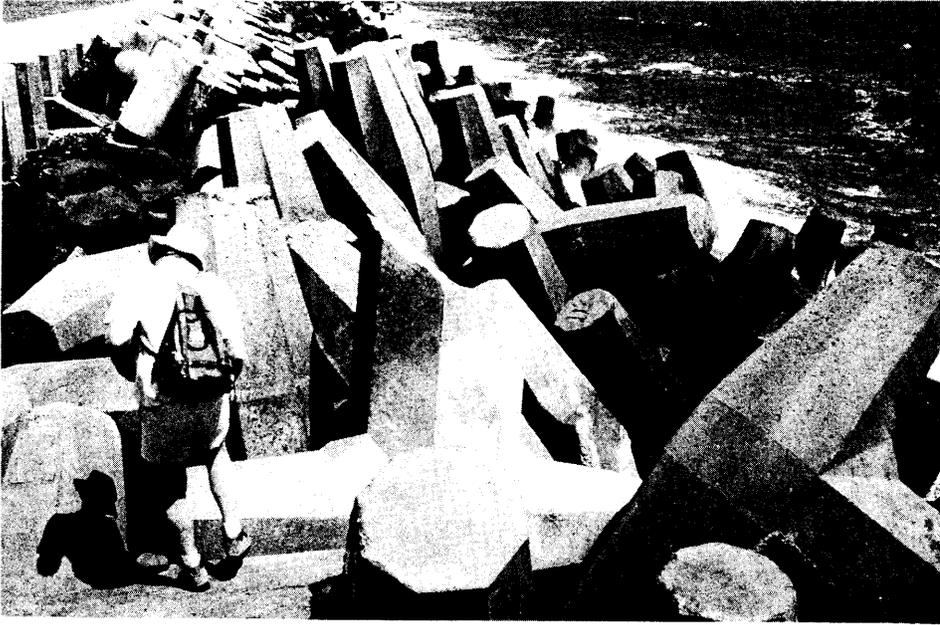
considered torsion-dominated, whereas Figure 4 shows a flexure-dominated shank failure. Figure 5 shows a typical fluke failed due to bending-induced shear.

Figure 3. Typical torsion break of dolosse shank

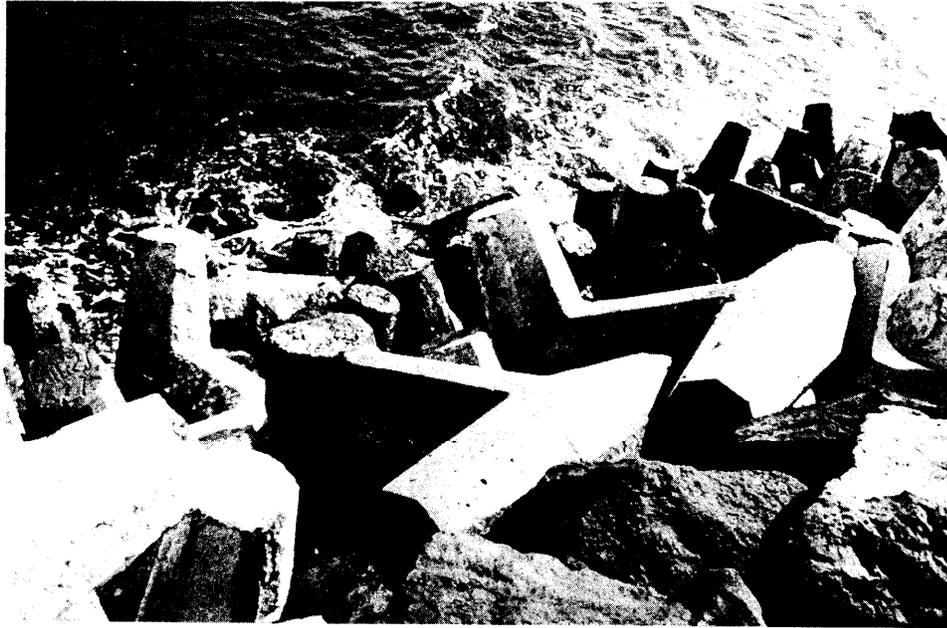
Figure 5. Dolos with fluke section sheared off

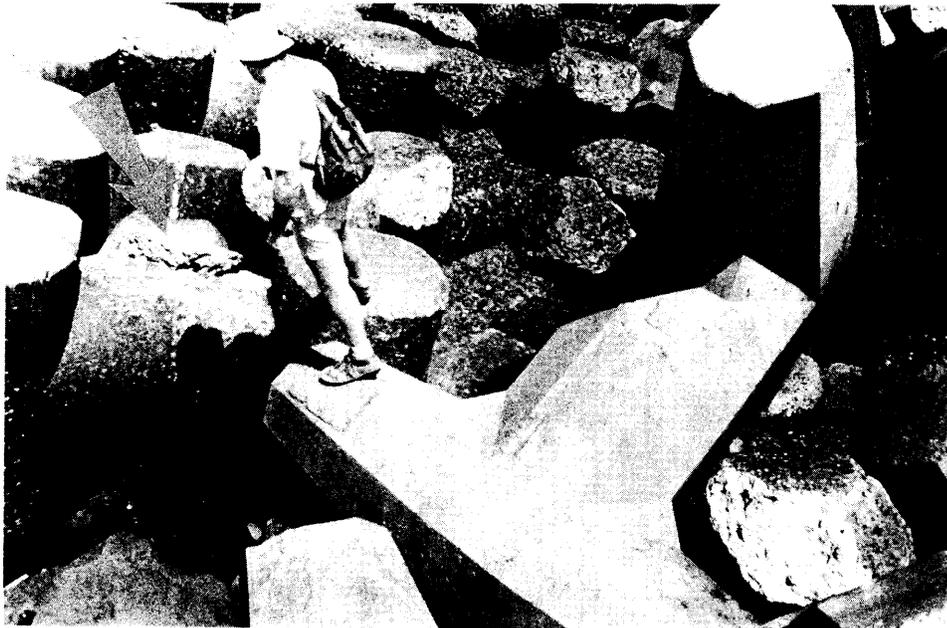
- b. *Tribar failure.* Tribars tend to fail at their central node. The slender spars typically fail in flexure (Figure 6), but can fail in torsion. Also noted were failures of the cylindrical legs.
- c. *Spalling.* Two types of spalling were observed. Unstable units that were obviously rocking under wave loading showed signs of spalling due to repeated impact. Spalling was observed both on tribars and dolosse. Reinforcement-induced corrosion spalling was in evidence in both CAU types. The steel reinforcing bar had corroded and expanded, causing sections of the overlying concrete to spall. Figure 7 shows spalling on a dolos from corrosion of underlying reinforcing bars.

Figure 6. Tribar failure at central node

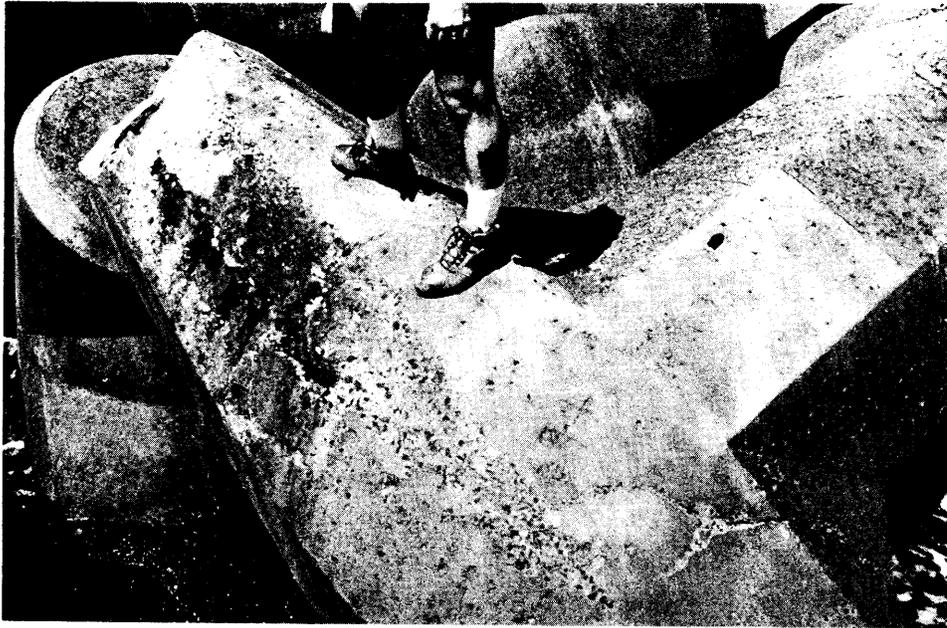
Figure 7. Corrosion of rebar causing spalling of dolos

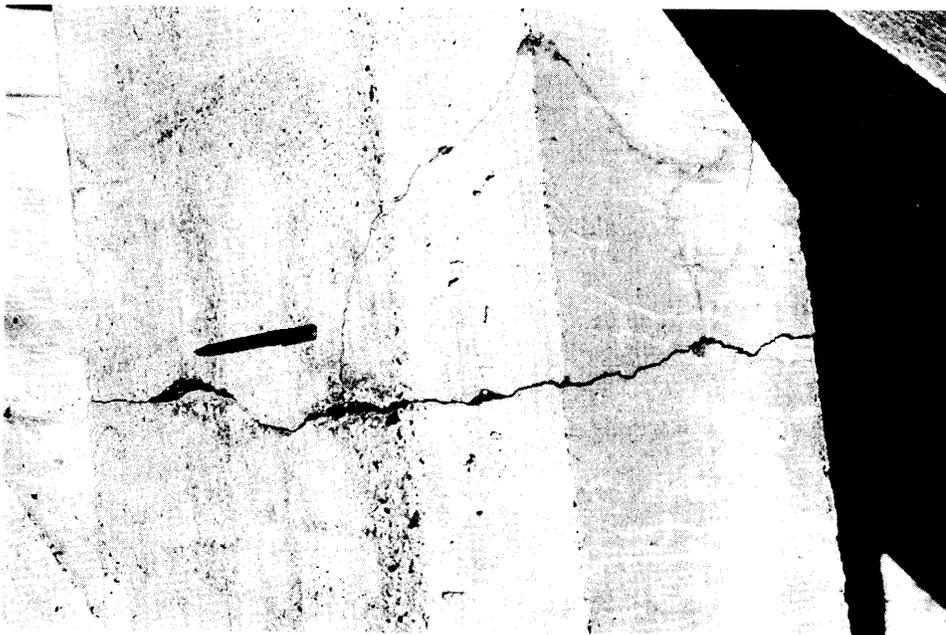
- c. *Armor unit-to-ribbed cap transitions.* The Nawiliwili breakwater and both of the Kahului breakwaters have ribbed caps. The caps have functioned well, with only slight cracks in the longitudinal members between ribs (Figure 8). They not only provide access along the structure for tracked vehicles, but also serve as a buttress for armor units at the crown, without buildup of wave pressures. All three structures do exhibit some downslope separation between the armor units and the cap.

Figure 8. Crack in concrete rib cap at Kahului West
