## REMR TECHNICAL NOTE CS-MR-8.3

### CASE HISTORY OF IMPROVING STRUCTURAL STABILITY OF CONCRETE STRUCTURES ON ROCK: GROUTING, CRACK REPAIR, AND INSTALLATION OF ROCK ANCHORS AT JOHN DAY LOCK AND DAM\*

**PURPOSE:** To present a case history of repair of structural cracking in lock monoliths.

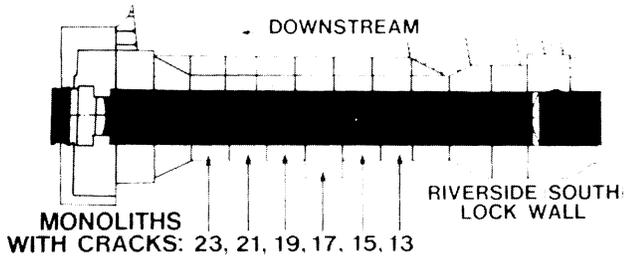
**PROBLEM:** During an inspection in 1975, significant structural cracking and associated spalling were discovered in lock monoliths 17 and 19. By 1979, cracking and spalling had been detected in monoliths 13, 15, 17, 19, 21, and 23 (Figures 3 and 4). The structural distress in the monoliths consisted of a crack that originated at and propagated from the upper inside corner of the

Figure 3. Position of lock monoliths with cracking and spalling

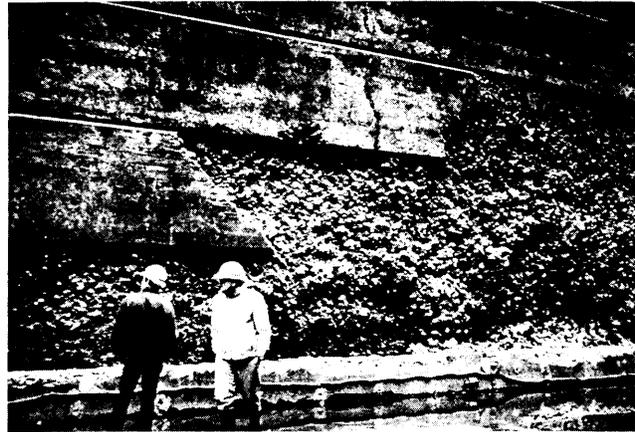
Figure 4. Wall of locks showing structural deterioration

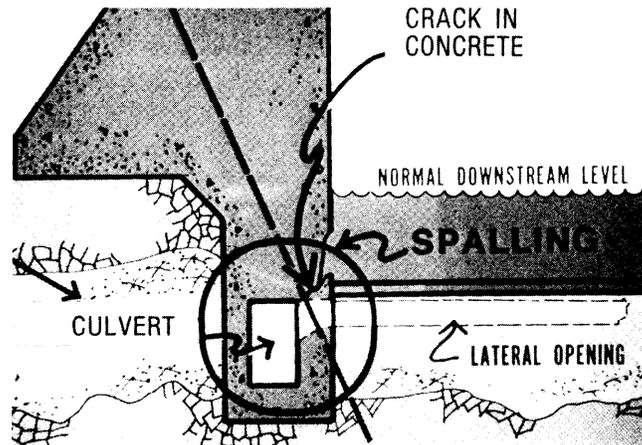
filling and emptying culvert and terminated at the surface of the wall in the lock chamber (Figure 5). Because of the continued progression of the cracking and spalling, a remedial repair was devised to halt and correct the ongoing structural deterioration.

Figure 5. Schematic of cracking and spalling in the culvert

CRACKING: Stress analysis using finite element models revealed two probable causes for the cracking. One cause was due to the original filling procedure that, before it was changed, produced high hydraulic surge pressures in the culvert. The other cause was due to the normal lock-full condition that produced excessive foundation deformations because of a layer of weak-flow breccia rock (Figure 6). Both causes produced high tensile stresses in the concrete and, because of inadequate reinforcing steel in the cracked area to distribute these stresses, lead to the ensuing cracking and associated spalling. Prior to the Phase I and II repairs, the cyclic loading of the lock walls, due to the filling and emptying of the lock, contributed to the continued propagation of the cracking and spalling.

REMEDIAL REPAIR: The philosophy behind the remedial repair was to restore the existing cracked structure to its near original uncracked condition. This goal was to be accomplished by a three-phase repair. The repair consisted of: (a) grouting the foundation rock, (2) installing rock anchors through the cracks after injecting structural epoxy adhesive into the cracks, and (3) repairing the surface of the wall in the lock chamber. The foundation grouting (Phase I) was performed to reduce the excessive foundation deformations. The structural repair (Phase II) was performed to return the cracked areas to a monolithic state and subsequently to maintain this state. The proposed surface repairs (Phase III) will be performed to replace any drummy concrete, to return the walls to their original neat concrete lines, and to add extra protection to the structural repair elements. The Phase I and II repairs were designed with the intent of keeping to a minimum any disruptions to normal lock service.

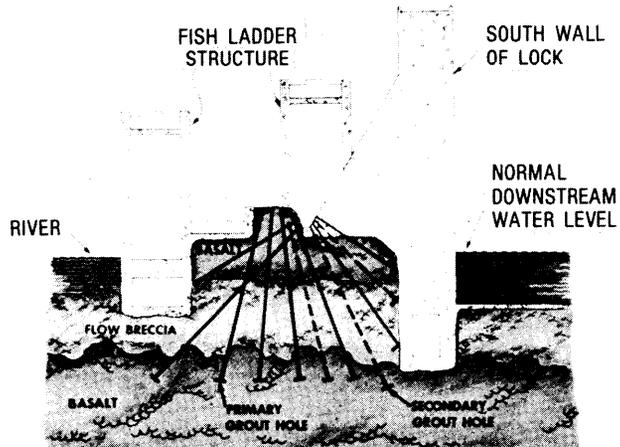
Figure 6. Cross section shows orientation of grout holes.  
View is looking downstream

FOUNDATION GROUTING: Consolidation grouting using cement grout was performed in 1980 as the first phase of the remedial repair. A contract was awarded to Continental Drilling - U.S., a Division of R. F. Thies, Inc., and R. O. Thies, an individual, as joint venturers on 22 January 1980 to perform the Phase I work. The purpose of the grouting was to fill any void spaces or open joints in the supporting rock mass. The supporting rock mass consists of a weak layer of flow breccia sandwiched between two layers of basalt. The soft, weak, highly fractured flow breccia layer was the primary target of the consolidation grouting (Figure 6). Finite element modeling during the repair design showed that increasing the rigidity of the confining and supporting rock mass would significantly reduce the monolith deflections and related tensile stresses around

the culvert. Postconsolidation grouting deflection measurements at the crest of the monoliths revealed that the deflections were reduced approximately 50 to 60 percent from the pregrout condition.

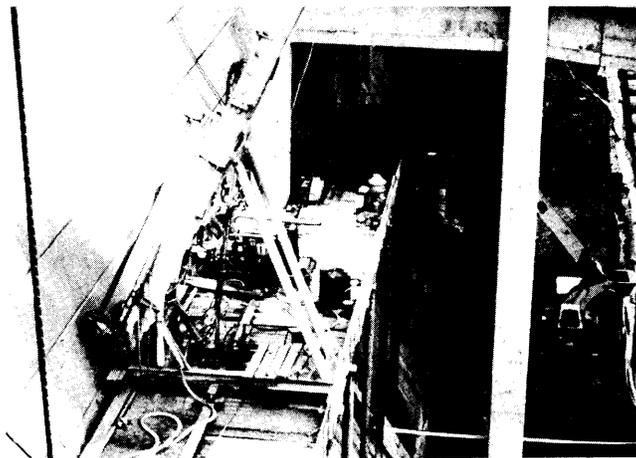
Figure 7. Contractor's equipment used in drilling

Without interrupting lock service, 10-in.-diam rock anchor holes, up to 172 ft in length, were drilled from the outside of the monoliths and into the basalt rock below. The holes were drilled at either 55- or 66-deg angles from the horizontal. The allowable deviation to avoid drilling into either the filling and emptying culvert or the lock chamber was 1 ft in 100 ft. The contractor accomplished this challenging requirement without any major difficulties (Figure 7).

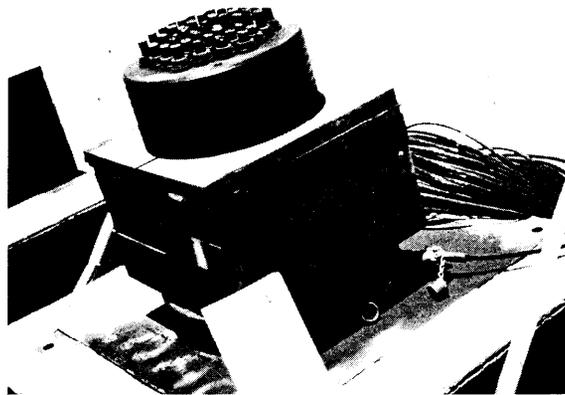
performance (Figure 8). To date all cells show a force remaining in the anchors above the 1300-kip design working force. The second phase of the repair program was completed in September 1981.

Figure 8. Load cells installed to monitor rock anchor performance

During the July 1981 lock outage, the cracks were pressure cleaned with a cleaning solution, rinsed with water, then dried. Epoxy was then injected under pressure into the cracks. Following the injection of epoxy into the cracks, the rock anchors were stressed. No major complications developed during the rock anchor stressing. Fourteen load cells were installed to monitor rock anchor

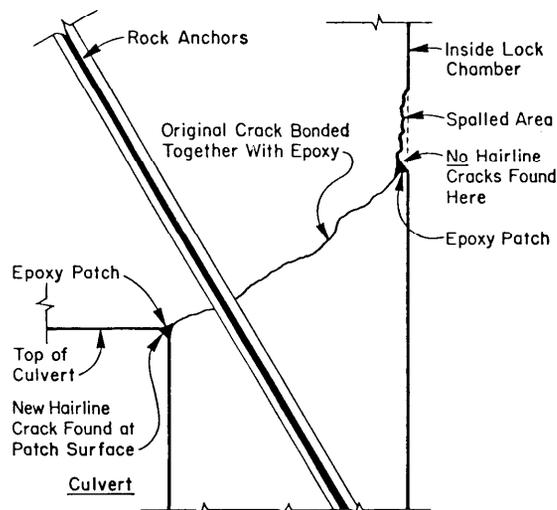
INSPECTION: On 17 March 1982, the dewatered navigation lock was inspected by Portland District and North Pacific Division personnel. The purpose of the inspection was to evaluate the effectiveness of the Phase II remedial repair. This was the first opportunity to inspect the repaired area since the completion of the structural repair in September 1981. The filling and emptying culvert was inspected initially. A hairline crack was discovered in the epoxy patch at the culvert north wall-ceiling interface (Figure 9). The hairline

Figure 9. Existing culvert wall section, March 1982

crack was most evident in monoliths 21 and 23 where it was continuous throughout the length of the monoliths. Traces of the hairline crack were also seen in the other repaired monoliths (11, 13, 15, 17, and 19), but they did not appear to be continuous and were evident only in short lengths. Because of no spalling or chipping at its edges, the hairline crack showed no signs of working or being progressive in nature. After inspecting the culvert, the lock chamber wall was then inspected. Evidences of re-cracking of the injected epoxy were found only in a monolith 15 ladder well. The crack was hairline in size and did not appear to be progressive. No evidence of re-cracking was found at any other areas and no traces of the crack were seen at the epoxy patch areas where the previous cracking had surfaced (Figure 9). Areas of previously drummy surface concrete were found to be solid, indicating that the injected epoxy was bonding the cracked surfaces together.
