US Army Corps
of Engineers

TECHNICAL REPORT REMR-CS-4

REPAIR OF WATERSTOP FAILURES: CASE HISTORIES

Final Report

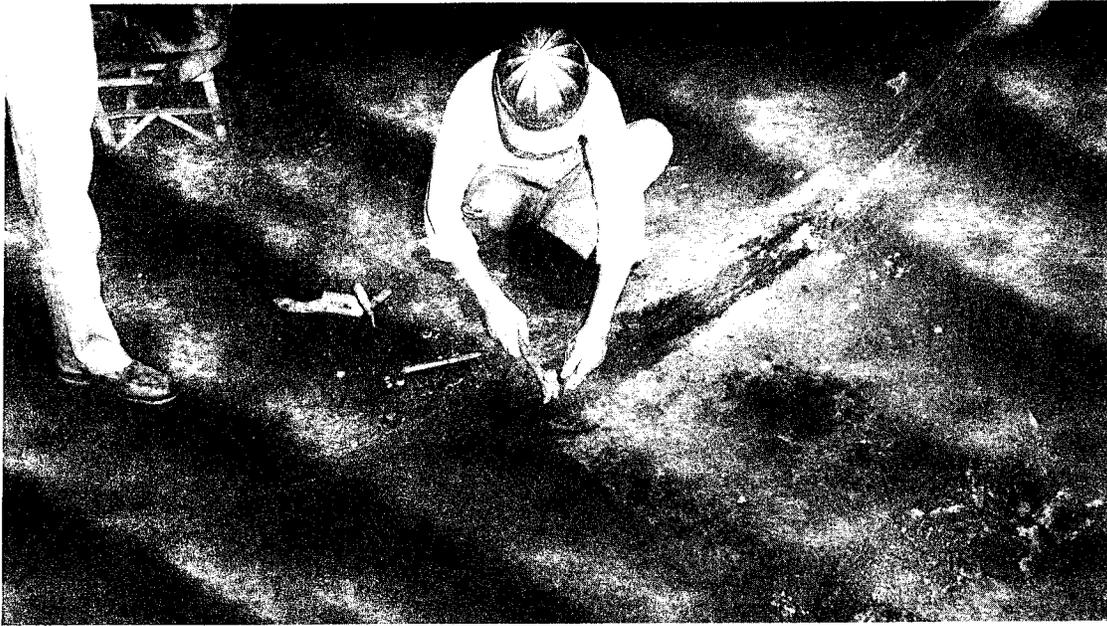
Figure 17. Removal of a portion of the remaining concrete key in preparation for repair, Sardis Dam

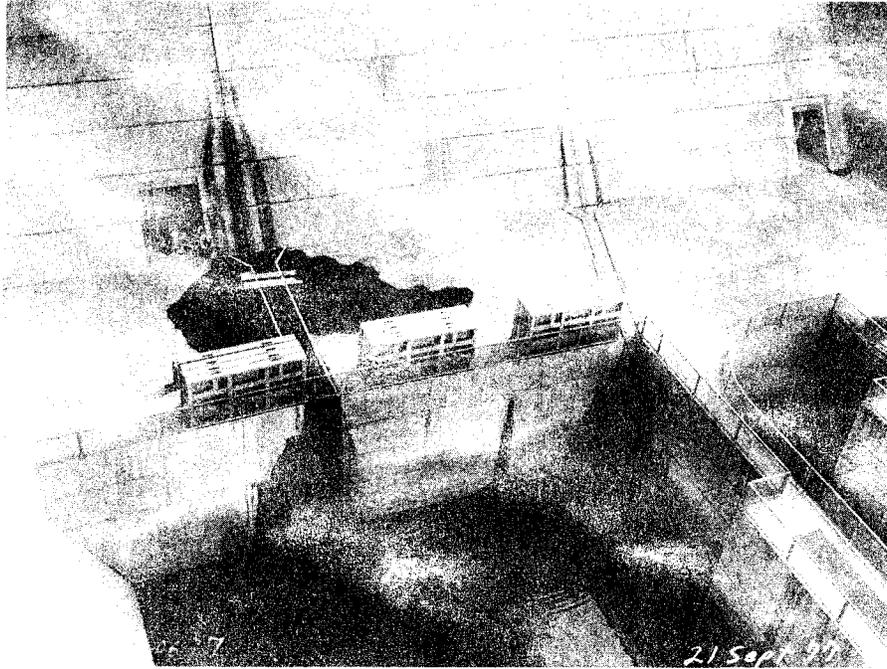
Figure 46. Leakage through north nonoverflow monolith joints, Ice Harbor Dam

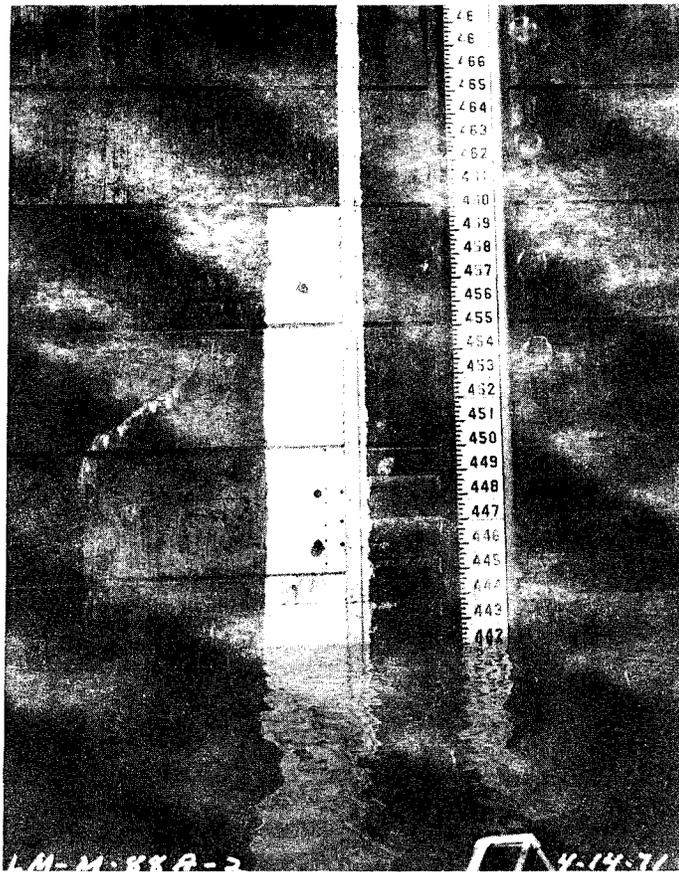
Figure 54. Joint 26/28 repairs,
Lower Monumental Lock

139. Leakage through gate monolith joints 25/27 and 26/28 was repaired by contract while the lock was dewatered in November 1970. A neoprene membrane epoxied to the concrete surface and retained by stainless steel cover plates was used for the repair (Figure 54). The areas which appear gray in Figure 54 have been treated with two coats of an epoxy, Colma-Rote M,

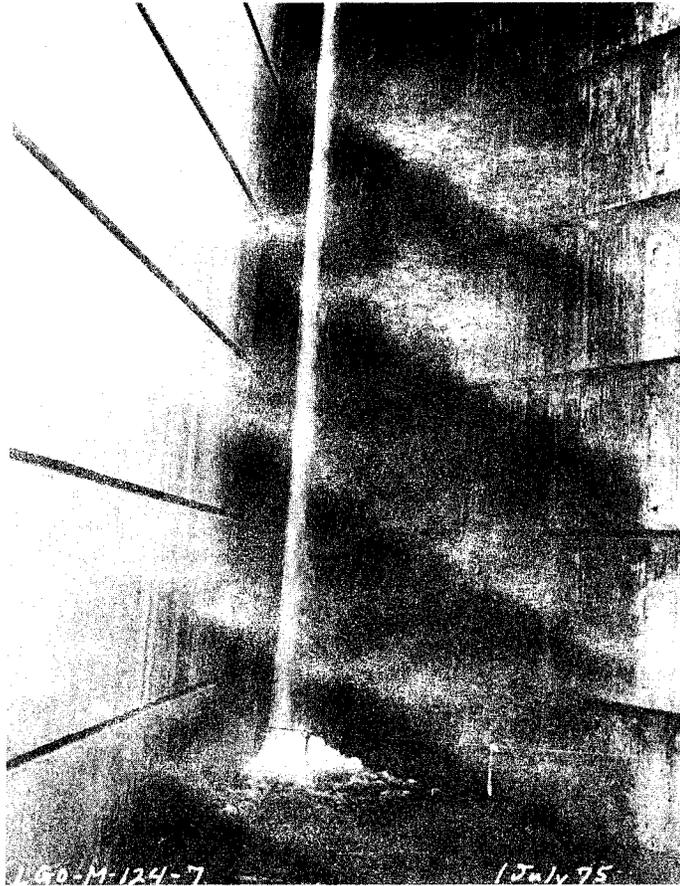
Figure 63. Monolith joint 4/6 leakage,
July 1975, Little Goose Lock

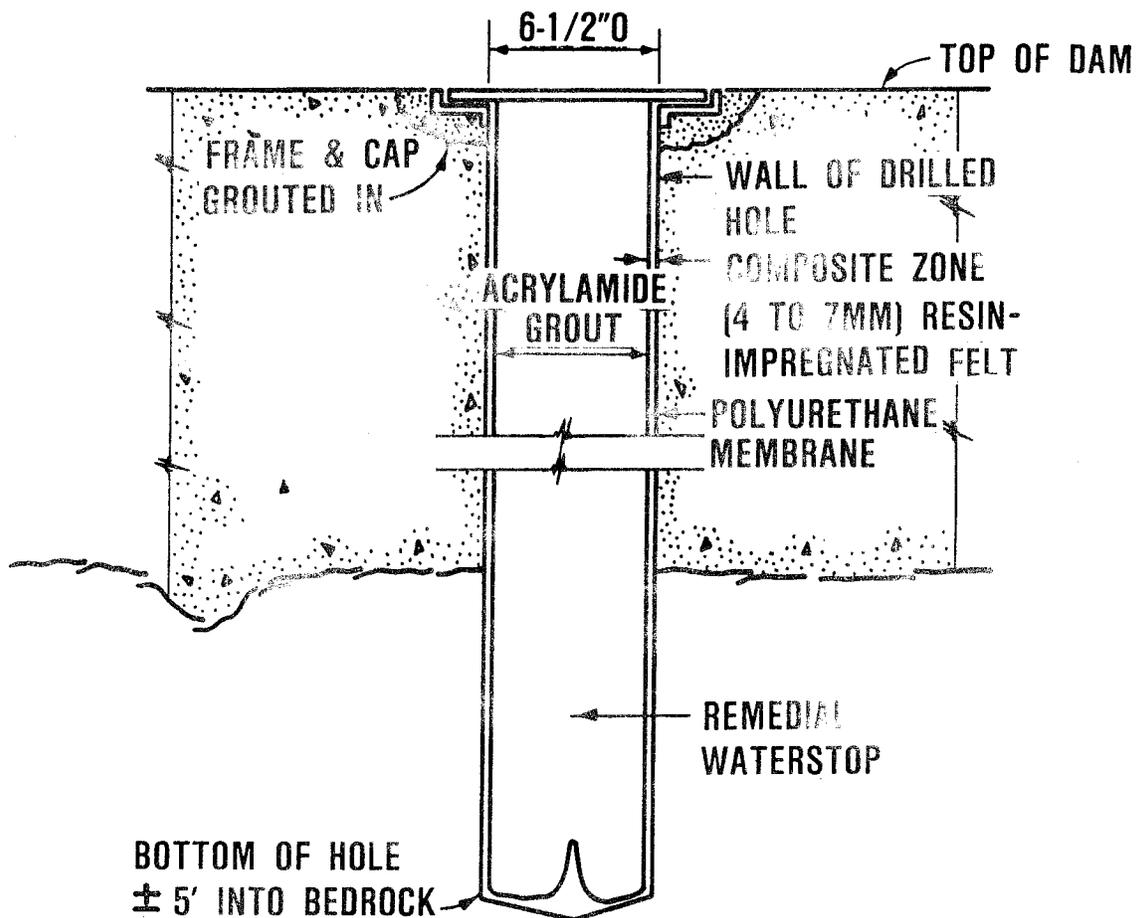
Figure 105. Completed remedial waterstop, Pine Flat Dam

196. A remedial waterstop was installed in hole 30/31 (191 ft deep) on 7 March 1985. As the end of the liner tube approached the bottom of the drill hole, resistance to further progress was encountered. This was mistakenly interpreted to indicate that the bottom had been reached and the control cable was tied off. Later television inspection showed that the tube was within approximately 10 ft of the bottom of the hole. Apparently, the joint near the bottom of the drill hole is relatively tight. Since water within the drill

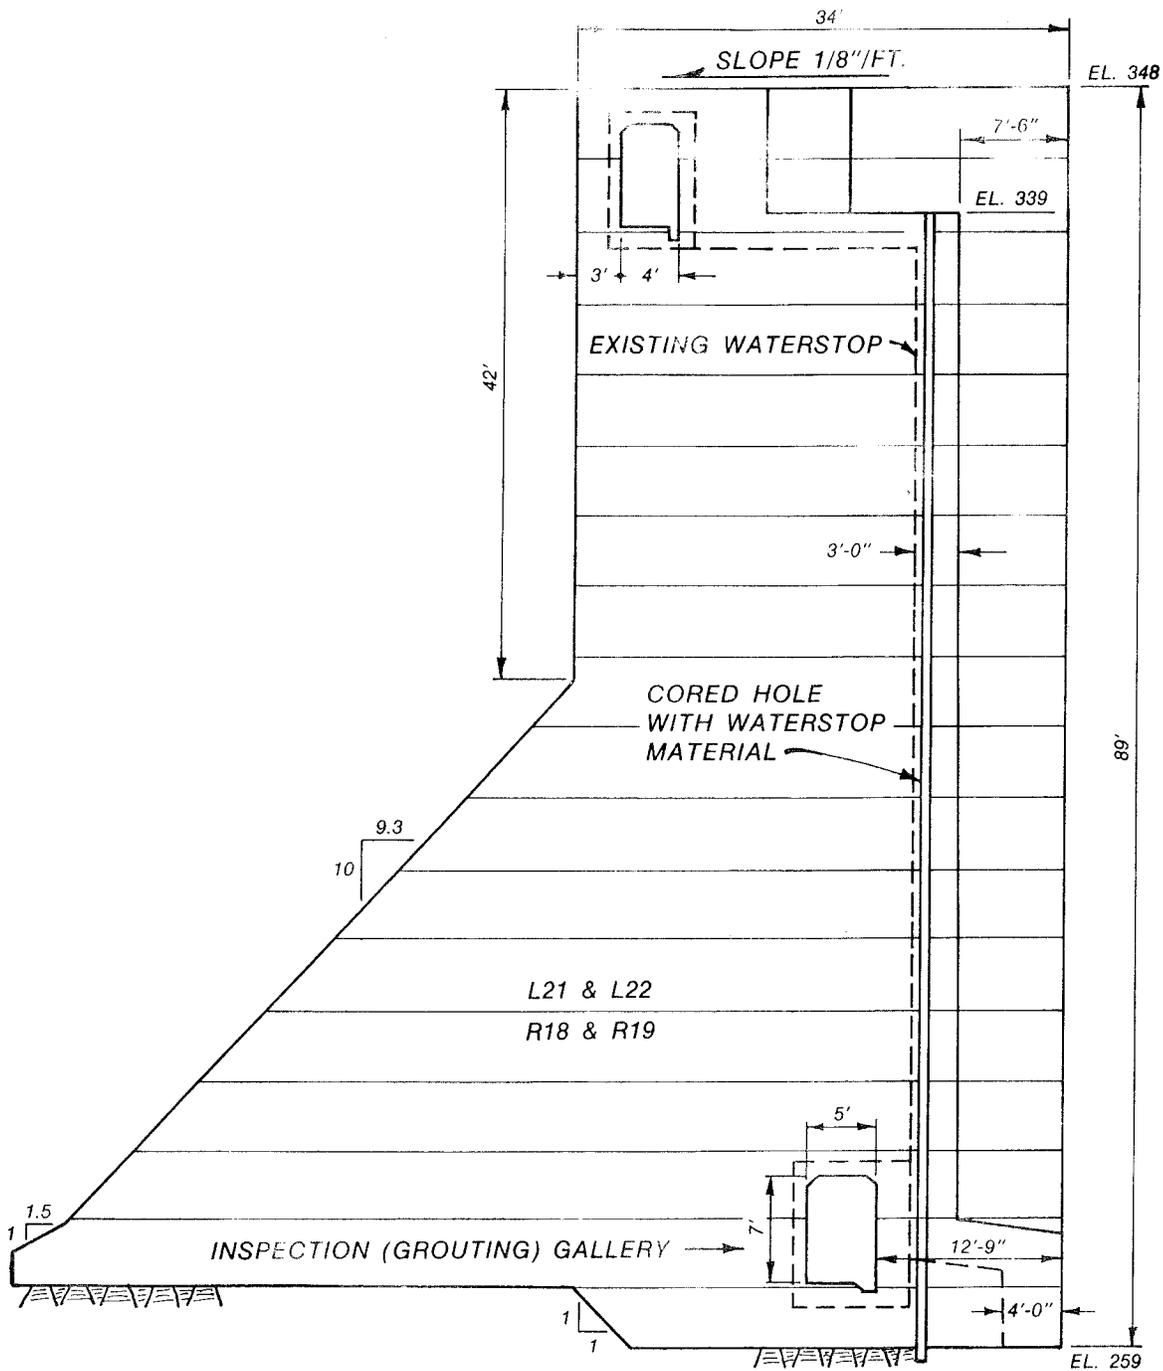
Figure 115. Monolith joint repair, Dardanelle Lock
