**REPAIR, EVALUATION, MAINTENANCE, AND
REHABILITATION RESEARCH PROGRAM**

TECHNICAL REPORT REMR-CS-6

**IN SITU REPAIR OF DETERIORATED
CONCRETE IN HYDRAULIC STRUCTURES:
FEASIBILITY STUDIES**

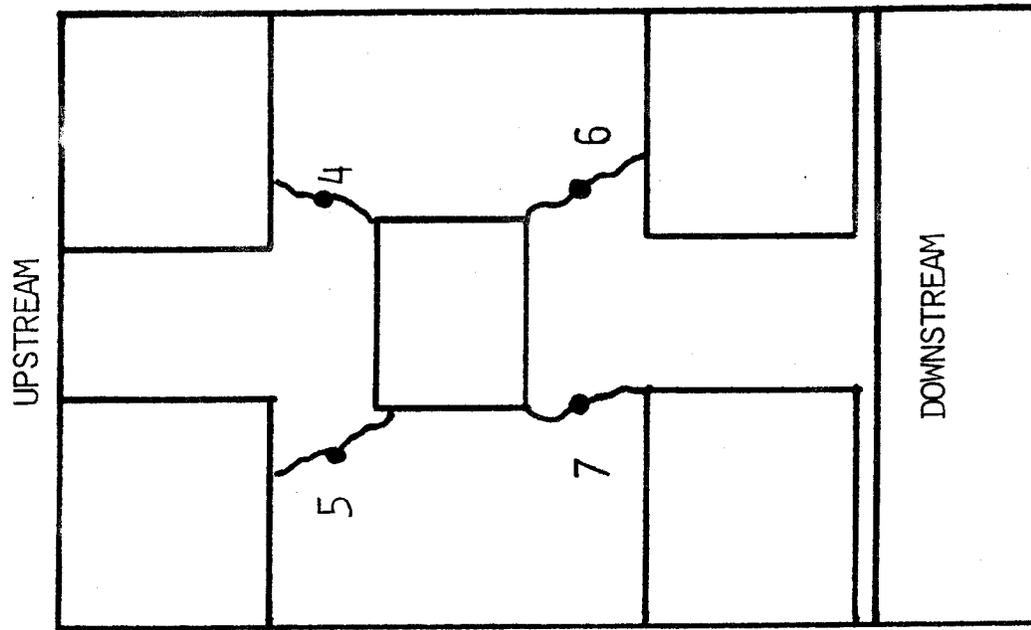
Figure 12. Top view showing major cracks and locations of injection ports (Flock and Walleser, 1983).

Epoxy injection was started in the middle of the archway ceiling at Port No. 9 (refer to Figures 10-12). Pumping was continued, while the epoxy reached injection Ports Nos. 2, 3, and 12 on the downstream face. The operation was then moved to the upstream ceiling port (No. 8). The contractor had difficulty maintaining a seal around the injection packer. In addition, leakage of epoxy was noted at the bottom edge of the access manhole and adjacent to the electrical conduits embedded in the archway ceiling. An attempt was made to inject epoxy into Port No. 10; however, it was impossible, even at a pressure of 160 psi.

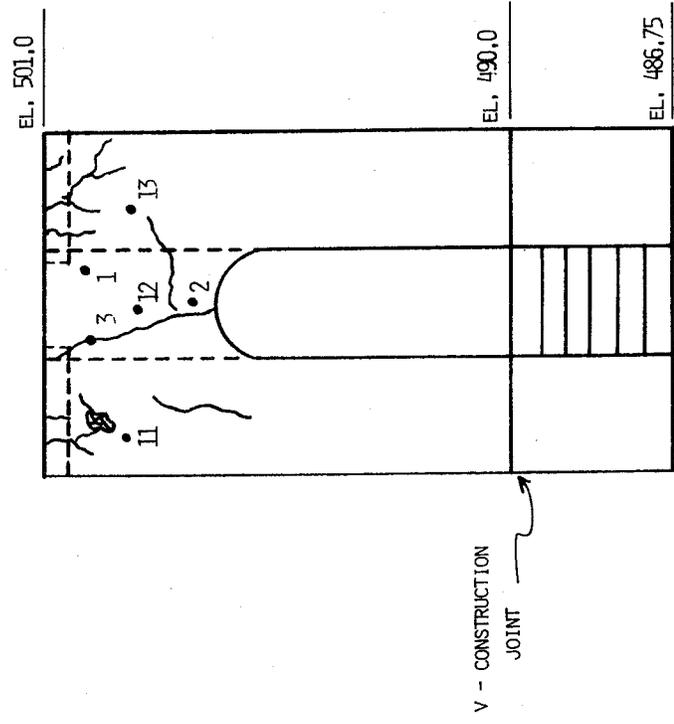
Figure 11. Downstream view showing major cracks and locations of injection ports (Flock and Walleser, 1983).

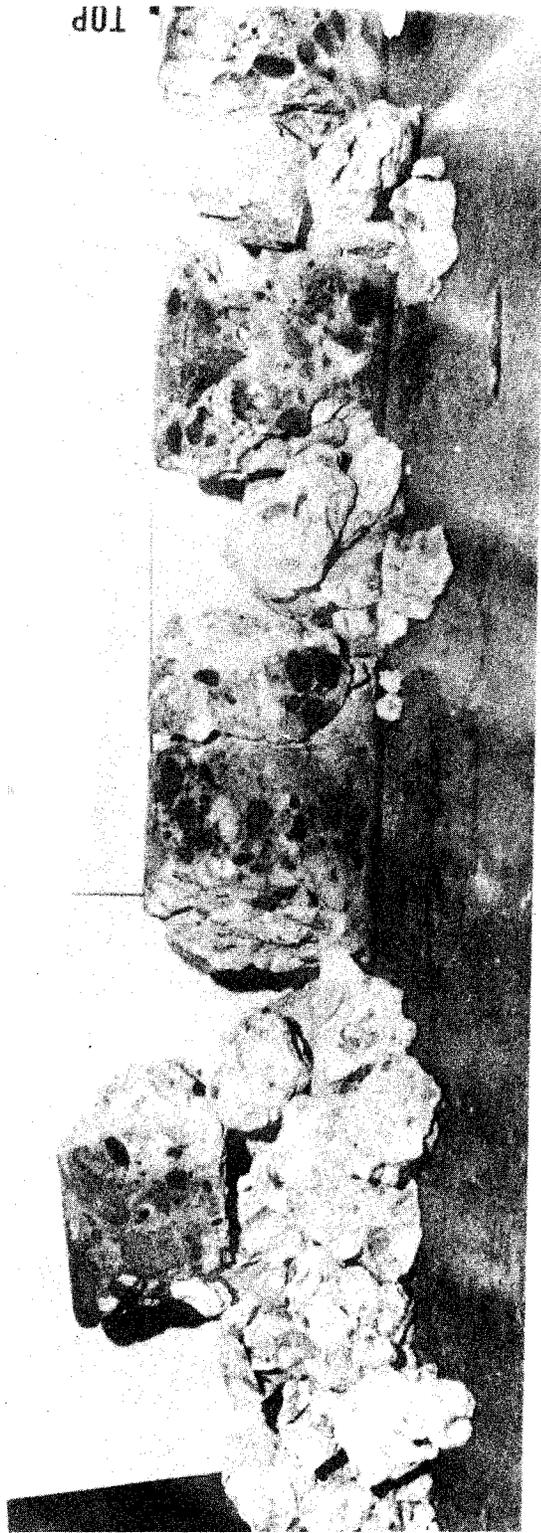
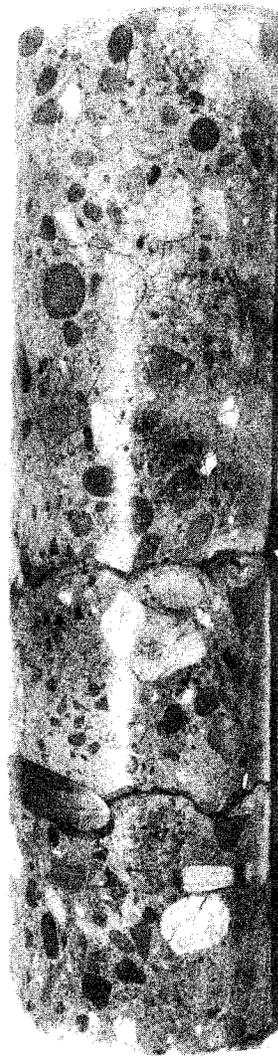
LOCK&DAM 20
PIER 39

Upon completion of the pulse velocity tests, concrete cores were taken from various locations to further evaluate the effectiveness of the repair. Presented in Figure 13 are photographs of cores taken before and after the pier was repaired. Cores removed from the pier top contained numerous random and crudely parallel diagonal cracks as well as many fractured aggregate particles. Only 5 to 10% of the cracks were filled with epoxy, explaining the difficulty in obtaining pulse velocity readings.

Figure 13. Cores taken from Pier 39 before and after epoxy injection.

The cores taken from the downstream face were not as severely cracked as the core removed from the pier top. The cracks were finer and more randomly distributed throughout the length of the cores. Fifty to ninety-five percent of the cracks were filled with epoxy. Tests for resistance to freezing and thawing subsequently run on two of these cores indicated the epoxy injection was successful in rebonding the concrete and in holding it together under freezing and thawing conditions. Most of the failure observed in these tests resulted from crumbling of the non-air entrained mortar and cracking of the coarse aggregate particles. In general, it was concluded that the epoxy in the fractures tended to hold the concrete together during the freezing and thawing cycles and aided in slowing down the deterioration of the concrete. Based on the tests, the performance of the concrete in the structure cannot be predicted absolutely; however, it is expected that while the exposed concrete surface would be subjected to damage due to freezing and thawing, the deeper interior concrete may be cemented together well enough to form an integral whole and to perform satisfactorily.
