BULLETIN

VOLUME 14, NUMBER 1 36755630

FEBRUARY 1997

Development of a Geomembrane System for Underwater Repair of Concrete Structures

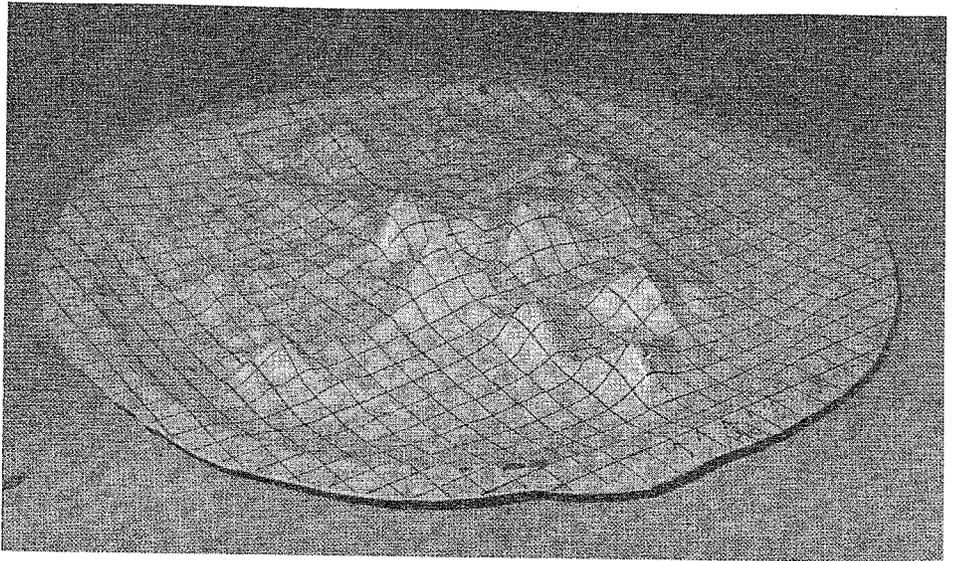
Figure 2. Condition of the reinforced PVC after a sustained load of 150 psi (1 MPa) for 24 hr

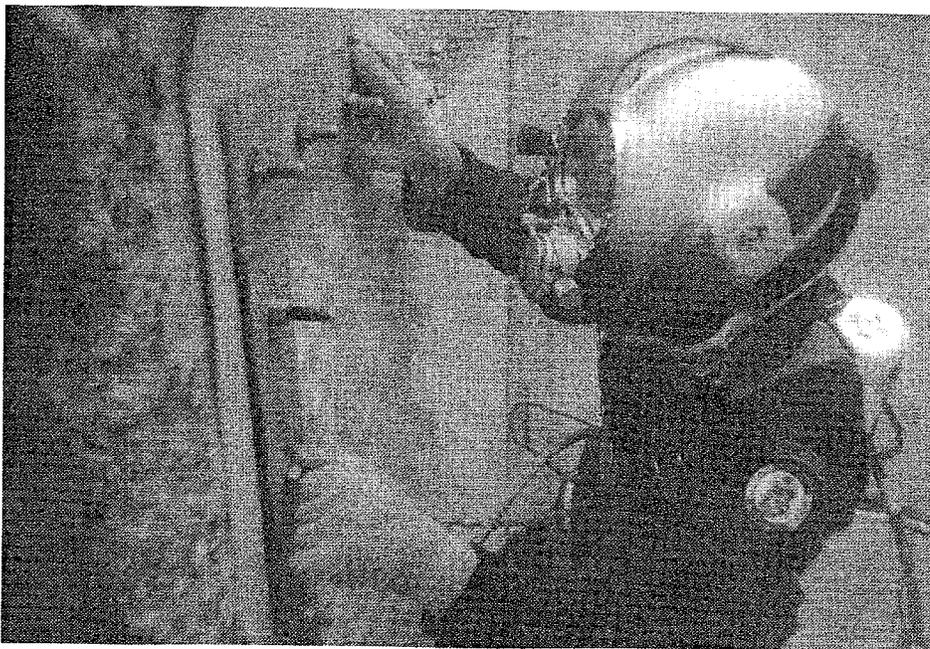
membrane remained tightly conformed to the wall (Figure 8), indicating that seepage through the repair system was extremely slow. During one of the underwater installations, five anchor bolts that used a combination of two-part epoxy and a glass-encapsulated resin cartridge were used. These five bolts loosened as the nuts were tightened. Failure was later attributed to the installation technique.

Figure 8. Membrane tightly conformed to the substrate

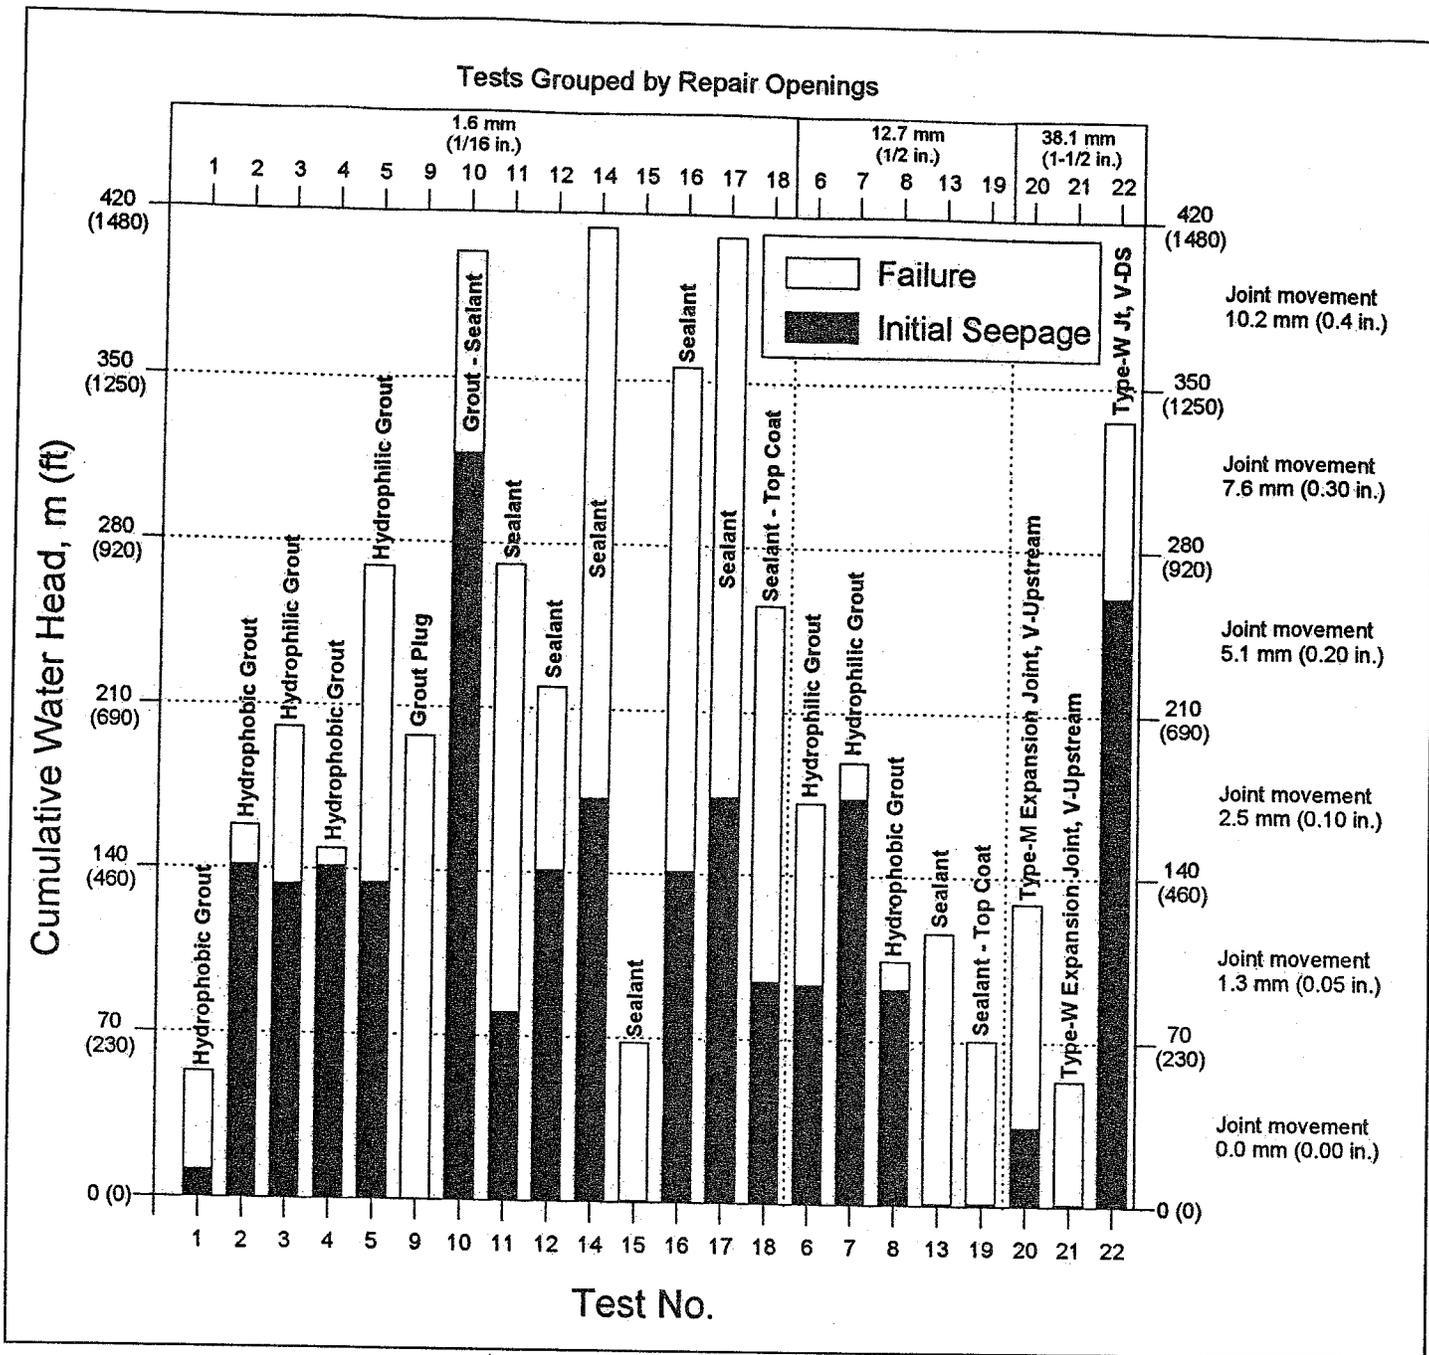
Figure 3. Cumulative sum of water heads for joint movements at times of initial seepage and failure of the repair (Tables 1 and 2 for repair details)
