The REMR Bulletin

News from the Repair, Evaluation, Maintenance,
and Rehabilitation Research Program

Floating Debris Control Systems for Hydroelectric Plant Intakes

Protection of Lock Gates from Vessel Impact

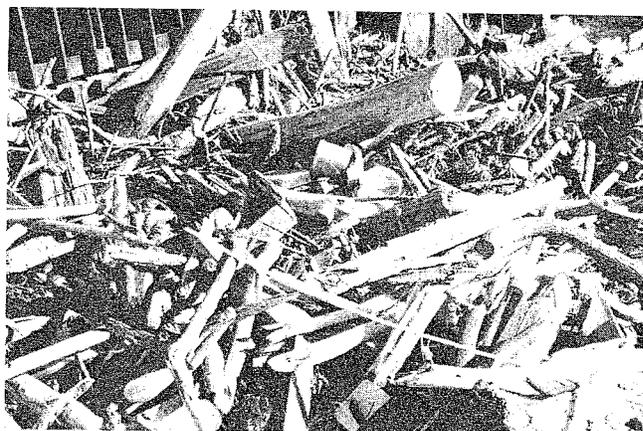
Figure 2. Floating debris trapped against the trash racks at Racine Hydroelectric Plant.

Initially, the forebay was provided with a 300-foot-long debris boom anchored at each end to cell structures with floating connection points. The boom proved ineffective because of two characteristics: First, when flow to the turbines was initiated, the boom would tilt up and let floating debris pass beneath it. Second, openings in the face of the boom caught and held debris so that it could not move laterally to a discharge or pickup point. Eventually the boom was removed in hopes that the flow characteristics of the forebay would be improved and that it would be easier to remove the debris from the trash racks. The open boom arrangement is shown in Figure 1. A typical view of floating debris in front of the trash racks is shown in Figure 2.
