The REMR Bulletin

News from the Repair, Evaluation, Maintenance,
and Rehabilitation Research Program

VOL 8, NO. 3

Zinc Backing Material Expected to Extend Service Life of Bankhead Miter Gates

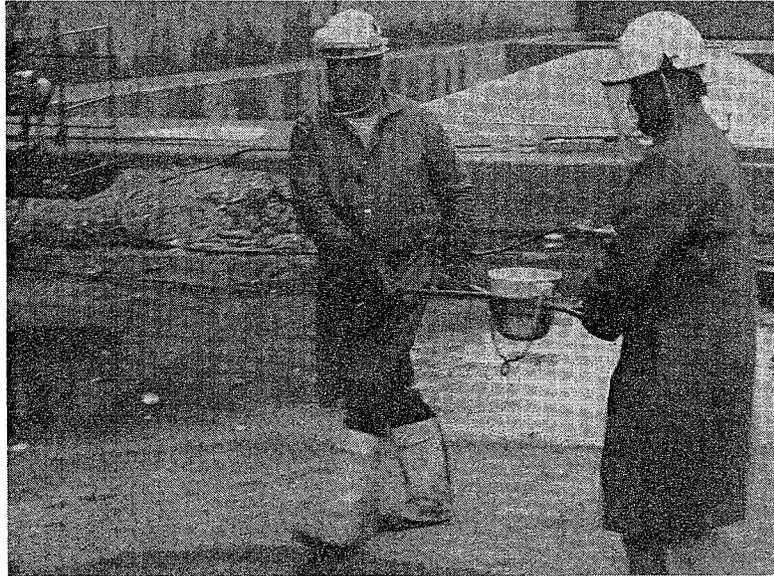
Workers, dressed in safety gear, carry a bucket of molten zinc with a temperature between 850 and 1,100 °F to the work site at Bankhead Lock, AL.

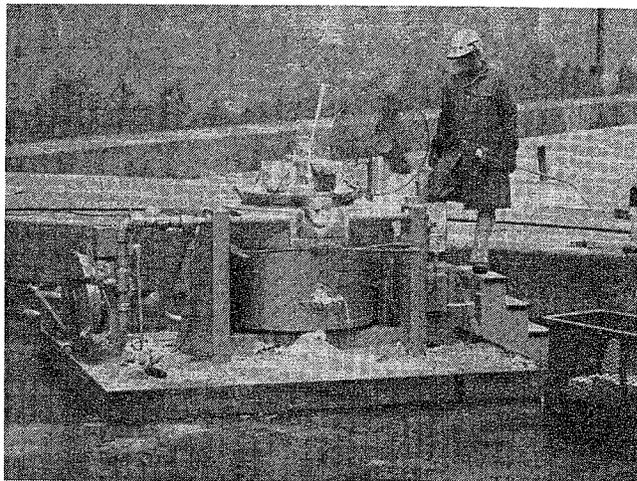
Figure 1. Furnace used to melt zinc in Bankhead lock rehabilitation. Zinc ingots are stacked in basket at lower right. Impurities skimmed off molten zinc are piled under furnace spout.

Zinc comes in 50-lb ingots. For handling ease during the Bankhead rehabilitation, the ingots were cut in half and stacked in baskets near the furnaces (Fig. 1). The furnace crew, as well as anyone else working near the molten zinc, wore safety helmets and shields, foundry gloves and shin covers, and fire-retardant work coats. Zinc bars were lifted with thongs and placed into the furnace. As the bars melted, more zinc was added. The furnace was gas fired until the molten metal reached the desired temperature of 1,100 °F.

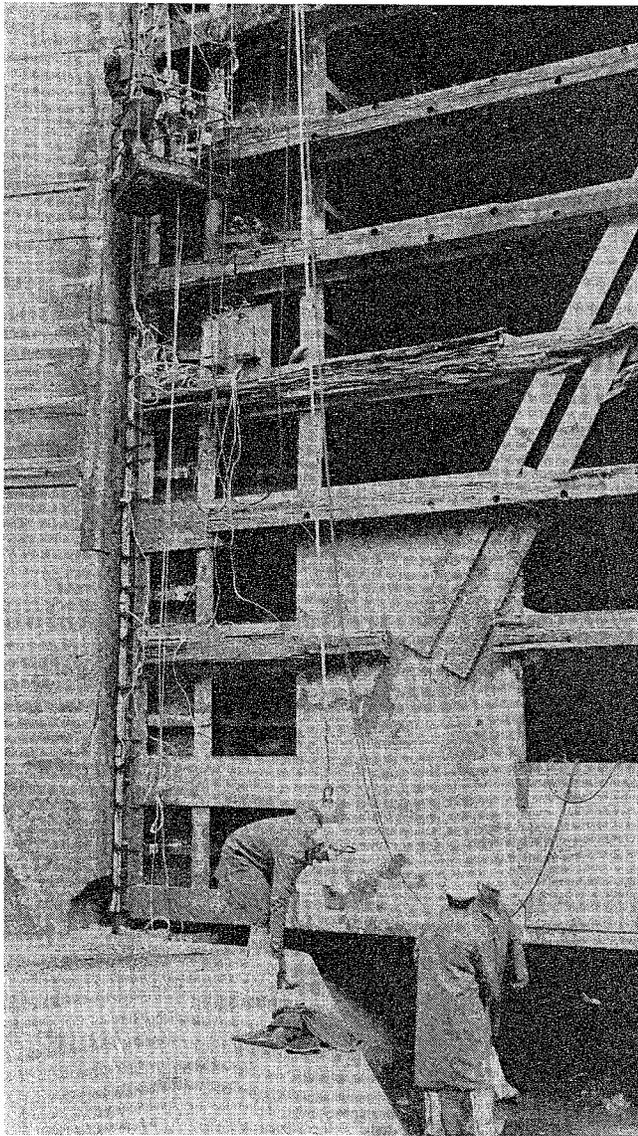
Figure 2. A worker steadies the bucket, filled with molten zinc, before the hoist crew pulls it up to the pourer. Clearly visible are blankets strapped to the stainless steel block, plugged into electrical supply visible underneath the work cage.

At the work site, the bucket with the molten zinc was attached to a rope (Fig. 2), hoisted by a work crew with the help of a pulley assembly to the basket supporting the worker (see front page, top side photo) who poured the zinc. The worker used a stainless-steel funnel to pour the molten zinc between the steel block and the gate's end plate (Fig. 3). The funnel was custom made for the job at Bankhead.

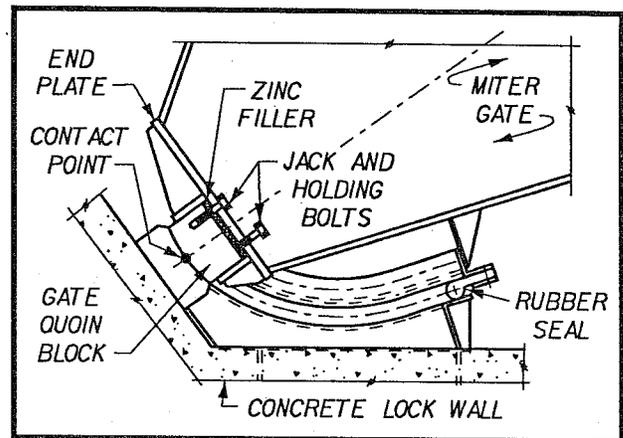
Figure 3. Schematic of a quoin showing push-pull bolts and area to be filled with zinc.

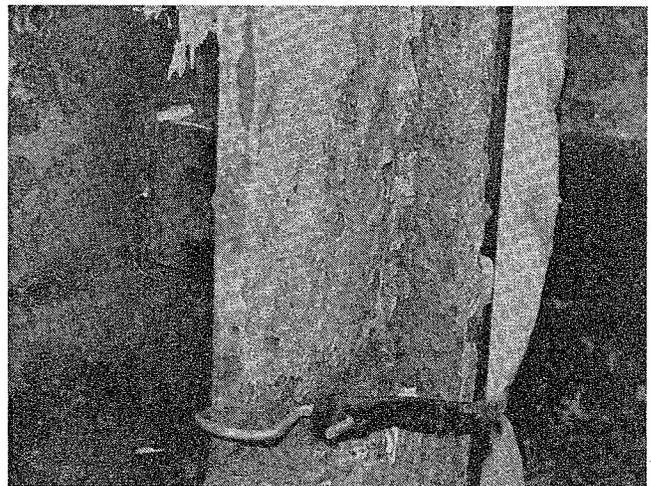
Figure 4. Close-up of a pour hole on right miter gate at Bankhead lock. Blanket heating the steel block is also visible.

ing the zinc (Fig. 4). Coupled with the initial high temperature of the zinc, the heated steel block prevented cooling the zinc below its 850 °F melting point during the handling and application processes. This procedure is vital since premature solidifying of the zinc could result in voids in the backing.

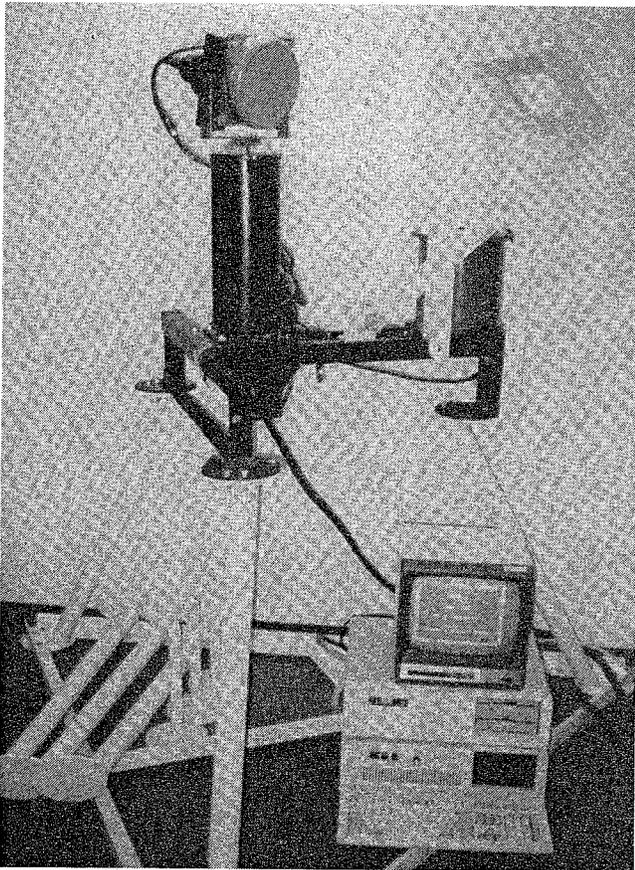
Figure 1. Coastal Structure Acoustic Raster Scanner (CSARS) System

In Figure 1, the underwater unit can be seen atop the bottom-sitting tripod, with the shipboard unit at lower right.

The round transducer head and tilt motor are seen at the top of Figure 1. The head transmits pulses of acoustic energy in a very narrow conical beam pattern ("pencil beam") towards the structure along a straight ray path. The range to the target reflector (the structure) is determined from the elapsed time until the return signal (echo) is detected. The relatively low acoustic frequency of 300KHz results in a relatively long-ranging capability and allows ample structure-to-transducer standoff distance (typically 100 to 300 ft).

inclinometer (measures tilt from vertical) and a pressure sensor to provide water-depth readings. The short, dark cylinder that can be seen at upper right of Figure 1 contains the digital compass. Bolting on extension legs and spikes (shown at lower left of Fig. 1) allows the transducer head to be raised farther above the sea bottom.

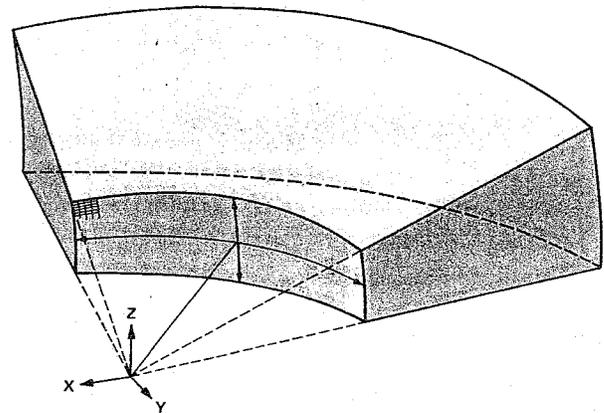
Figure 2. Scan volume diagram.

Figure 2 illustrates the operating concept of the CSARS, showing the three-dimensional "scan volume," within which range data are collected. The transducer is located at the origin of coordinates. CSARS collects range data by scanning this operator-specified region point-by-point along horizontal lines similarly to the way a television screen image is built up by the moving electron beam inside a cathode ray tube. This type of operation is called raster scanning. Each range value thus obtained corresponds to a "cell" or "bin" of the spherical raster (matrix). Good ranges (strong returns) may not be obtained for all bins.

Automatic scanning proceeds according to specifications selected through the software menu. The operator defines the scan volume (shown as the shaded region in Figure 2) by specifying a central ray direction (azimuth and inclination) in reference to magnetic north and the horizontal plane, horizontal and vertical excursions (in degrees of arc), and minimum and maximum range limits (radial distances). Azimuth values are specified in degrees clockwise from north; inclination values are in degrees up from horizontal. Bin (cell) dimensions are determined by step-size increments in horizontal and vertical directions, also specified in degrees of arc.

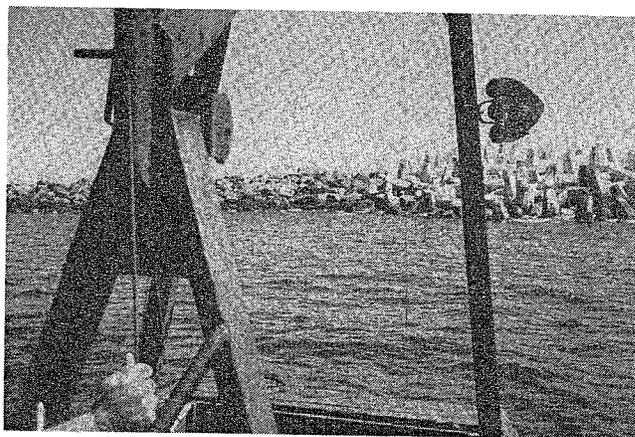
Figure 3. View of Crescent City breakwater, "Ski's Hole" site, from deployment vessel.

At Crescent City, a 35-ft fishing vessel was fitted with a boom/winch deployment system assembled onsite. One of the scan volumes covered the frequently damaged transition area between stone armor units and concrete dolos armor ("Ski's Hole"). Figure 3 shows a view from the deployment vessel of the part of the breakwater being scanned. In Figure 3, the lifting apparatus and cable leading to the bottom unit can be seen, as well as a prism cluster (upper right) used with a total-station survey instrument located on the breakwater at the center of the photo. Figure 4 shows a side-scan sonar image of the area of interest (from a different date). The approximate location of the CSARS scan volume is shown overlaid on the side-scan image, in a plan view.

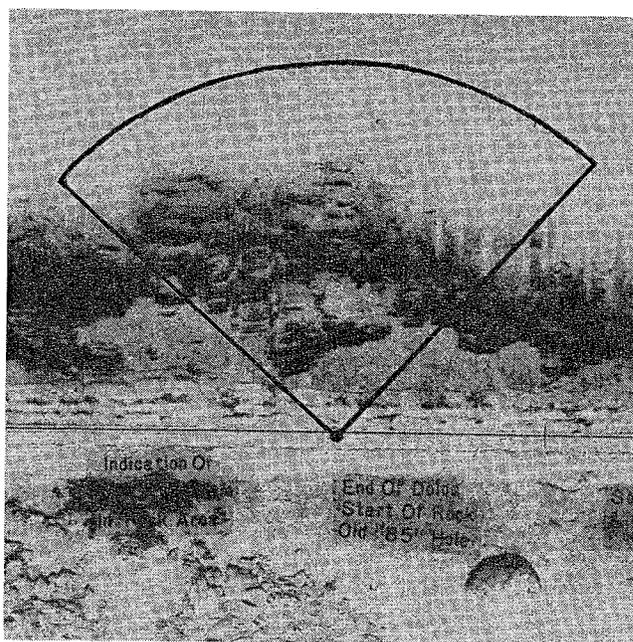
Figure 4. Side-scan sonar image of Ski's Hole site with scan volume position, obtained by William (Ski) M. Kucharski.

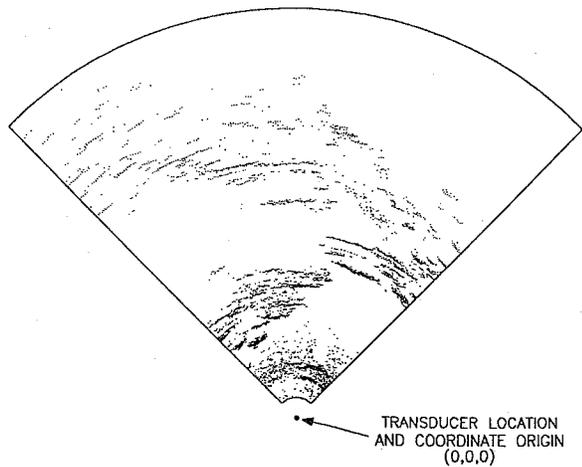
Figure 5. Scan volume and collected data points for "Ski's Hole" site.

Figure 5 shows a plan view of the scan volume and collected data points (good ranges). The central ray for the scan volume has an azimuth of 40° magnetic and an inclination of zero. Excursions were 40° vertical and 90° horizontal. Minimum and maximum ranges were 10 and 200 ft, respectively. The step size between bins was the

minimum possible (0.45°), resulting in a data set of 5,114 points. The scanning process took about 40 minutes. Seas were unusually calm during the field operation.

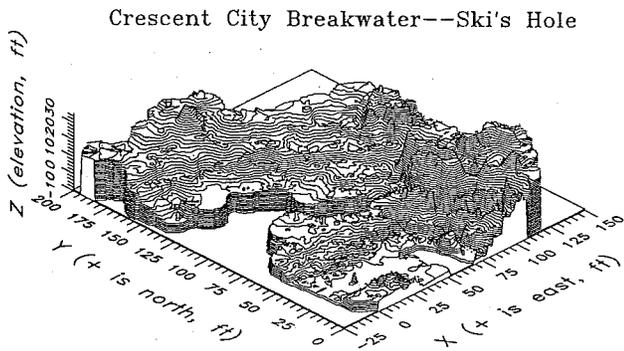
Figure 6. Stacked contour plot of a surface created from unfiltered data of "Ski's Hole" site.

Figures 6 and 7 show plots produced from unfiltered data at the "Ski's Hole" site. The stacked contour plot of Figure 6 was created after the data were interpolated onto a regularly spaced 1-ft grid in the horizontal plane with a commercial PC software package with a kriging algorithm. The view is from a position above and behind the transducer position (located at coordinates 0,0,0) looking towards the breakwater, as it might be seen from aboard the deployment vessel if the water were transparent. A flat, horizontal surface is plotted in areas where data points are spread apart too far from one another horizontally. The flat areas are at an elevation corresponding to the lowest point

in the data set, which is about 10 ft below the transducer elevation. Note that in addition to the stacked contour plot (1-ft contours in Figure 6), a conventional contour drawing can easily be produced. Figure 7 shows a shaded plot of a surface created from the same data set with an inverse distance gridding algorithm with a 2-ft grid size. Figure 7 was created with the use of three other PC software packages. The surface in Figure 7 shows a greater amount of bridging across data voids than that of Figure 6. The viewing position in Figure 7 is the same as that of Figure 6; the outline of the scan volume (dark lines) is also shown. In Figure 7, the flat, horizontal part of the surface is at zero elevation. Figures 6 and 7 seem to confirm the features seen in the side-scan sonar image, in spite of shadowing-related gaps in the data set. The advantage of the CSARS data set is that measurements such as slopes, lengths, areas, and volumes can be obtained relatively easily and reliably, whereas the side-scan image is not scalable. Even automatic-correcting side-scan sonars are unable to provide undistorted plan images when the sea bottom slopes in any direction other than the along-track direction. Also, wave-induced towfish motions and curving tow tracks introduce uncorrectable scale distortions.

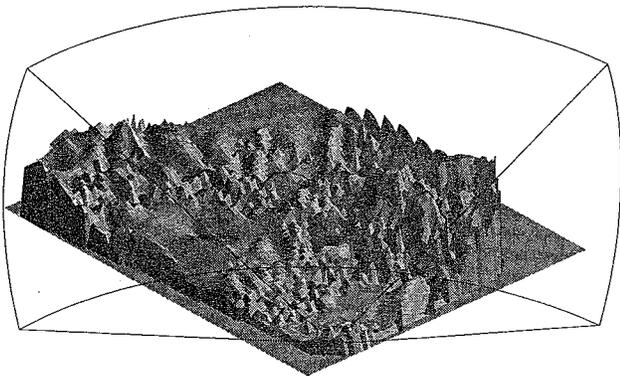
Figure 7. Shaded plot of a surface created from unfiltered data of "Ski's Hole" site.

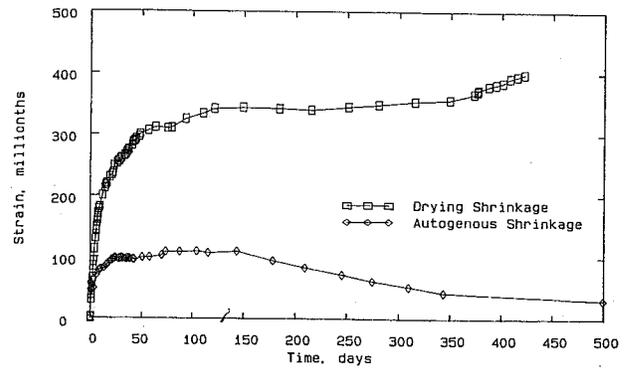
Figure 1. Average results of drying shrinkage tests initiated at 1 day and autogenous shrinkage tests

Average results of the volume-change tests at early ages exhibit a rapid shrinkage of about 60 millionths within the

first 24 hours followed by a more gradual increase in shrinkage to approximately 80 millionths at 10 days. Similar results were reported by Paillere et al (1989), who noted that whereas conventional concrete shrinks very slowly after the usual stage of hydration swelling, silica-fume concrete exhibited no swelling stage and shrinkage was immediate. This high autogenous shrinkage is attributed to self-desiccation resulting from the hydration of the cement at a very low water-cement ratio, with or without silica fume.

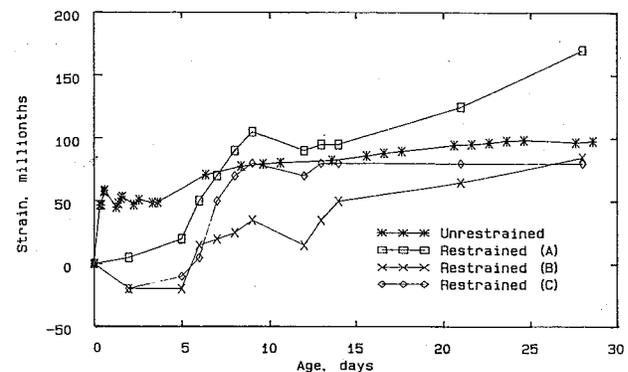
Figure 2. Autogenous volume change of unrestrained and restrained test specimens

In each environment, shrinkage strains of the restrained specimens were slower to develop than those of the unrestrained volume-change specimens at comparable ages (Fig. 2). Specimens stored in the moist curing room and lime-saturated water expanded to day 5 and then began to shrink. At the end of the test, these specimens exhibited an average shrinkage strain of 83 millionths, 15 percent less than the unrestrained specimens. The restrained specimens

placed in plastic bags and stored in air did not exhibit a swelling stage. With no external source of moisture, these specimens exhibited immediate and continuing shrinkage with an average strain of 170 millionths, approximately twice that of the other restrained specimens, at 28 days.

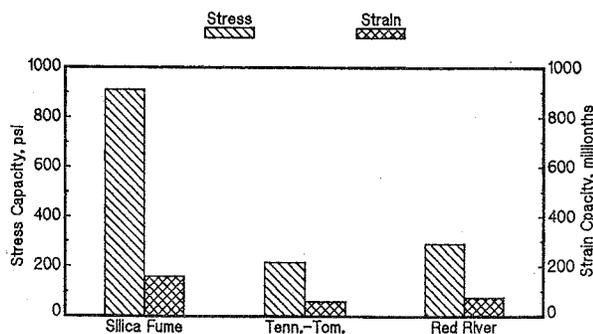
Figure 3. Tensile stress and strain capacities of silica-fume concrete compared with that of conventional concrete

- The modulus of elasticity and poisson's ratio are comparable for the two types of concrete.
- The tensile stress and strain capacities of silica-fume concrete were 2-1/2 to 3 times higher than those of conventional concrete, a definite advantage.
- The high autogenous shrinkage of silica-fume concrete is a disadvantage.
- The lower drying shrinkage, compared to that of conventional concrete, is an advantage.
- The lower creep of silica-fume concrete may be a disadvantage in some applications.
- The higher temperature rise of the silica-fume concrete is a disadvantage.
- The coefficients of thermal expansion were comparable.

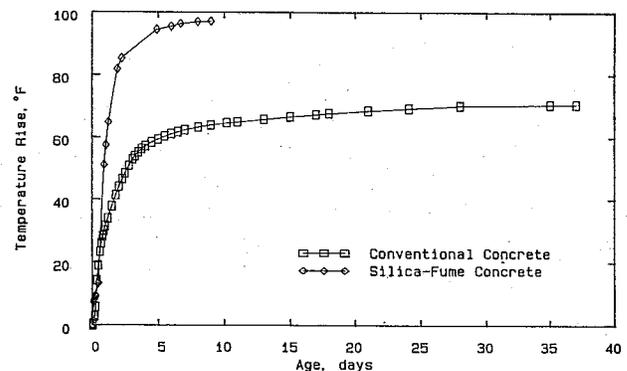
Figure 4. Adiabatic temperature rise for conventional and silica-fume concrete

The adiabatic-temperature-rise test had to be terminated prematurely because of equipment failure. The results obtained indicate a temperature rise for silica-fume concrete of 97.1 °F after approximately 8-1/2 days. This significantly higher temperature rise, compared with that for conventional concrete (Fig. 4), is primarily attributed to the increased cement content of the silica-fume concrete. If the test had been completed, it is expected that a temperature rise of at least 100 °F would have been recorded, a rise about 10 percent higher than predicted for conventional concrete with the same cement content.

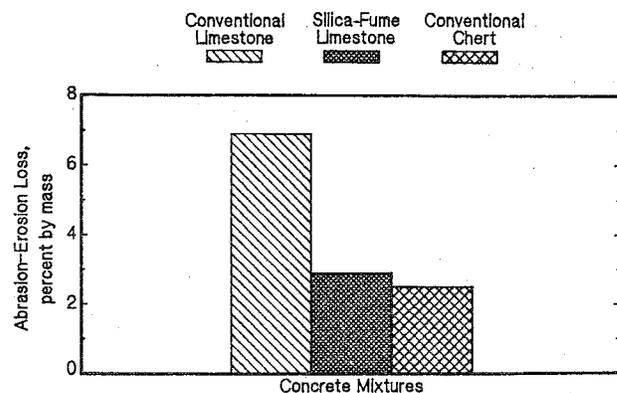
Figure 5. Abrasion-erosion resistance of limestone aggregate concrete with and without silica fume compared to conventional chert aggregate concrete

Abrasion-erosion testing of three specimens was initiated at 28 days. This underwater test procedure subjects concrete specimens to the abrasive action of steel grinding balls. Abrasion-erosion losses of the silica-fume concrete, expressed as a percentage of original mass, averaged 2.9 percent. This loss is approximately 60 percent less than that for concrete without silica fume and a high-range water-reducing admixture (Fig. 5).
