# The REMR Bulletin

Volume 10, Number 1

March 1993

## REMR-Designed Precast Concrete Stay-in-Place Forming System Used for Concrete Repair at Troy Lock and Dam

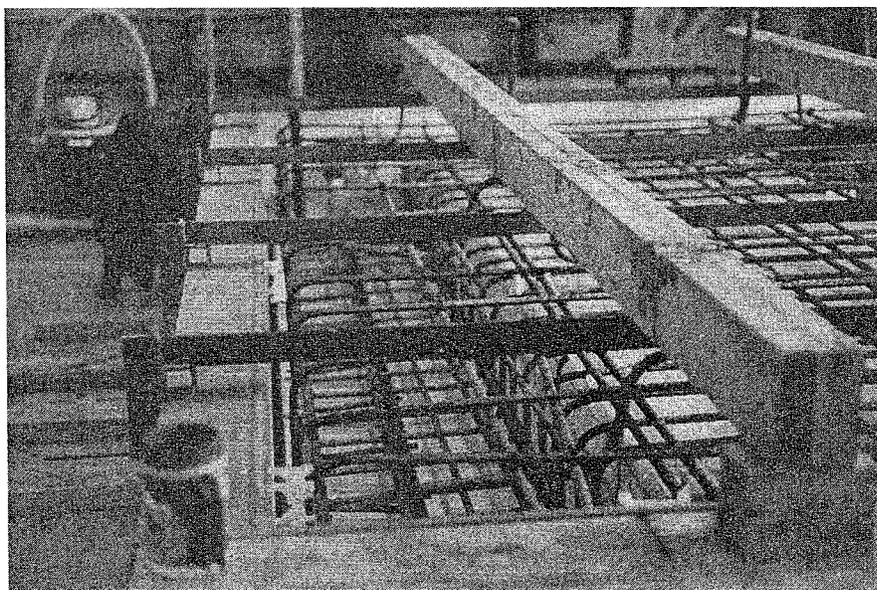
**Figure 1. Precast panel fabrication, showing reinforcement and panel anchor.**

All precasting operations were performed offsite by a National Precast Concrete Association certified precasting plant (Fort Miller Company, Schuylerville, NY). Formica-faced forms were used to provide a smooth exterior surface. Panel anchors positioned to align with anchor dowels in-

stalled in the lock walls were cast into the panel along with reinforcing bars and erection devices (Figure 1). The panel anchors protruded approximately 4 in. from the back of the interior surface. The interior surface was raked to give it a rough finish to enhance bonding with the infill concrete. Riverside river wall panels were also fabricated with holes to accommodate she-bolts during installation.

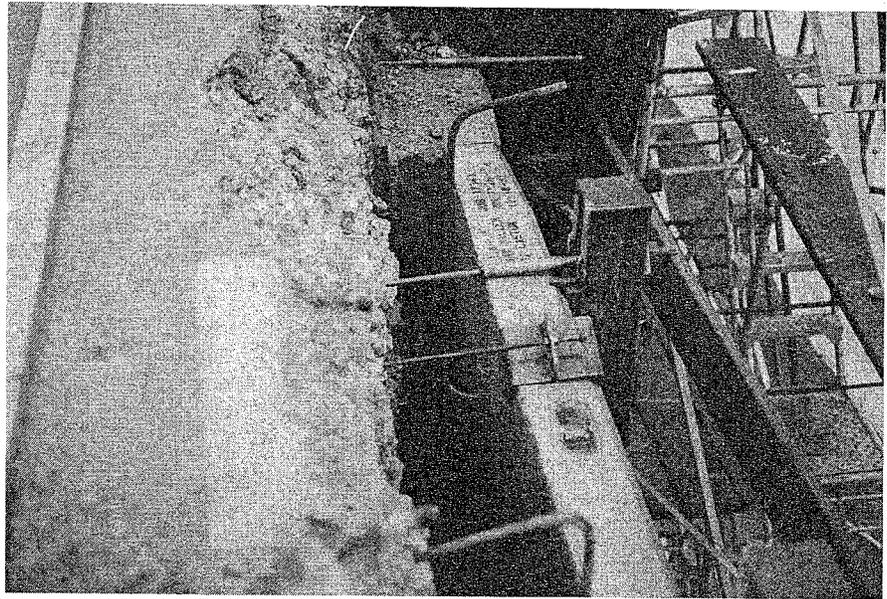
**Figure 2. Installation of lock chamber panel, showing adjustable holding device, lifting inserts, strongback, shebolt, panel anchor, wall dowels, vertical reinforcing rod.**

The panels were temporarily held in place by contractor-fabricated adjustable holding devices, which facilitated vertical adjustment of the panels (Figure 2). Upon completion of all adjustments and verification of alignment by means of a laser, vertical reinforcing bars were inserted into the opening created between the panel anchors and the L-shaped anchor dowels behind the panel (Figure 3).

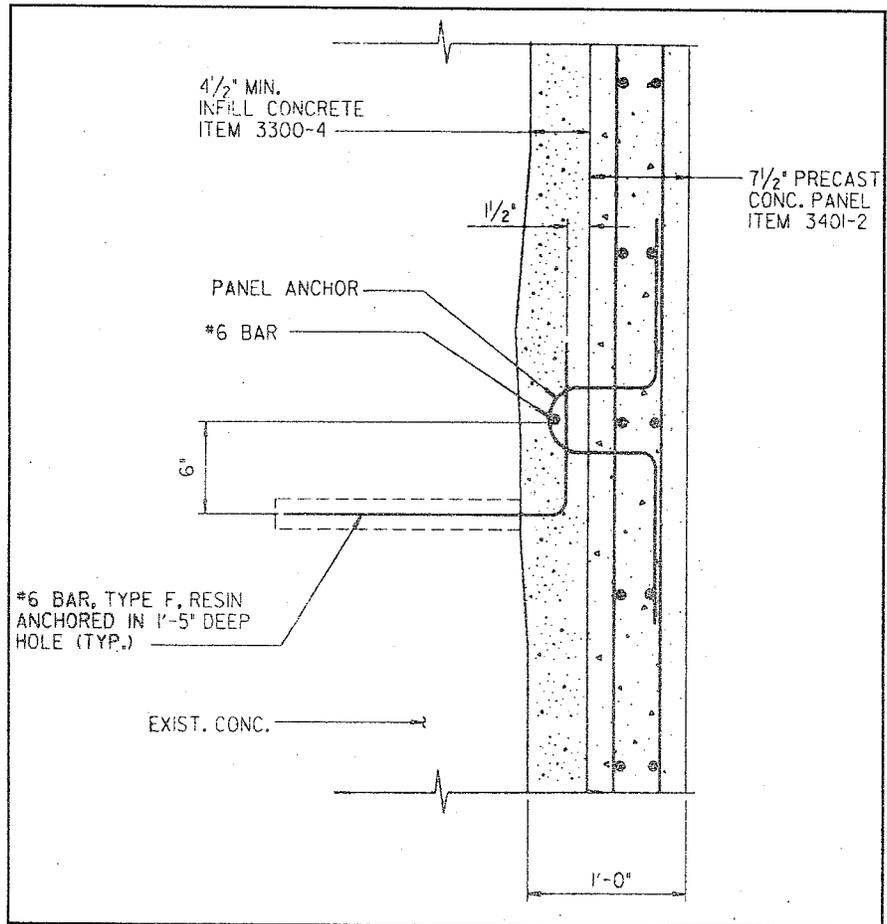
**Figure 3. Lock chamber panel anchoring system.**

The original design called for steel plates and a series of shebolts anchored into the existing concrete at the top and bottom of the panels to resist form pressures during infill concreting operations. An alternate contractor-designed supporting system was approved which used vertical steel strongbacks (two connected C6 steel channels attached to shebolts anchored 1 ft, 5 in. into the existing wall at the top and bottom of the panel, with steel plates in contact with the panel surface at the top, midpoint, and bottom) to resist form pressures during infill placement (Figure 4). Wooden bulkheads were installed at the panel joints to prevent migration of infill concrete out of the forms. Infill concreting of the +/- 4.5-in. void behind the panel was limited to one-half of the vertical panel height (6 ft) by design to avoid excessive form pressures on the panels and resultant cracking; however, several panels could be filled during the same pouring operation.

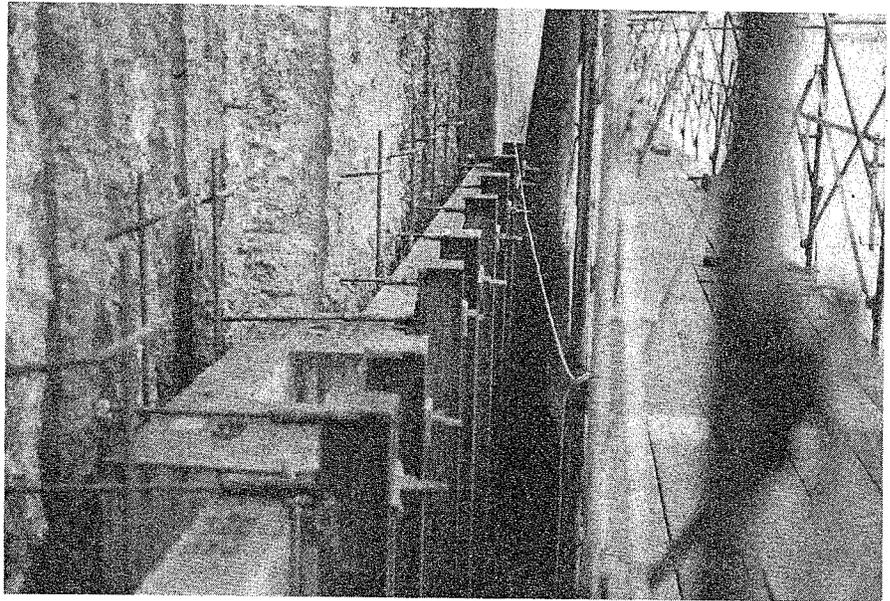
Figure 4. Lock chamber specialty panel, showing strongback system in place prior to infill placement operations.

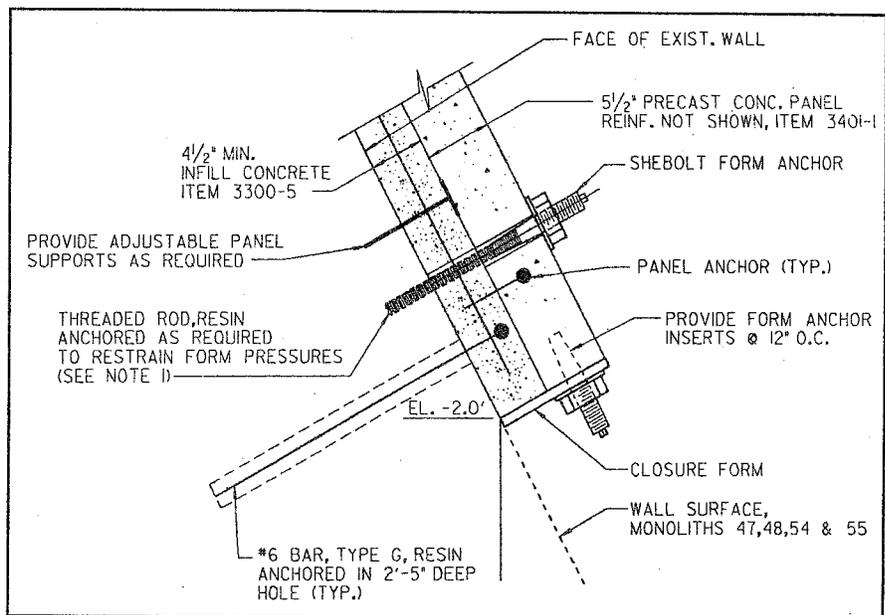
Figure 5. River wall panel support system.

Prior to the installation of panels, loose concrete was removed from the riverside of the river wall by pressure washing. The contractor fabricated and installed an adjustable steel bulkhead on the bottom of the first course panels to provide a seal with the existing wall. The contractor also fabricated a template to match the slope of the river wall to enable panels to be rigged at the proper angle prior to hoisting them into position. The steel strongback securing system used for the lock chamber panels was not required for the riverside panels; shebolts anchored 2 ft, 5 in. into the wall through prefabricated holes in the panel were used to secure the panels and resist form pressure during infill placement (Figure 5).

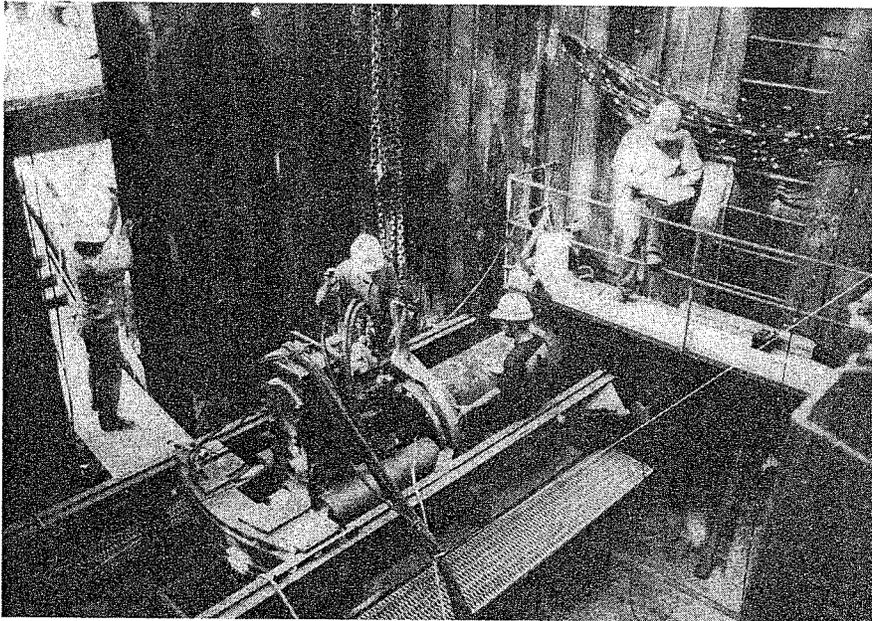
**Soltau microtunneling machine**

The auger microtunneling tests were conducted between 8-26 September 1992, using a Soltau RVA250 machine, with an outer diameter of approximately 26.3 in., furnished by American Microtunneling, South Daytona, FL. The manufacturer's specifications provide a full description of this machine. The control panel was set up adjacent to the drive shaft and was fitted with a computerized data acquisition system to monitor and record machine performance parameters, including position of the steering head, torque, thrust, and steering jack pressures. This data acquisition system was set up to record data at 3-min intervals, keyed to time, date, and distance. The jacking frame was fitted with 250-ton capacity jacks. The jacking pipe used was 10 ft long, 24 in. ID GRP, rated at 115 tons design load. Four of the jacking pipes were strain-gaged. Strain data were recorded continuously during the jacking operation. A computer data acquisition system read all strains 60 times per minute, and the average of the peak strains over that minute for each channel was recorded. This setup was intended to correlate peak jacking thrusts with strains, while avoiding extraneous data from unloading cycles with the jacking system.

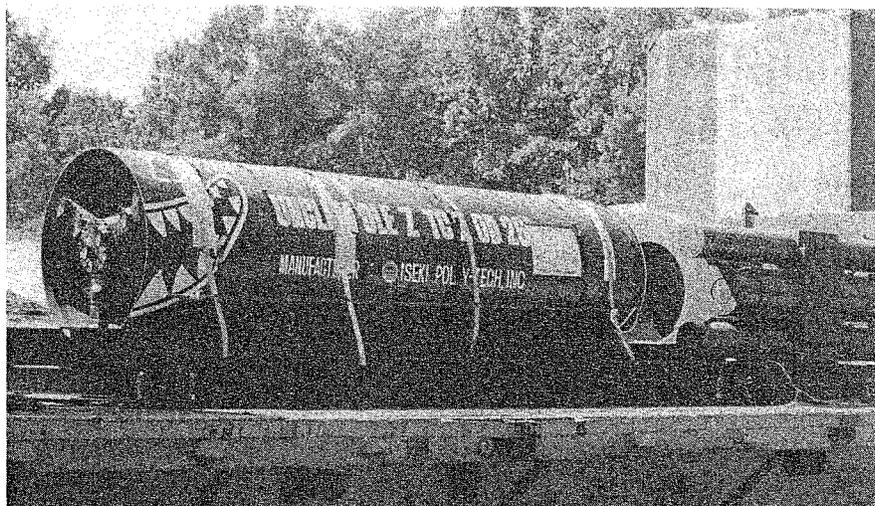
Figure 1. Iseki microtunneling machine

guided, pipejacking process. The guidance system is usually a laser mounted in the jacking pit with a target mounted inside the articulated steering head of the microtunneling machine. The microtunneling process does not require personnel entry. Since the same type of system can be used to install almost any size pipe, there is no size constraint on the process. The process can be successfully used under a variety of ground conditions, ranging from soft soils to rock, including mixed face conditions and boulders, both above and below the water table. A typical microtunneling machine is shown in Figure 1.

The slurry microtunneling tests were conducted between 28 September and 31 October 1992, using an Iseki Unclemole Z TCZ, with an outer diameter of 26 in. furnished by Iseki, Inc., San Diego, CA. Again the manufacturer's specifications provide a complete description of this machine. The control panel was set up adjacent to the drive shaft. Machine performance data were displayed on gages on the control panel and recorded manually as each pipe was pushed. Recorded data included penetration rate, torque, thrust, slurry flow rates, and position of the steering head. The jacking frame was fitted with three stage Molemeister 150-tonne (or 165-ton) capacity jacks. The jacking pipe was 8 ft long, 24 in. ID by 25.8 in. OD GRP, rated at 115 tons design load. Four of the pipes had strain gages installed as described previously. As with

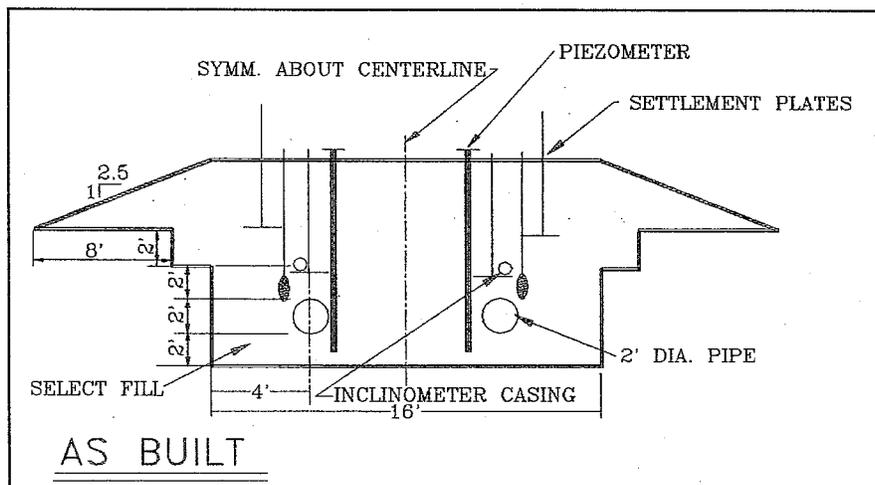
Figure 2. End view of test bed

The microtunneling tests were performed at a specially constructed test facility built at WES. Figure 2 shows an end view of the test facility, which is 340 ft long, 16 ft wide, and 13 ft deep. It was constructed, by first excavating a trench into which six different types of soils were placed and compacted in approximately 60-ft-long sections. Figure 3 is a view of the top of the test bed. The soil profiles included a lean silty clay (loess), a dry sand, highly plastic buckshot clay, wet sand, clay gravel, and silt.

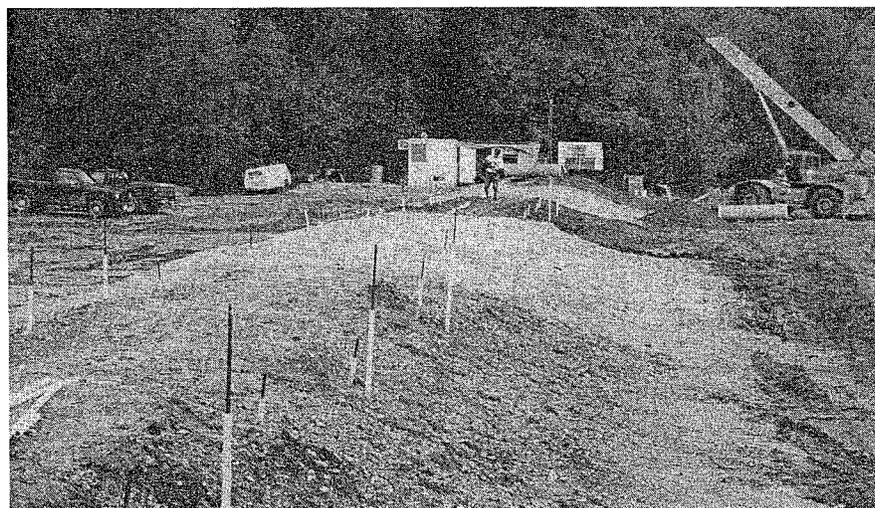
Figure 3. Top of test bed

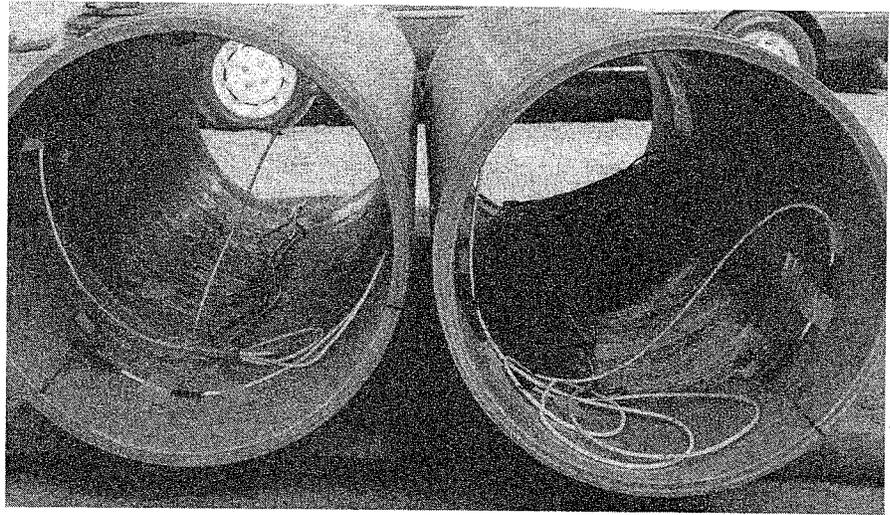
Figure 4. GRP pipes with strain gages installed

Strain gages were installed in eight of the 24-in.-ID glass reinforced plastic (GRP) jacking pipes to measure strains along the tunnel length and around the pipe circumference. Jacking loads generated in the drive pit were resisted by soil shear stresses along the installed pipe string and soil pressure against the face of the tunneling machine. Consequently, the thrust at the face of the machine was only a fraction of the force generated by the jacks in the drive pit. The strain gages were installed in the first two pipes that were to be positioned behind the steering head for each tunnel, in a third pipe to be located at approximately the mid-point of the drive, and in a fourth and final pipe to be installed near the end of the drive. This arrangement was intended to provide continuous strain data on a

given pipe as it was pushed from the drive pit and to provide measurements of strain at key points between the drive pit and steering head. Figure 4 shows the GRP pipes with strain gages installed.

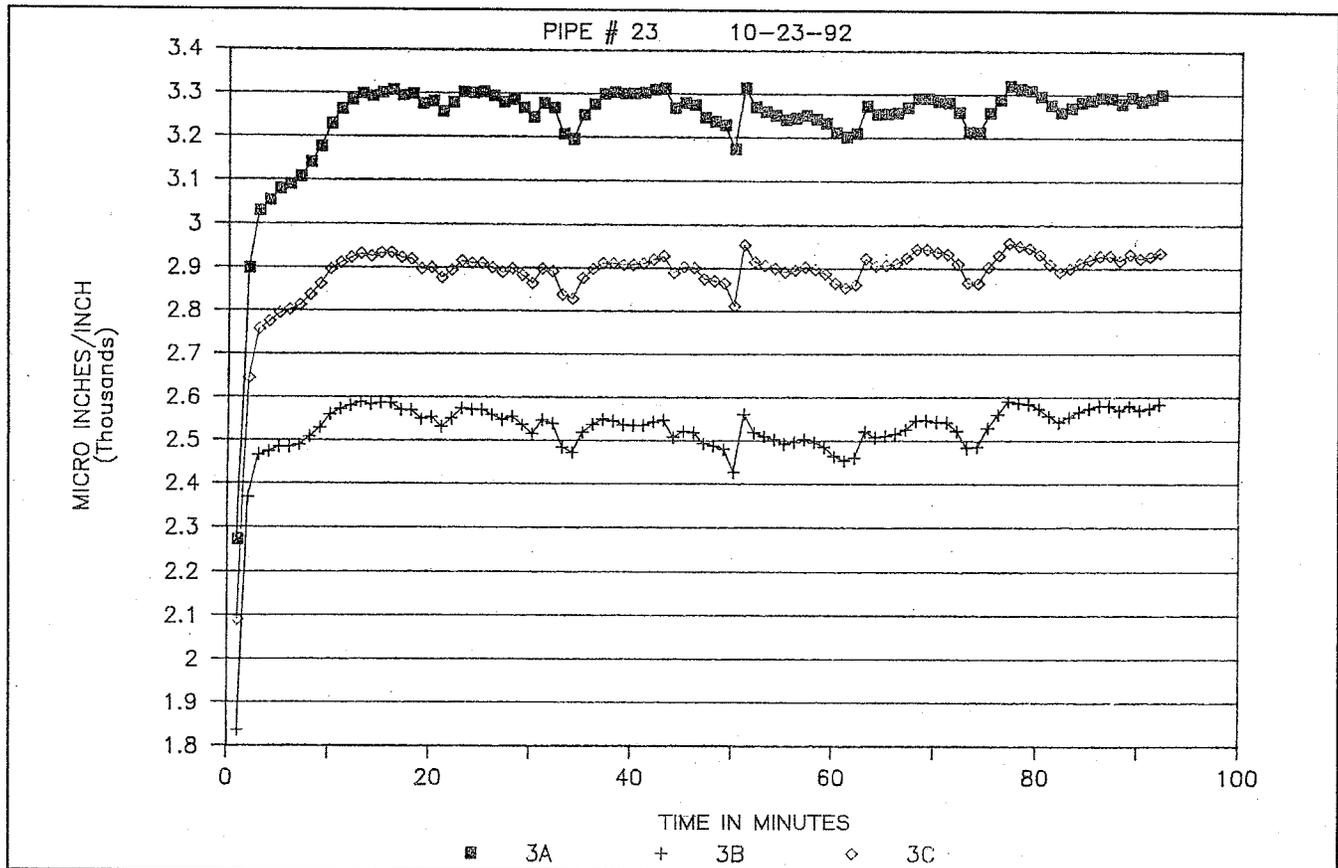
Figure 5. Strains measured in jacking pit while pushing pipe no. 23 during slurry microtunneling test. Gages A, B, and C located at 12, 8, and 4 o'clock, respectively

Pipe strain data are being evaluated to determine soil resistance at the face of the machine and along the sides of the pipe in each type of soil. A typical strain data plot is shown in Figure 5. These strain data will be used together

with additional data to improve methods for estimating jacking loads under various ground conditions for the different types of machines evaluated.

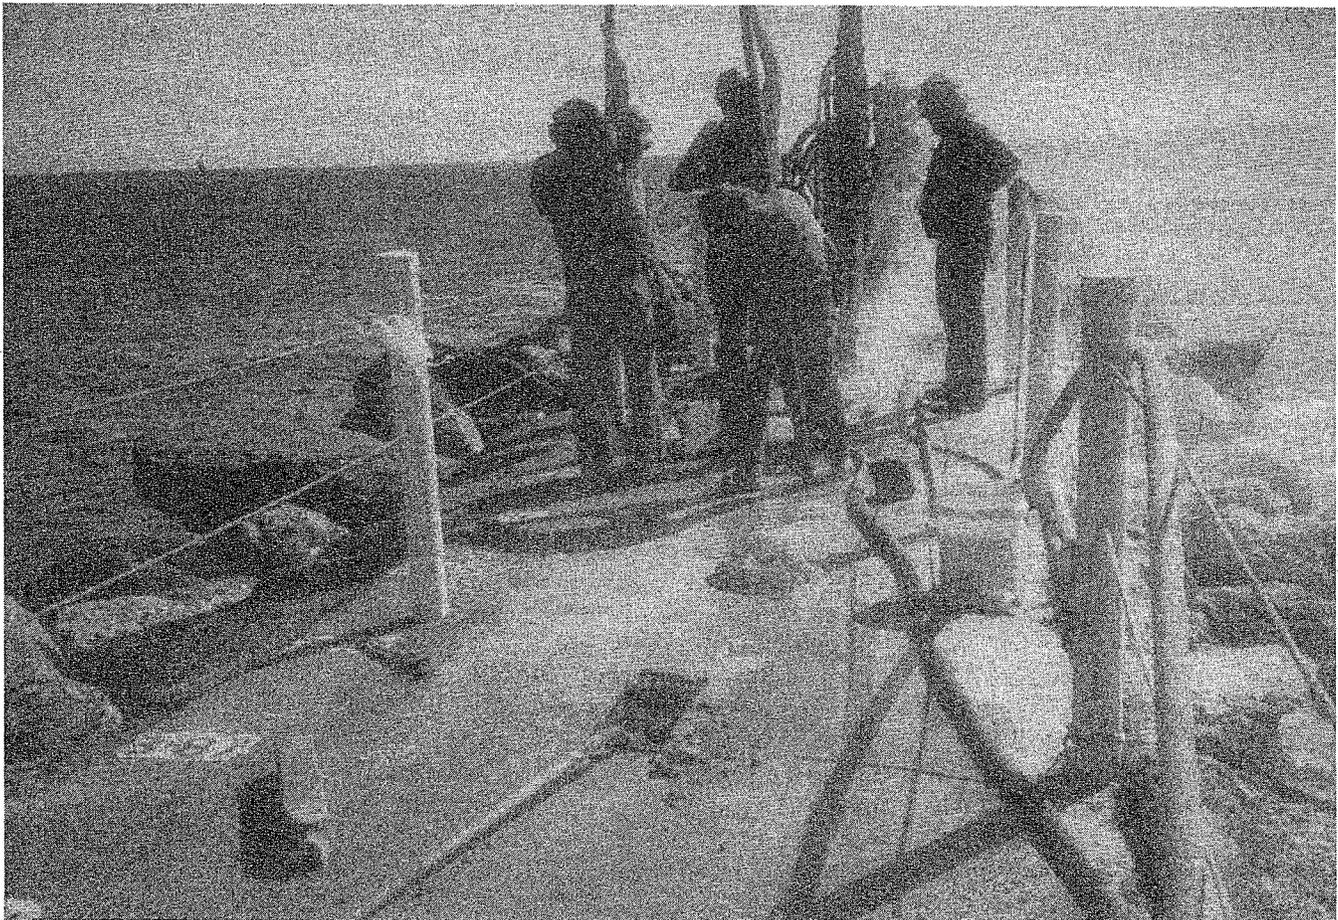
Figure 2. Sealing Port Everglades, Florida, south jetty

An asphalt fishing walkway on the crest of the jetty provided an ideal foundation from which to conduct the drilling and sealing operation. The 3-1/2-in.-diam holes were drilled at 3-ft spacings along the center line of the structure to specified elevations beneath the base of the jetty (Figure 2). Initially, every other hole (primary) was sealed with the sodium silicate-cement mixture, which began to "set up" in 70 to 80 sec. After the primary holes were suf-

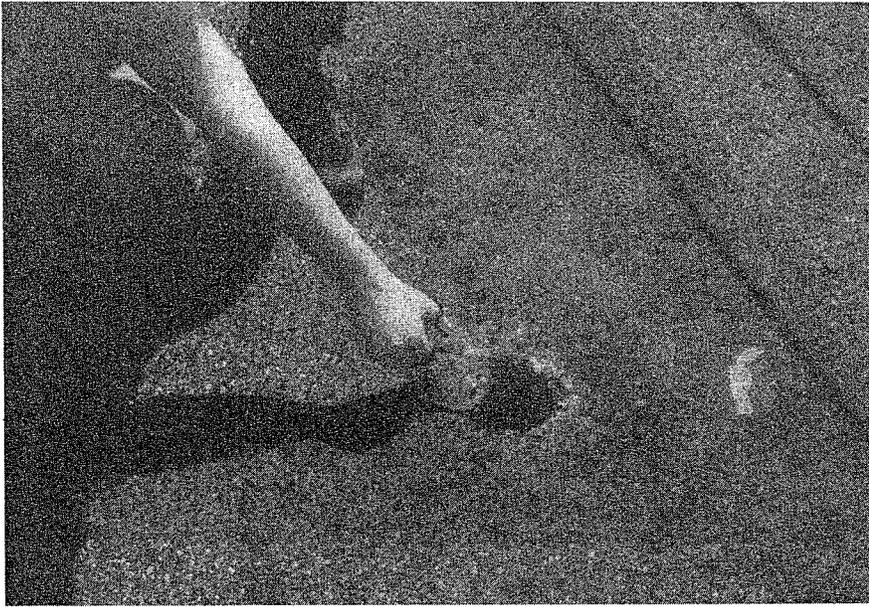
**Figure 3. Dye being placed down unsealed drill hole**

The preconstruction experiment, conducted during the month prior to actual sealing activities, consisted of collecting current magnitude and direction data in three structure voids and measuring the time rate of dye dispersal through the structure with a fluorometer. Data were collected for an hour, beginning 1/2 hr prior to either peak flood, peak ebb, or slack flow. Rhodamine dye was placed in structure voids on the south side of the jetty during peak flood conditions, and on the north side during peak ebb flow. Surface water samples were taken every 10 min for an hour at three stations on both the north and south side of the structure. Water samples also were taken at the seabed to determine if dye transmission was uniform with depth. One-inch diameter elec-
