TECHNICAL REPORT REMR-CS-11

**IN SITU REPAIR OF DETERIORATED  
CONCRETE IN HYDRAULIC STRUCTURES  
LABORATORY STUDY**

R. P. Webster, L. E. Kukacka

Process Sciences Division  
Brookhaven National Laboratory  
Upton, New York 11973

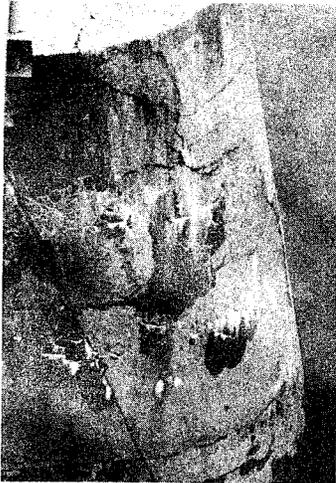
TOP — Repair of slab by injection using a plastic syringe

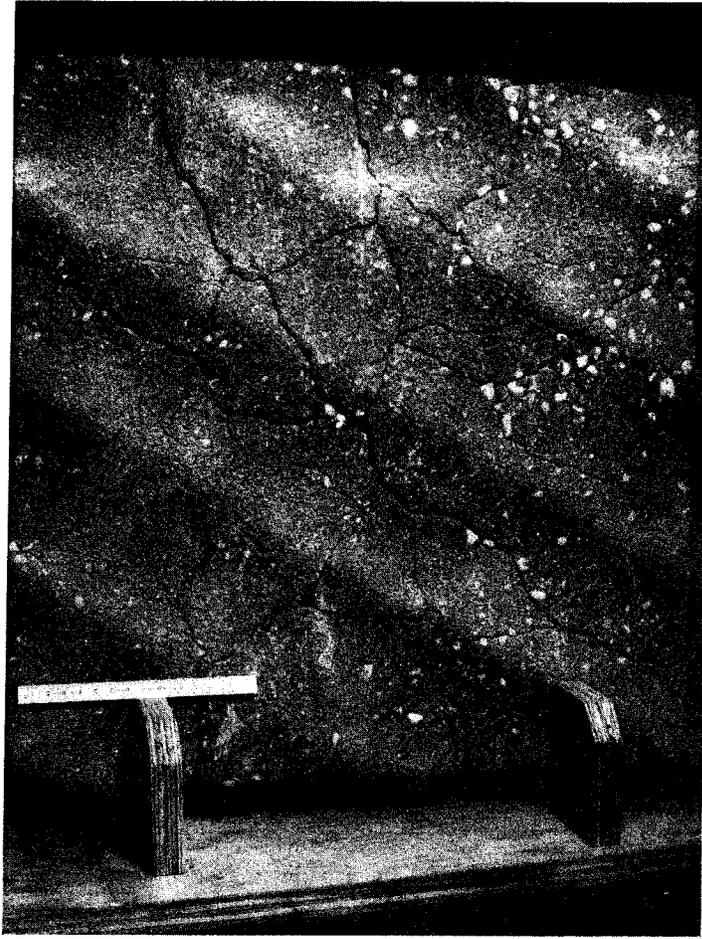
Figure 1. Typical "cracked" concrete slab.

10. The "cracked" slabs were fabricated by casting them individually into sheet metal forms. After the mixture had taken its initial set (3 to 4 hr after being fabricated), the corners of the forms were opened, and the slabs were flexed by hand until cracks began to open up in the surface. Cracks varying in width from hairline to 1/4 in. could be created this way (Figure 1). All slabs were sandblasted prior to being repaired.

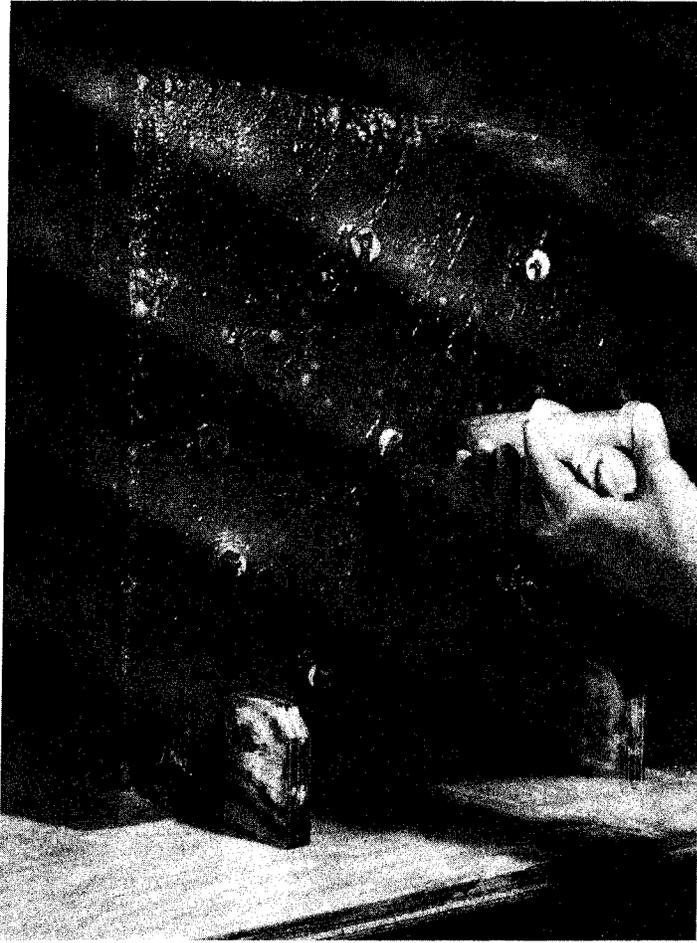
Figure 2. Repair of slab by injection using a plastic syringe.

25. The water-saturated slabs were soaked in water for a minimum of three days between steps 2 and 3. They were then patted dry to a SSD condition before the injection ports (1-in. diam wooden dowel into which a hole had been drilled) were glued to the surface. Because of the small quantities of materials used to repair the slabs, all the injection work was done by hand using plastic syringes (Figure 2).

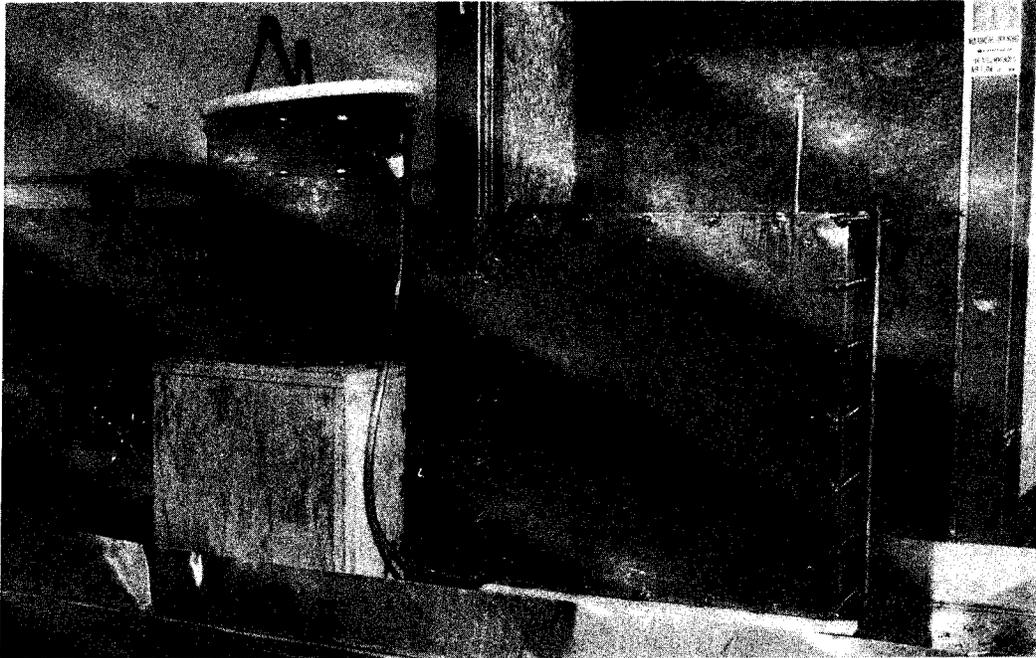
A. Laboratory set-up for vertical impregnation studies.

37. All vertical impregnations were done using a soaking jacket which was braced against the face of the slab (Figure 6). The soaking jacket was made of 0.05 in. thick stainless steel sheet with a 0.5 in. thick stainless steel spacer around the edge of the jacket. A closed-cell polyurethane was used as a gasket material to seal the soaking jacket to the face of the slab. The sides and back of all slabs were coated with a gel epoxy to prevent leakage of monomer during soaking.

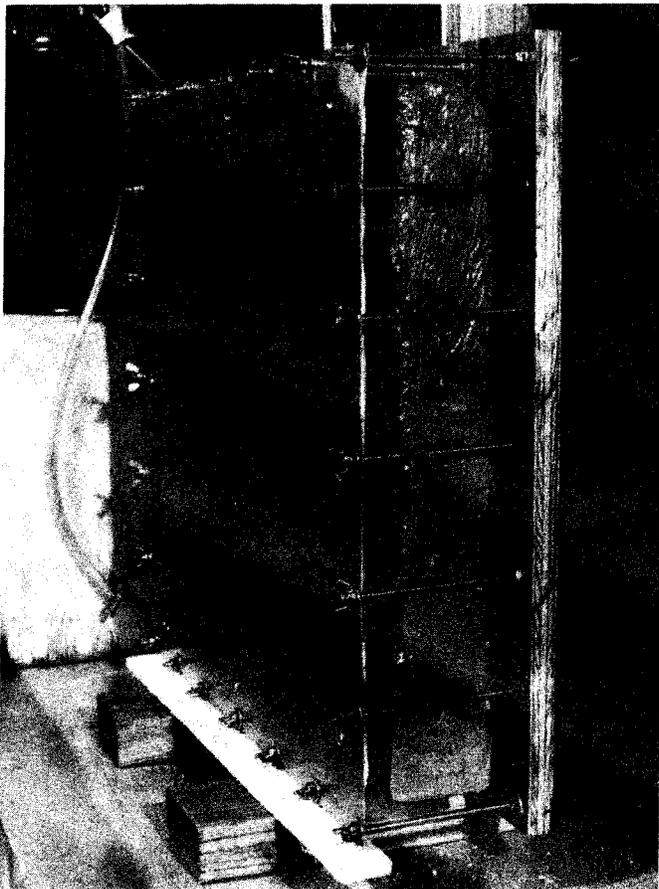
B. Close-up of slab  
inside impregnation  
soaking jacket.
