THE REMR BULLETIN

VOLUME 13, NUMBER 3 AUGUST 1996

Rehabilitation of Concrete Structure and Steel Sector Gates at the Court Street Dam in Rochester, New York

By William R. Miles, Bergmann Associates

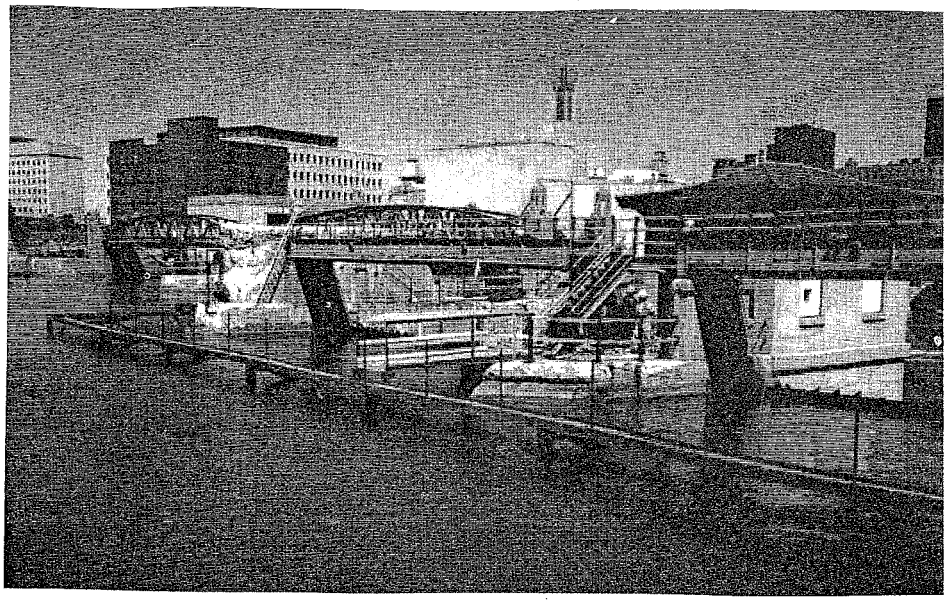
Figure 2. Upstream view of Court Street Dam during cofferdam installation

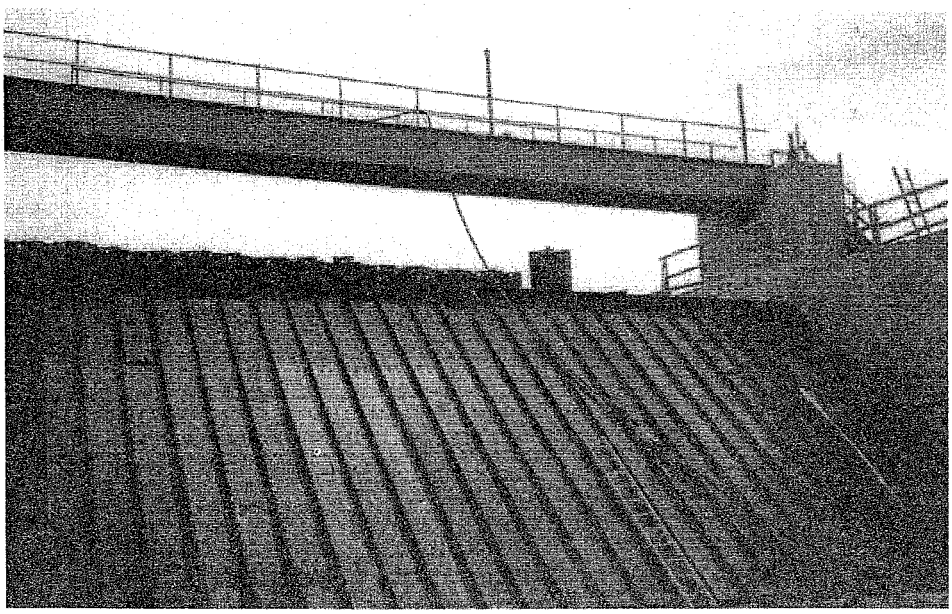
Figure 3. Rehabilitation Gate No. 2, new access bridge, and center pier with precast panels

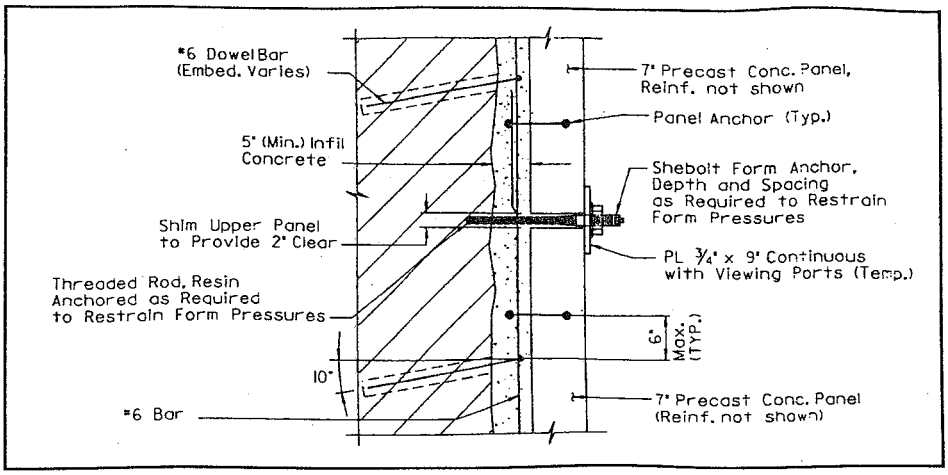
Figure 4. Precast repair detail

Precast panels at the Court Street Dam were designed and detailed for the two operating piers, the center pier, and the west abutment. The panels extended from elevation 505 on the upstream faces of all units (about 2 to 3 ft below low-water levels) and from the sill slab on the downstream side of the center pier up to between 12 and 18 in. from the top of the unit, to allow for a new cast-in-place cap. There were a total of 36 panels at the four unit locations. The typical panels were 7 in. thick and were of variable surface dimensions, many of which were trapezoidal in configuration with widths up to 11 ft-10 in. and lengths up to 20 ft-8 in. See Figure 4 for a typical precast repair detail.

The typical panel installation required (a) a minimum removal of 12 in. of existing surface concrete (primarily using small impact hammers), (b) No. 6 reinforcement anchor dowels at a 2- to 4-ft spacing and a minimum 18-in. embedment, (c) a minimum of 5 in. of 4,000-psi infill concrete with 1/2-in.-maximum coarse aggregate, (d) she-bolt form anchors at a 4-ft-maximum spacing for construction phase tiebacks, and (e) completely sealed joints.

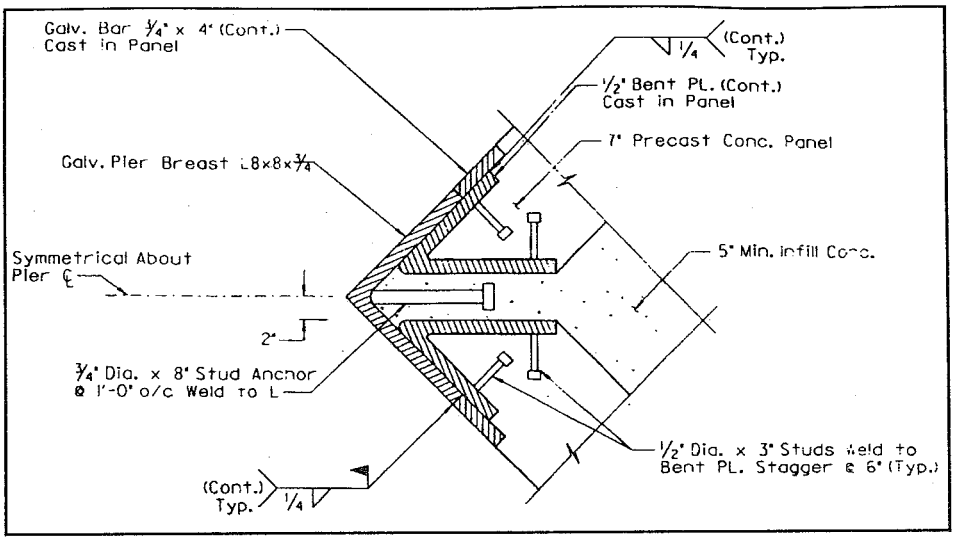
Figure 5. Nosing panel detail

- Cast-in bent-plate armoring for the nosing panels (see Figure 5 for detail).
- Cast-in angle armoring for the trashrack panels at guide locations.
- Beveled edges at nosing panels.
- Chamfers, 1-in. wide, at joint locations.
- Two-in. grouted horizontal and 3/4-in. sealed vertical joints.

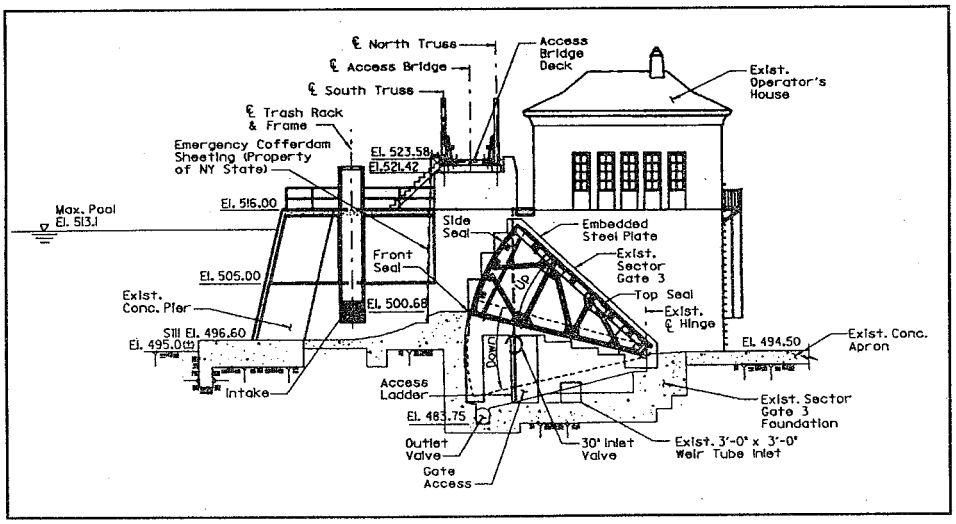
As a result of over 70 years of use and constant wear from water and ice forces, the four steel sector-type tainter gates at the Court Street Dam had suffered extensive deterioration. Based on previous biennial inspection data and in-depth hands-on inspection, including exterior, interior, and underwater, the various structural elements of the gate were evaluated, and repairs were developed for necessary rehabilitation. See Figure 6 for a typical pier and gate cross section.

Figure 6. Pier and gate section

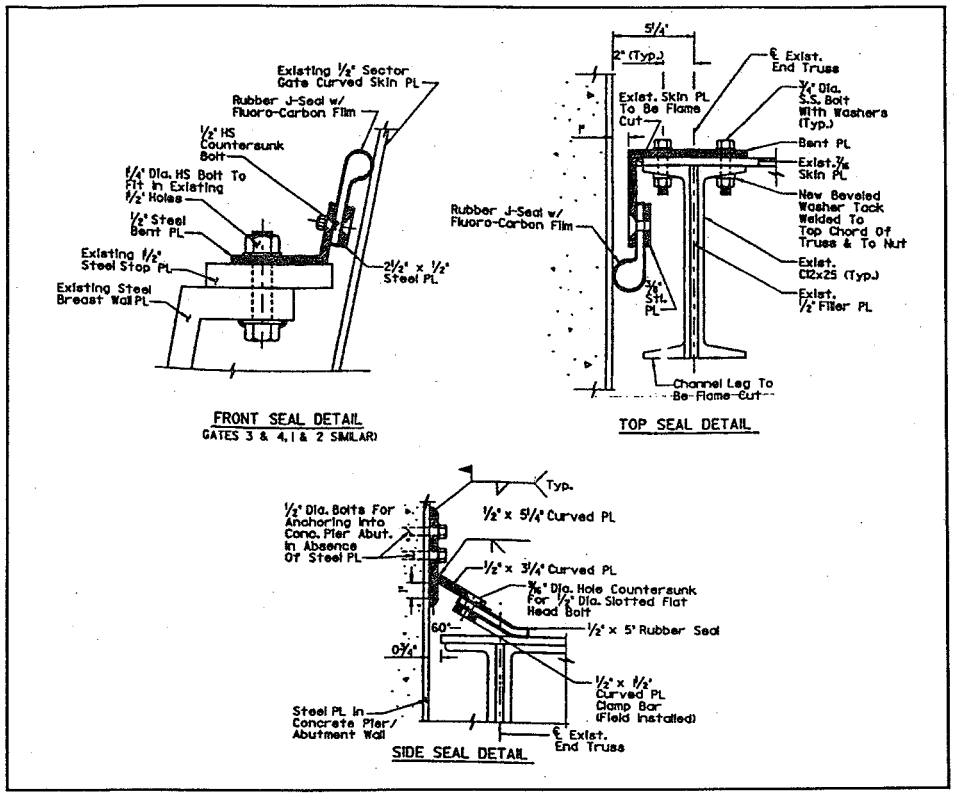
The original top seal system at each gate consisted of a two-piece section of conveyor belting in the form of a tee that was originally considered experimental. Those seals had a tendency to be forced out of the tee-shape by water and ice pressure. The result was substantial leakage, especially near the bottom of the top plate. The original front seal system consisted of a bent plate that was connected to the fixed concrete sill and closed against the front skin plate of the sector gate by water pressure. The original gates had no side seal system, which meant the gate maintenance staff was forced to plug spaces with rope, sand bags, and gravel during gate dewatering operations.

Figure 7. Seal replacement details

The new seal systems installed under the Phase II rehabilitation contract consisted of new rubber sections as shown in Figure 7. The new top seals consist of a rubber J section connected to an 8- by 6-in. steel angle that extends inside the gate end frames. They seal against the steel seal plates cast into the piers and abutments by means of interior water pressure.

The new front seals consist of a rubber J section connected to a 1/2-in. bent plate connected to existing breast wall steel sections. They seal against the steel front skin plates of the sector gates by means of the upstream water pressure. Both the top and front seal J sections have a 0.03-in. thickness of fluorocarbon film on the bearing surfaces for improved durability.

The new side seals consist of a rectangular rubber section that is bolted to bent steel plates which in turn are bolted and welded to the pier and abutment faces. These seals function only when the gate is raised on its prop systems and dewatered. Only then does the upstream water pressure force this seal section against the curved front skin plates to seal off the end joints. The side seals were detailed to make them more resistant to impact damage from floating logs, a common hazard at the dam.
