REPAIR, EVALUATION, MAINTENANCE AND REHABILITATION RESEARCH PROGRAM

TECHNICAL REPORT REMR-CO-3

CASE HISTORIES OF CORPS BREAKWATER AND JETTY STRUCTURES

Report 2
SOUTH ATLANTIC DIVISION

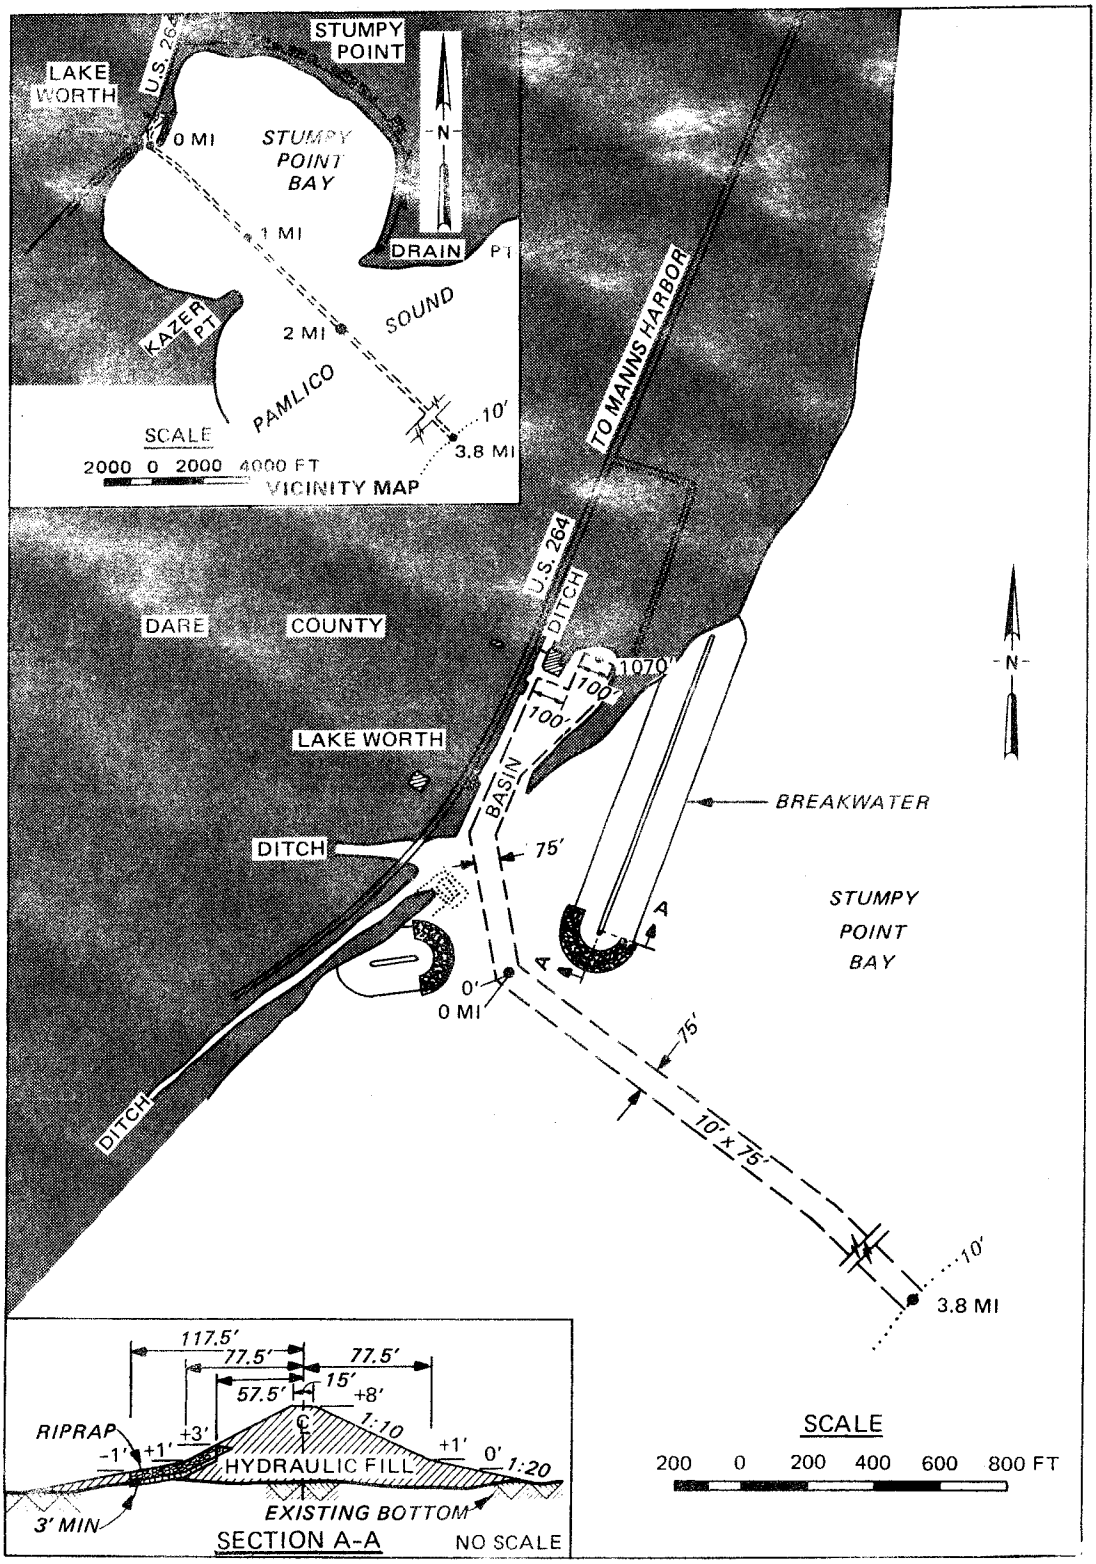
Figure 4. Stumpy Point Bay, North Carolina

1974	A reconnaissance survey was made to determine the severity of erosion to the breakwaters. It was found that the riprap protected sections were functioning satisfactorily but that the fill material adjacent to the riprap sections had substantially eroded. Maximum vertical scarps of 7, 3, and 3 ft, respectively, were noted on the bay and harbor sides of the north breakwater and bay side of the south breakwater. The erosion on the north breakwater was on directly opposite sides of the breakwater with only 30 ft of original material separating the narrowest point. It was felt that "the southeasterly wind with its associated fetch is very erosive to the breakwaters on both sides of the dredged channel."
1985	Neither repairs nor maintenance has been carried out since the breakwaters were originally constructed.

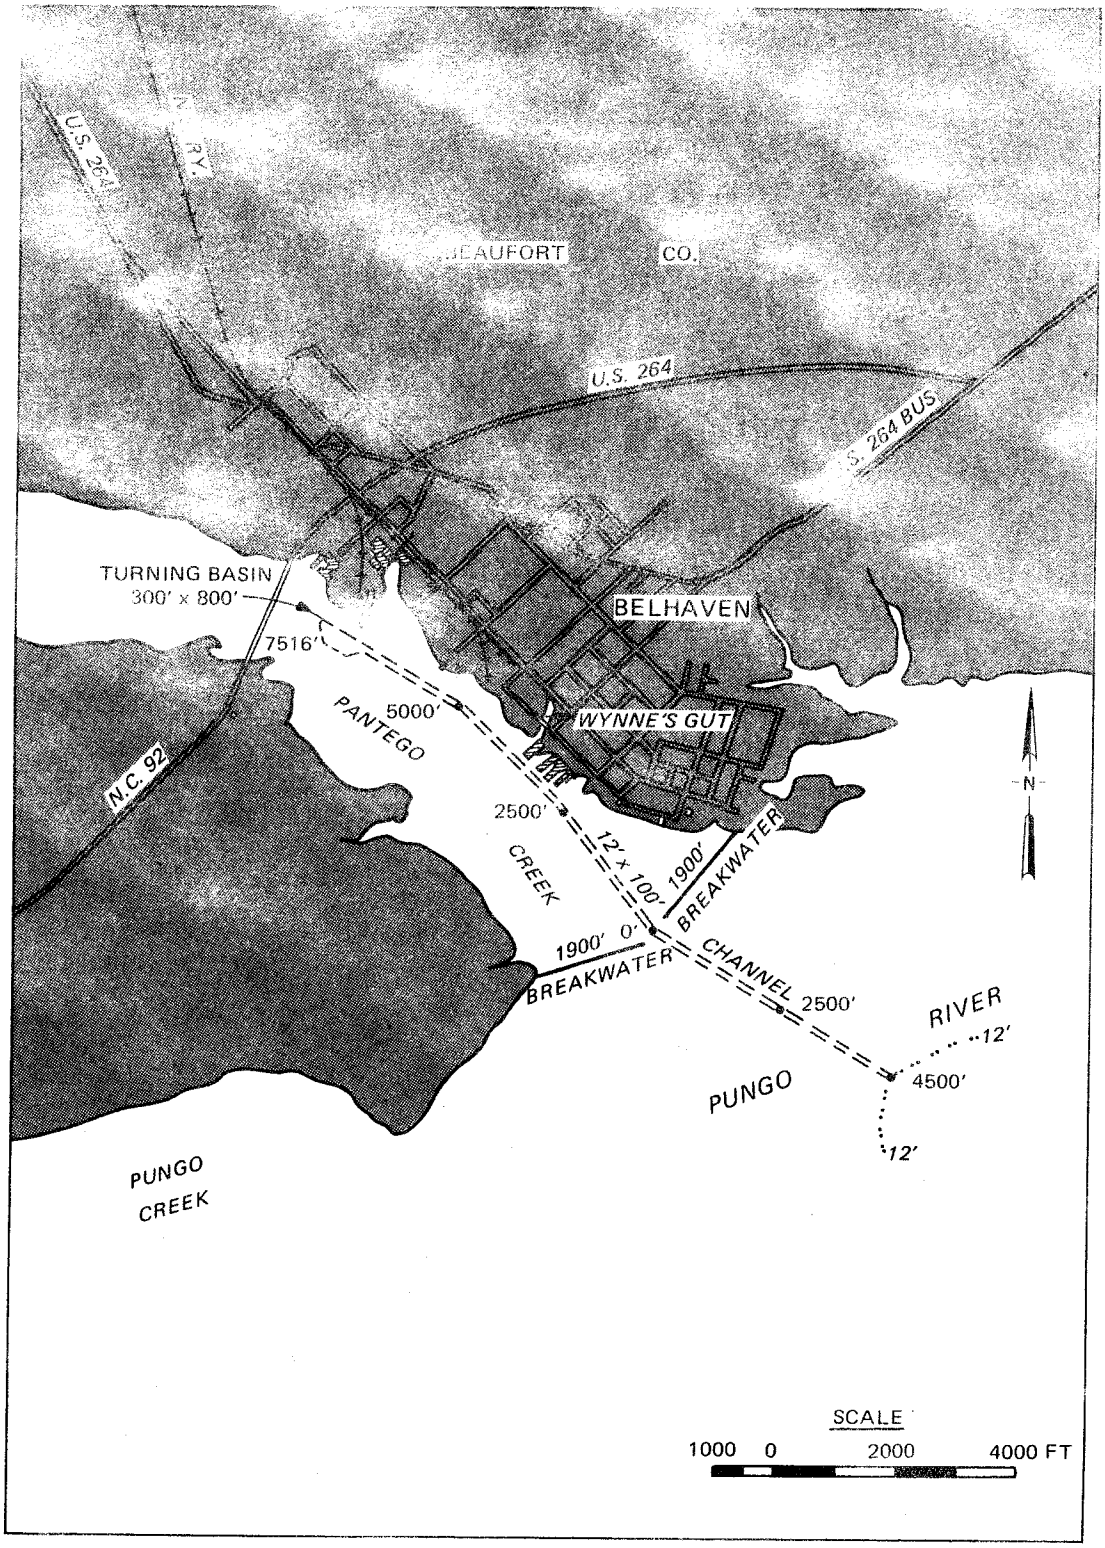
Figure 5. Belhaven Harbor, North Carolina

1982	Visual examination showed that approximately three dozen timbers were missing over the length of the breakwaters. Also, a few pilings were missing. It was thought that the damage resulted from the impact of transient barges tied to the structure.
1985	The structure does not provide its intended wave protection, but at present there are no plans for improvement.

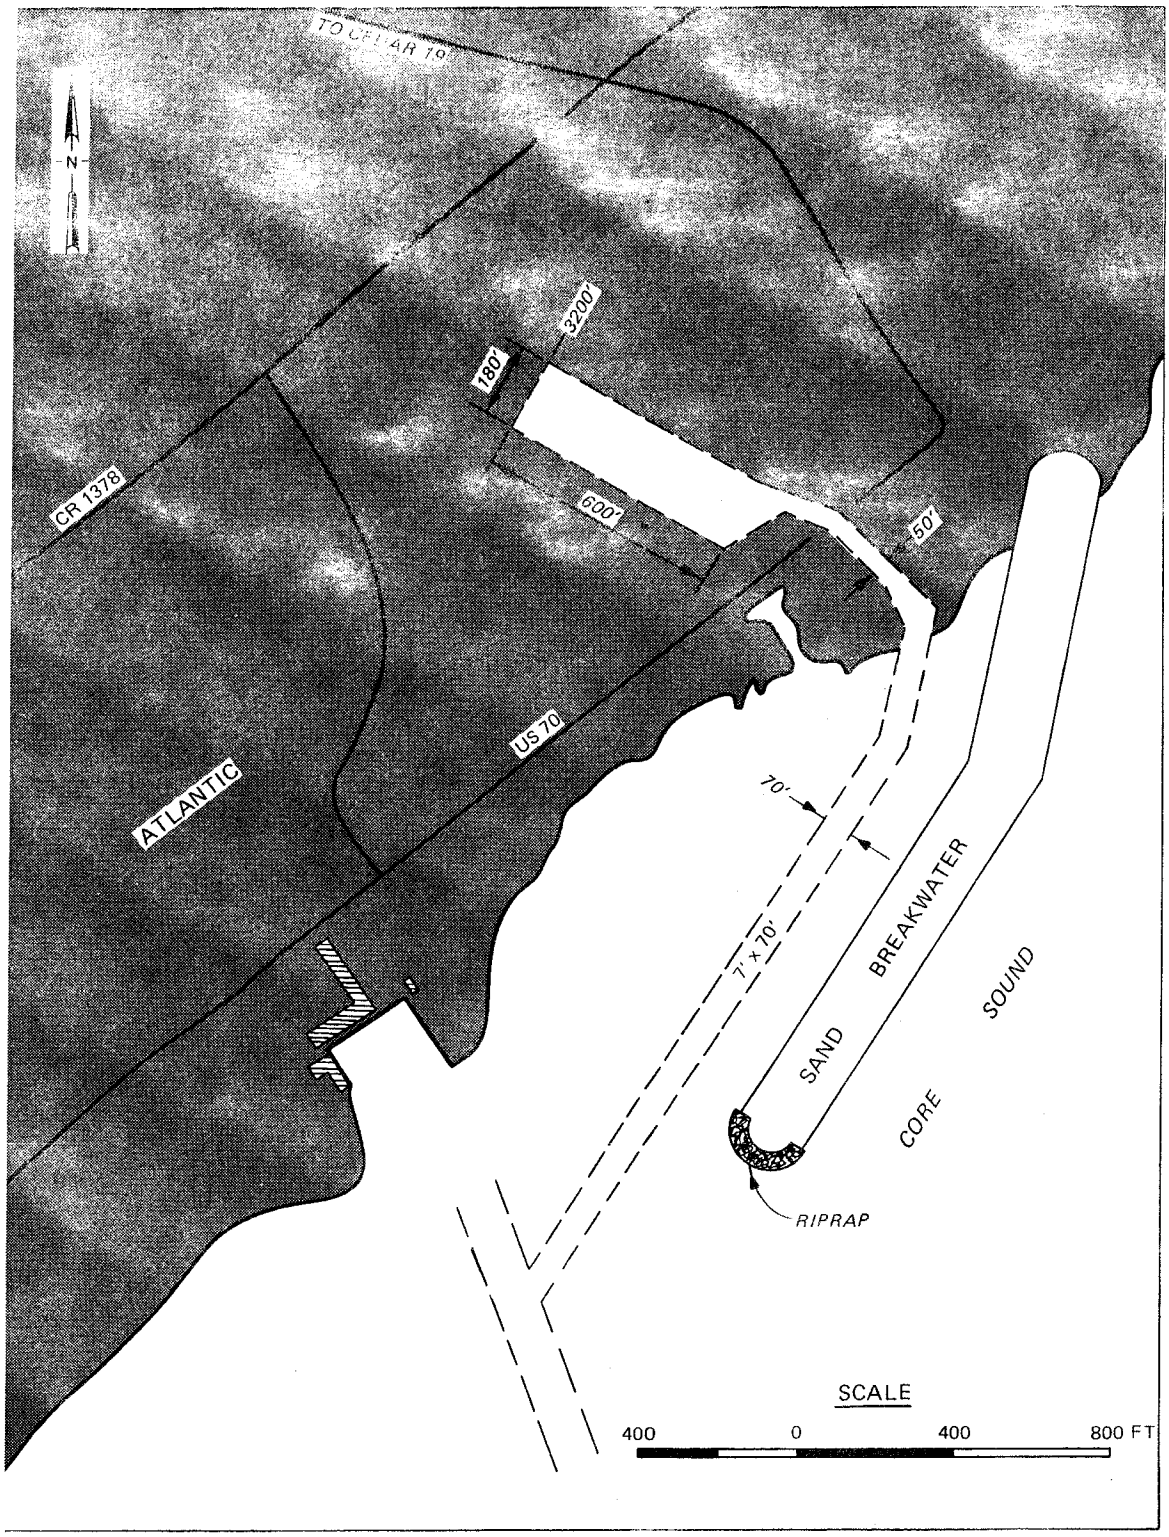
Figure 8. Atlantic Harbor of Refuge, North Carolina

Date (a)	Construction and Rehabilitation History
1971-1972	A 2,000-ft-long sand breakwater (Figure 8) with a riprap head was constructed in February 1972 as part of the Harbor of Refuge project. Material dredged from the access channel was used for the breakwater. A tentative design section called for a crest width of 15 ft at an elevation of +8 ft mlw, with side slopes of 1V:10H above mlw and 1V:20H below. The head of the breakwater would have a 3-ft-thick riprap section from -1 to +3 ft mlw. This design section was similar to the one used on the Stumpy Point Bay breakwaters. Estimated quantities were 46,500 cu yd of sand, 3,232 tons of stone, and 6.5 acres of grass (to hold the sand in place). The estimated total cost was $51,400.
1973	Erosion had occurred along a 400-ft section of the southeastern face of the breakwater. The erosion extended from 35 to 60 ft into the embankment, creating an escarpment of about 3 ft, and the planted grass had been destroyed in this area. Also, the stone protection on the south end of the breakwater (previously covered with sand) had become uncovered, displaced, and scattered. The sand fill behind the stone apparently eroded away first, undermining the rock and subsequently displacing it.

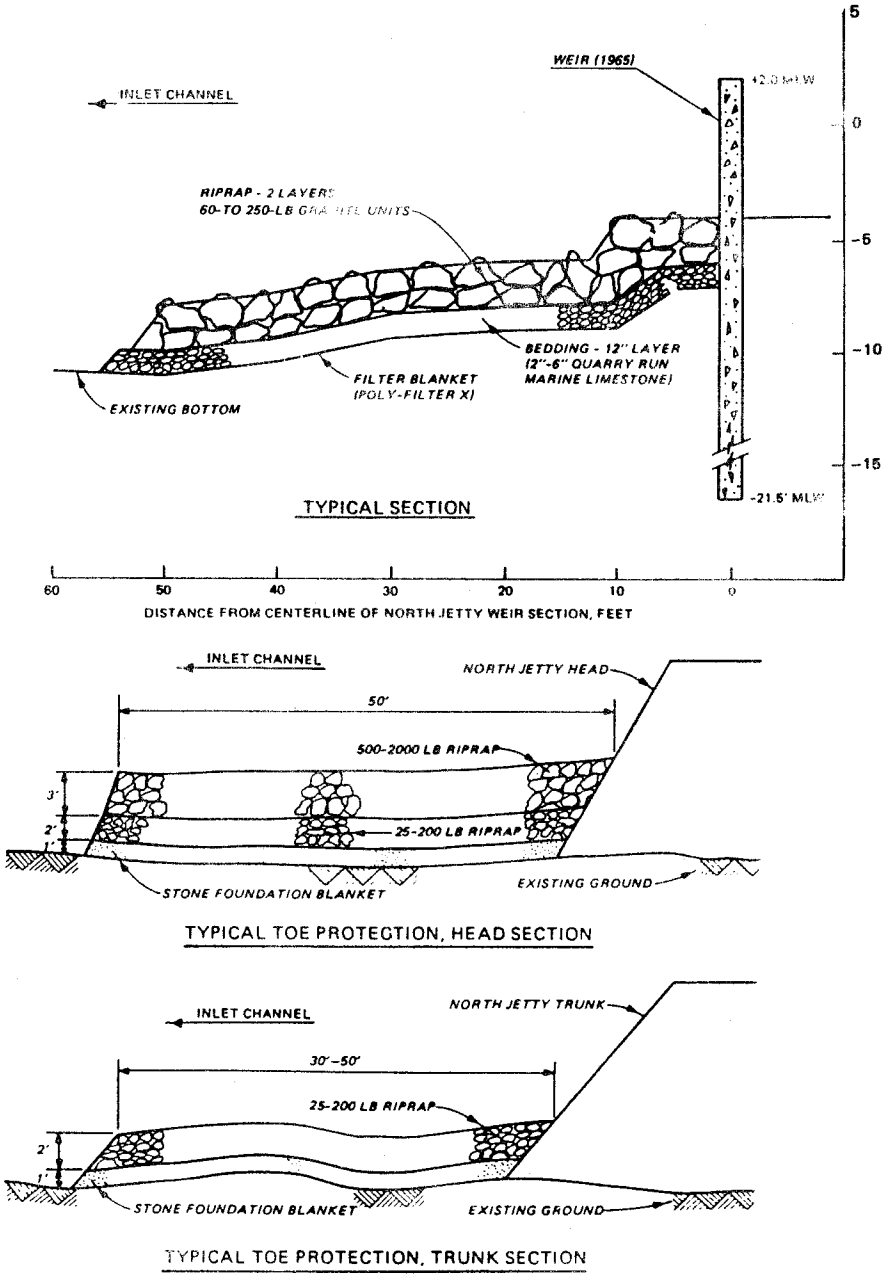
Figure 12. North jetty toe protection Masonboro Inlet

1973-1974	Toe protection (Figure 12) was placed along the channel side of the 1,100-ft weir section because of continued movement of the navigation channel and the costs involved should a catastrophic failure occur (loss of sheet-pile sections resulting from scour and undermining). The toe apron was to be 50 ft wide with a 1-ft-thick foundation blanket of 2- to 6-in. stone overlain with a 2.5-ft layer of 25- to 250-lb riprap. Total cost of the repair was $248,800.
1978-1980	Construction of the south jetty, built of quarry stone and concrete sheet pile to a length of 3,450 ft, began in July 1978 and was completed in August 1980. A bathymetric survey taken in 1978 showed the channel to be extremely close to the north jetty with water depths up to -25 ft mlw along the rubble-mound section and -12 ft mlw along the weir jetty section. Model tests of the south jetty alignment and geometry, conducted at the US Army Engineer

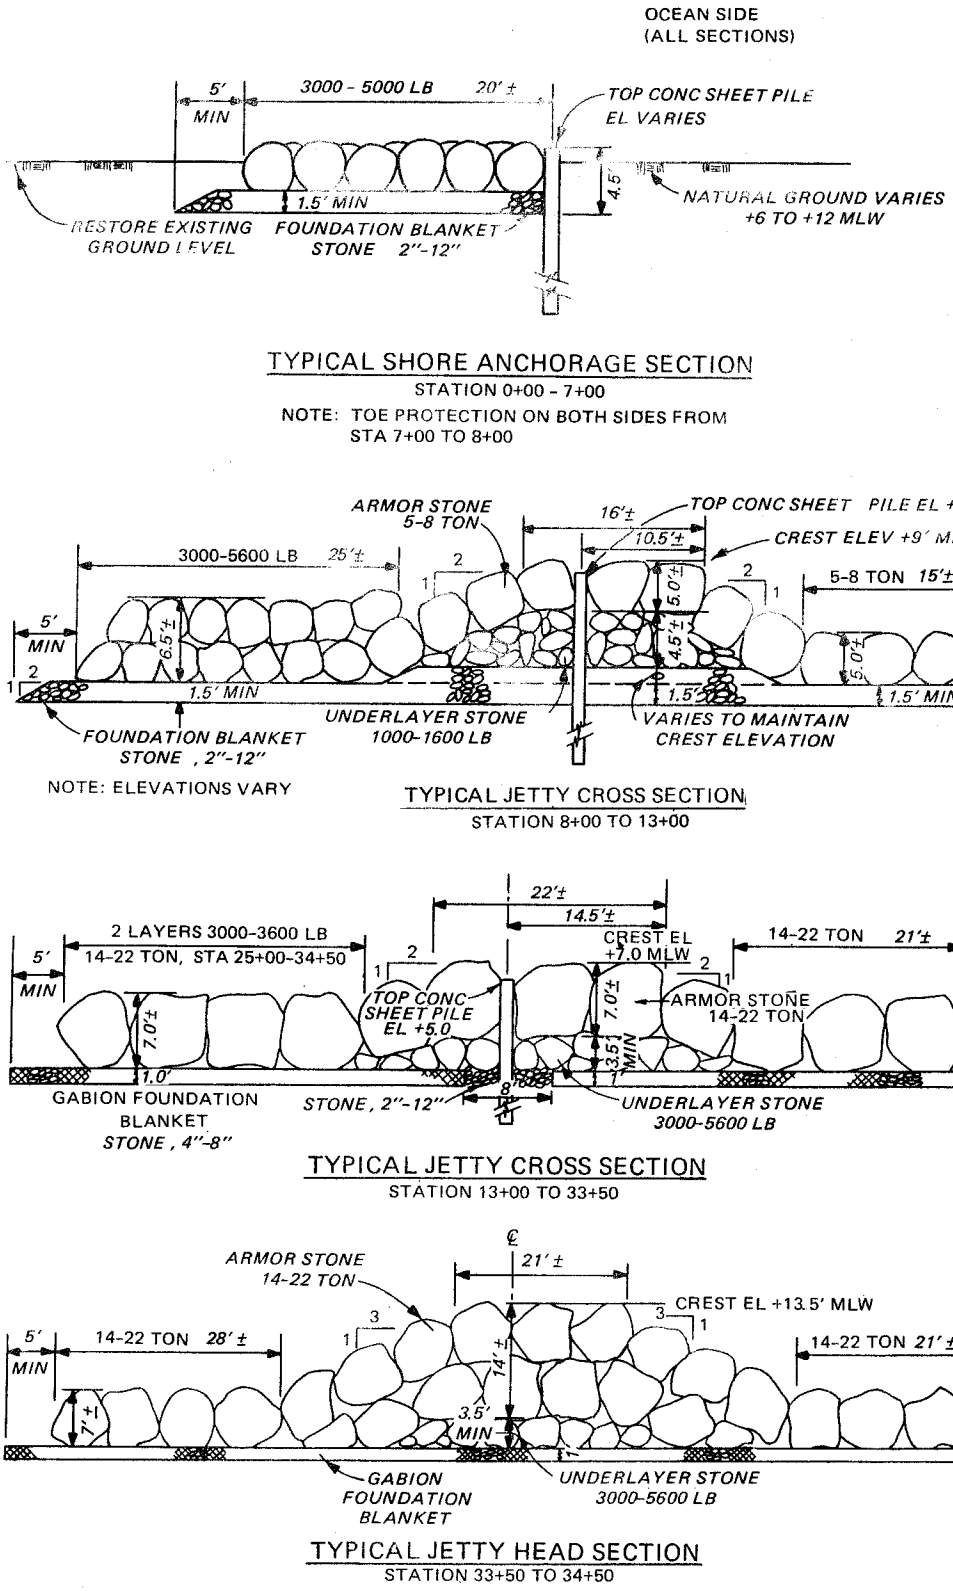
Figure 13. Typical south jetty cross sections, Masonboro Inlet

1985	Presently, the south jetty is in good condition; whereas, the north jetty, which was constructed of smaller size armor stone, is in need of repair work in several areas showing localized armor stone damage.

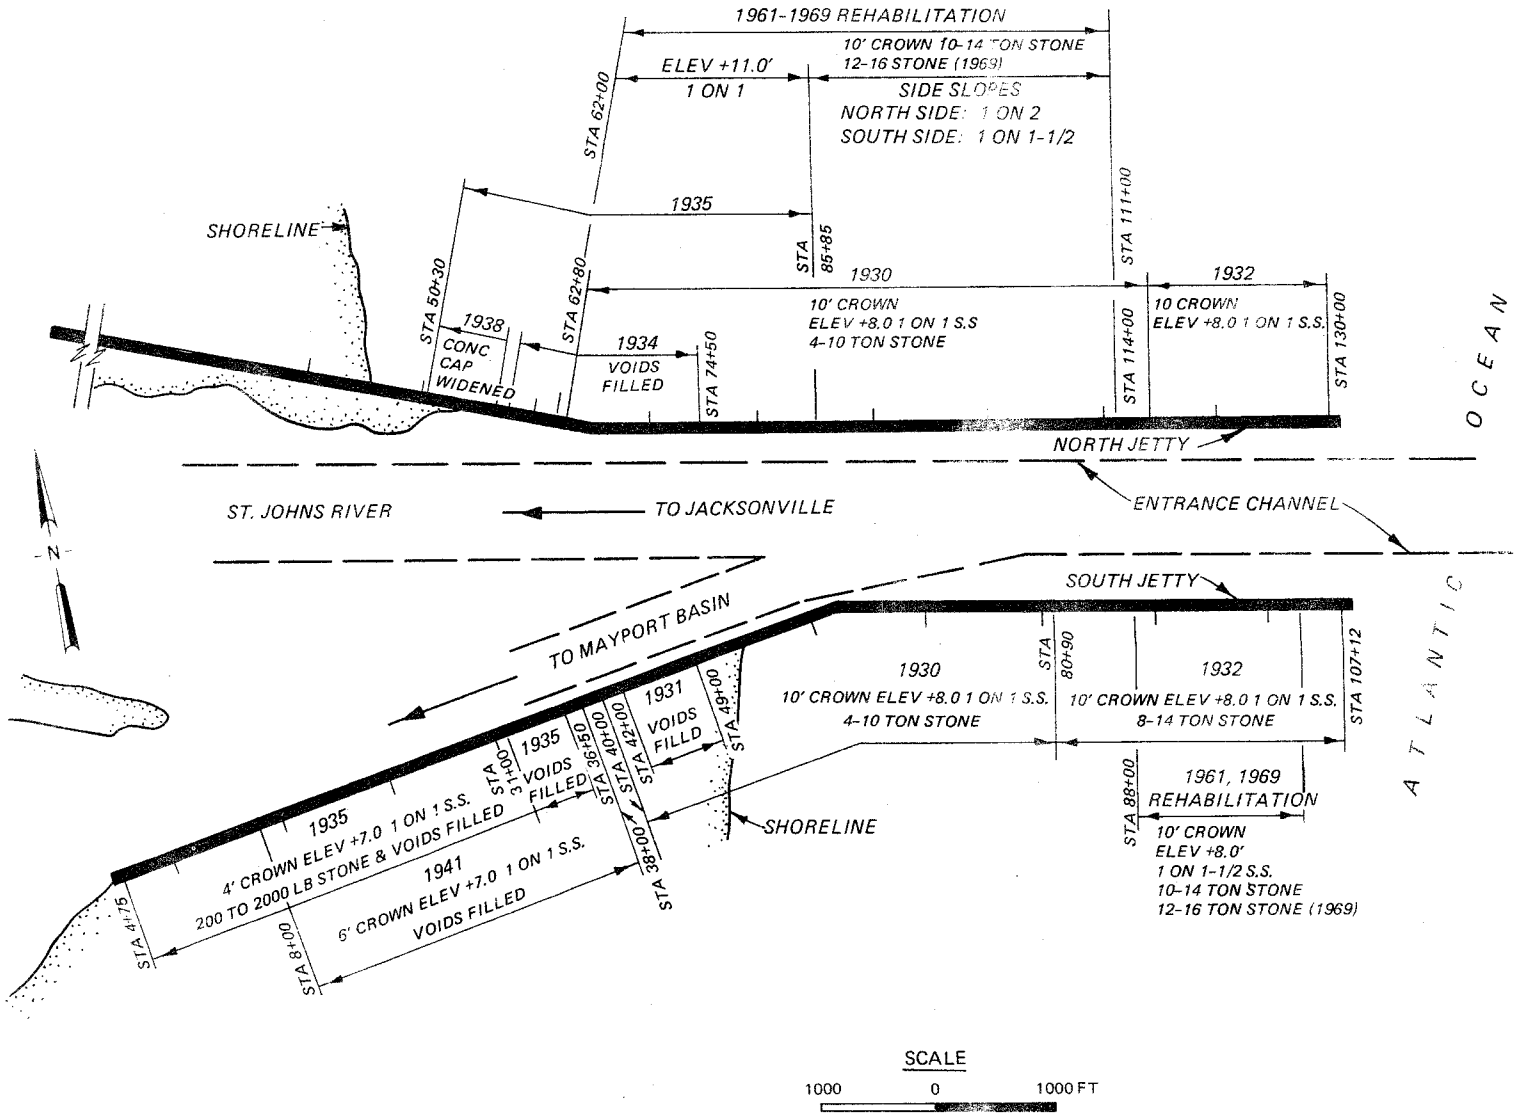
Figure 24. Plan view of cummulative repairs to Jacksonville jetties from 1930 to 1969

1930	Repairs were made between sta 62+80 and 114+00 of the north jetty with 29,700 tons of granite stone (Figure 24). Nine gaps with an average height of +4 to +5 ft mlw were raised to +8 ft mlw. The crest elevations on the outer 500 ft of the jetty were from -5 to -15 ft mlw. The south jetty was repaired between sta 40+00 and 80+90 with 26,600 tons of granite (Figure 25). Twenty major gaps with average heights of +3 to +5 ft mlw were raised to +8 ft mlw. The crest elevations on the outer 700 ft of the jetty were from +3 to -10 ft mlw. The stone size was from 4 to 10 tons with an average size of 6 to 8 tons. The crown width was 10 ft, and the side slopes were 1V:1H. Cost of the repairs totaled $228,000.
1931-1932	Voids below +4 ft mlw on the ocean side of the south jetty were filled with 25- to 100-lb granite stone to stop the flow of sand through the structure, and 3,450 tons of stone were placed between sta 36+50 and 54+00 (Figure 25). A 110-ft-long groin (crest elevation +7 ft mlw) constructed of 550 tons of stone was placed at sta 44+56 on the ocean side of the south jetty to stop the flow of water along the jetty. Later, a head section on the groin was constructed using 245 tons of granite and 50 cu yd of oyster shell. Total cost of the groin was $15,300. The seaward ends of the jetties were repaired (Figure 24), the north between sta 114+00 and 128+60 and the south between sta 88+00 and 106+30. Storm waves had, over time, lowered both jetties and created gaps, necessitating the repairs. Gaps (low points) on the jetties ranged from +3 to +4 ft mlw. The outer 500 ft of the north jetty ranged from -5 to -20 ft mlw, and the outer 700 ft of the south jetty ranged from +3 to -12 ft mlw. The armor stone ranged from 8 to 14 tons, and the design section consisted of a 10-ft crest width at +8 ft mlw and 1V:1H side slopes.

1938	The north jetty concrete cap was widened from the existing 2-ft section to a width of 6 ft between sta 50+30 and 56+60 (Figure 24).
1940-1941	Repairs were made to the south jetty between sta 8+00 and 38+00 (Figure 24). Granite stone of 1 to 3 tons and 3 to 6 tons was placed on the inner 1,200 ft and outer 1,800 ft, respectively. Void filling stone of 50 to 150 lb was placed throughout the repair section. The design called for a 6-ft crown width at +7 ft mlw with 1V:1H side slopes. Sand overlying the jetty was to be removed before stone placement. Small stone was removed between 33+00 and 38+00 as required to allow placing of the cover stone to the design section with the removed stone subsequently used to fill voids. 21,800 tons of 1- to 6-ton stone and 4,800 tons of 50- to 150-lb stone were placed at a cost $105,000.
1961	Rehabilitation made to the seaward end of the south jetty between sta 88+00 and 102+70 and the north jetty between sta 62+00 and 11+100 (Figure 24). Areas of deterioration from settlement and dislodgement of stone had occurred at the ocean ends and along landward portions of both jetties. Also, several portions of the north jetty concrete cap had been broken and displaced from the crown along with some of the underlying support stone. The major causes of settlement seemed to be slope flattening and the possibility of wave

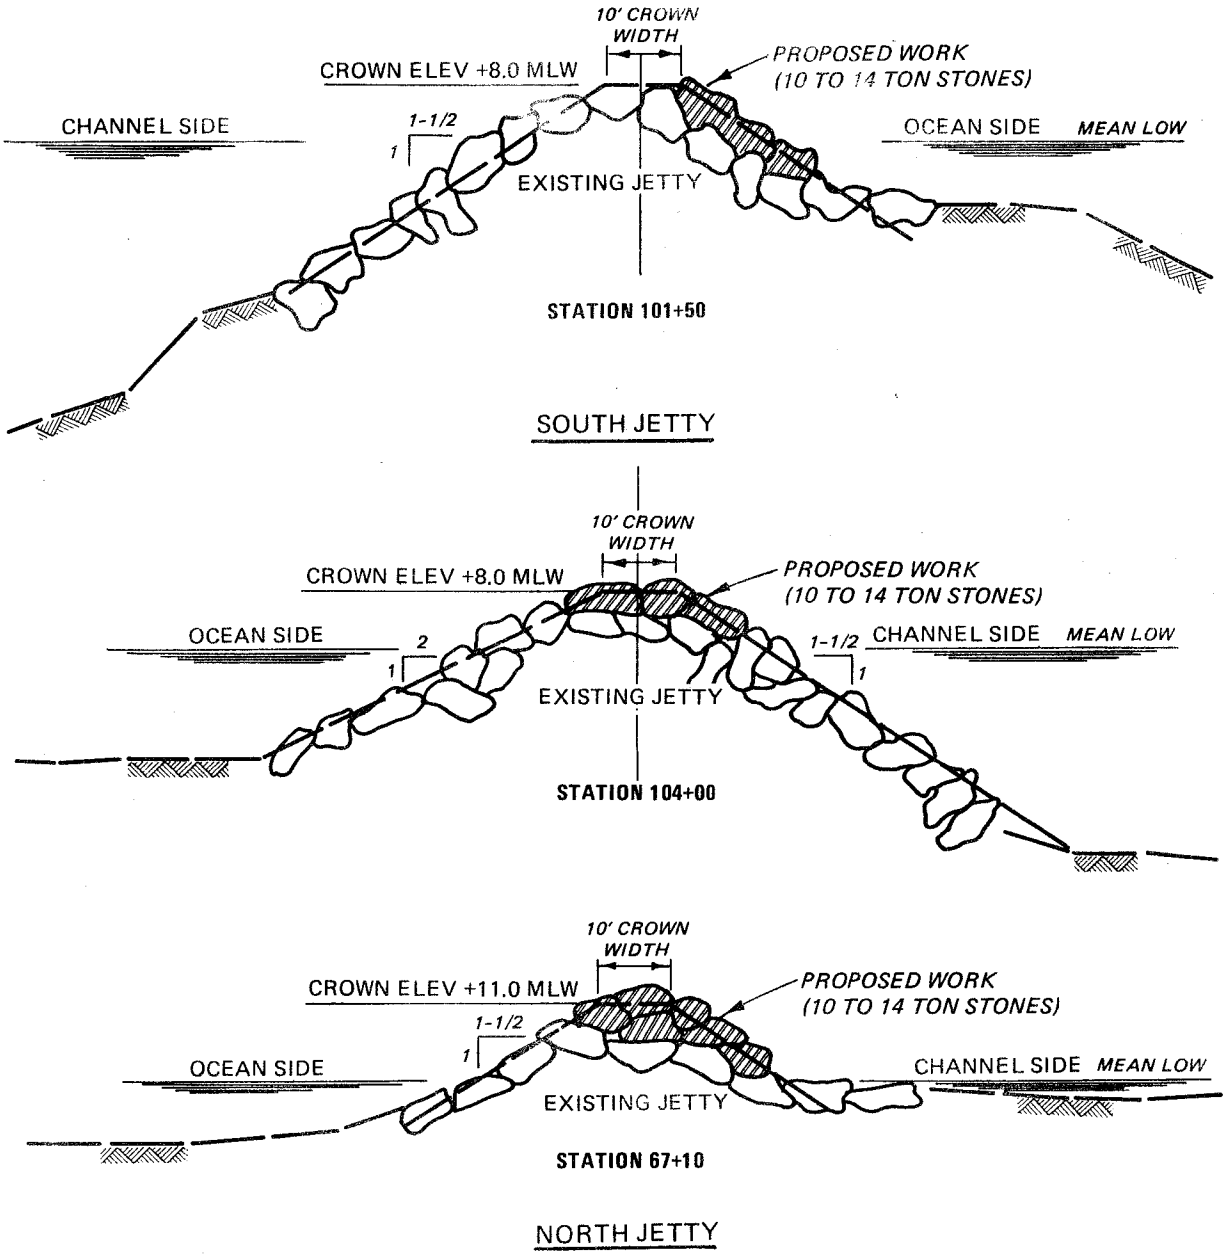
Figure 25. Typical 1961 repairs to Jacksonville jetties

Date(s)	Construction and Rehabilitation History
1961 (Cont)	action causing increased consolidation. Repairs were made to bring the structure back up to previous designs but with larger stone. The design called for 10- to 14-ton granite stone and a crown width of 10 ft for all repair sections (Figure 25). On the concrete cap section of the north jetty, between 62+00 and 85+88, the crown elevation was to be +11 ft mlw, and the side slopes were 1V:1.5H. The remainder of the jetty repairs were to have a +8 ft mlw crown elevation and 1V:1.5H side slopes (with the exception of the north jetty ocean-side slope which was 1V:2H). The design was based on a 14- to 15-ft wave height and Hudson's stability equation. Cost of the rehabilitation with 5,500 tons of stone was $54,600.
1969	Rehabilitation of jetties was carried out on approximately the same section as the 1961 repairs (Figure 25). Except for the use of 12- to 16-ton stone, the design sections were identical to those of 1961. The north jetty from sta 50+45 to 85+80 was built up to +11 ft mlw with 1V:1.5H side slopes and from sta 85+80 to 122+80 was built up to +8 ft mlw with 1V:2H and 1V:1.5H side slopes on the ocean and channel sides, respectively. The south jetty from sta 85+90 to 103+20 was built up to +8 ft mlw with 1V:1.5H side slopes. The crown width on all sections was 10 ft. Dislocation and consolidation of cover stone overlying smaller stone (below mlw) was thought to be the cause of jetty deterioration. The low areas to be repaired were wide which provided a good base to place new stone. Wave heights of 14 and 15 ft and Hudson's stability equation were used, similar to those in the 1961 design. A total of 21,500 tons of stone was placed at a cost of $398,000. Inner areas of the jetties were not rehabilitated although in need of some repairs.

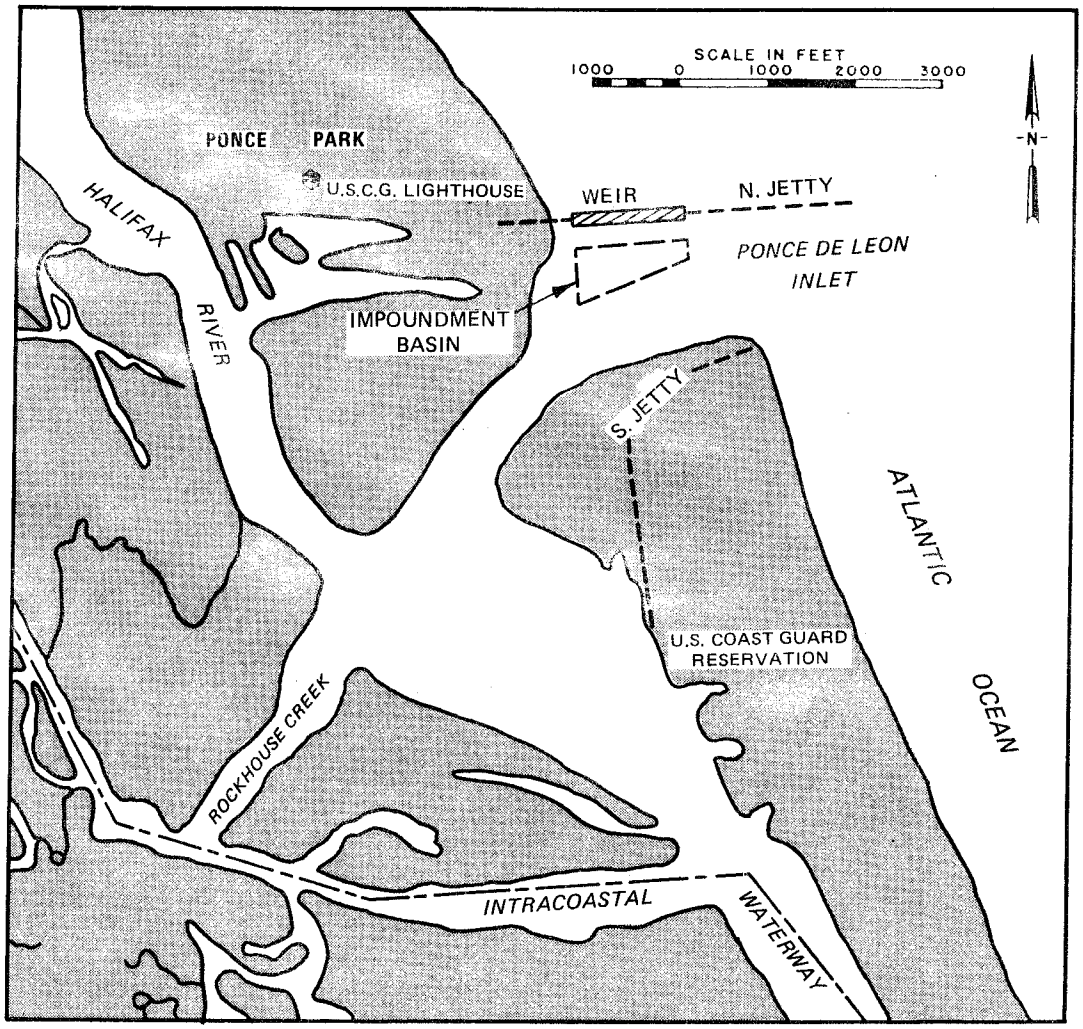
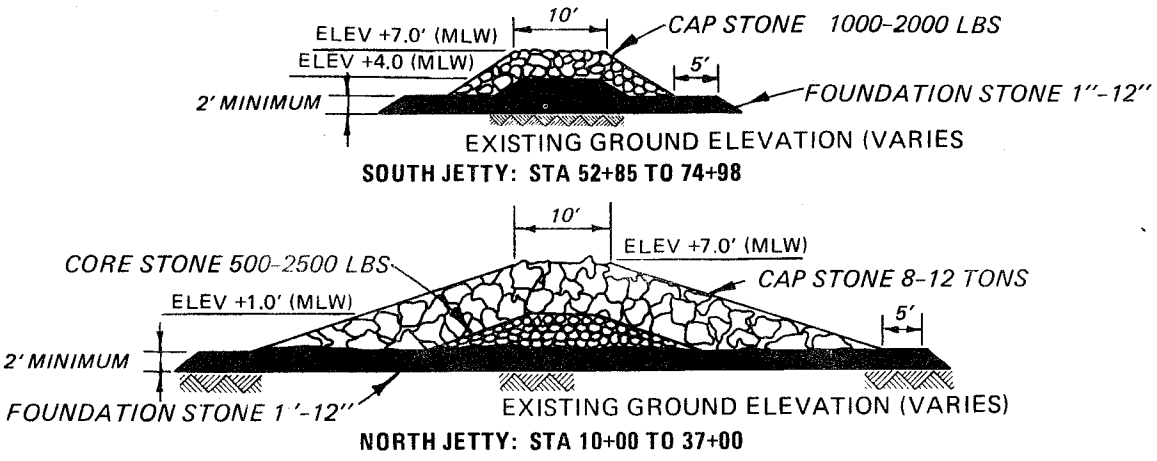
Figure 29. Ponce de Leon Inlet, Florida

Date(s)	Construction and Rehabilitation History
1981	Erosion at the root of the north jetty required placing stone over a 375-ft section of the existing jetty beginning 125 ft from landward end. The repair cross section consisted of a 1.5-ft layer of 1- to 50-lb bedding stone, a core of 30- to 1,000-lb stone, and 0.5- to 2-ton capstone. Side slopes were 1V:2H with a 5-ft crest width and crest elevations varying from +9 to +12 ft mlw. Additionally, 1,150 tons of bedding stone, 1,970 tons of capstone, and rearrangement of stockpiled core stone were used in the repair.
1982-1983	The north jetty weir section was closed using core and armor stone (no details). Armor stone size and cross-section geometry were similar to those for the existing rubble-mound section at the seaward end of the weir section.
1985	The jetties are presently in good condition except for some damage on the north jetty head because of a recent storm and continued erosion at the root of the jetty.

1978	A blanket of armor stone was placed at the base of the north jetty along the seaward 2,550 ft. A total of 23,100 tons of up to 700-lb riprap stone and 9,100 tons of 500-lb to 3-ton stone (75 percent greater than 1 ton) was placed. The cost of the repair was $1,453,000.

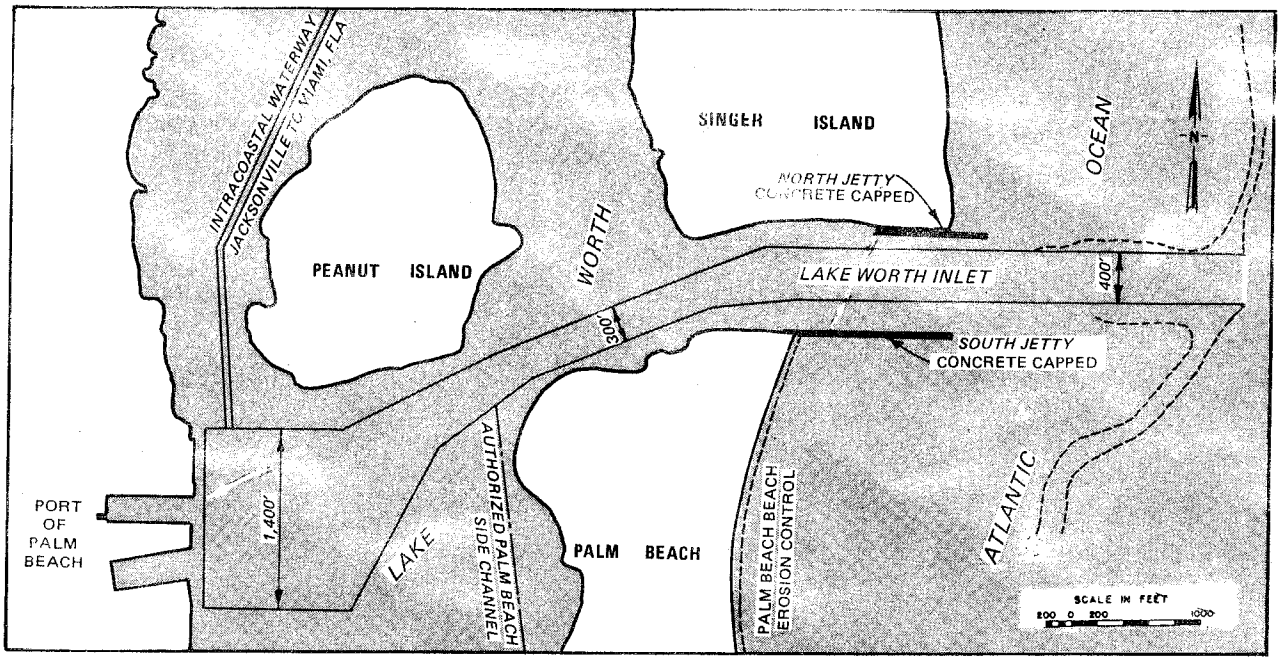
Figure 33. Palm Beach Harbor, Florida

1945	A 40-ft section of the concrete cap on the south jetty approximately 420 ft from the shoreward end had settled about 4 in., had longitudinal cracks, and was acting as a beam. These occurrences were brought on by tidal scour through, and settlement of, the underlying armor stone. The cause of the problem was thought to result from the lack of additional armor stone placed in this and adjacent sections of the old jetty during the 1934-38 rehabilitation. The north jetty was in good condition, and its only problem was its ineffectiveness as a barrier to tidally-induced sand motion under the structure. This problem was evidenced in the original jetties and

Date(s)	Construction and Rehabilitation History
1945 (Cont)	was one reason for the 1934-38 rehabilitation. Examination of the jetty heads showed that the north jetty, with its asphaltic concrete, was in good condition but that the south jetty, without the asphaltic concrete, had deteriorated and needed 1,000 to 1,500 tons of 8- to 10-ton stone to restore the original design.
1948-1949	The south jetty was inspected and surveyed. The outer 500 ft of the cap had settled 1 to 6 in. because of displacement of the underlying armor stone (occurred during the hurricane of 11-19 September 1947). On the landward half of the cap were a number of holes resulting from serious loss of armor stone from wave action. Near the shoreward end of the cap, a 40-ft section was cracked badly. By this time, the nonasphalted head of the jetty had largely disappeared. There was also some deterioration along a 170-ft section at the jetty cap revetment interface. Undermining of stone because of wave action and currents (scouring) was felt to be the major cause of deterioration. The channel was deepened to -27 ft mlw.

1950	In January 1950 repairs to the north jetty consisted of (a) placing a filter blanket of 1/4- to 6-in. stone along 200 ft of its shoreside landward junction (to impede sand motion) and (b) placing existing and additional 500- to 2,000-lb armor stone at the revetment/jetty cap interface (30-ft section). In March 1950 repair of the south jetty consisted of placing 2- to 10-ton armor stone as needed. Total cost of the repairs to the south jetty (26,000 tons of stone placed) and revetment was $227,000. (The jetty portion was roughly 90 percent of the total.) In August 1950 an underwater survey of the asphalt-filled north jetty showed some deterioration on the channel side; otherwise, it continued to function properly.
1955	Repairs were made to the north jetty from the existing shoreline to the landward end of the concrete cap (500 ft). A total of 1,300 tons of 6-ton minimum capstone was placed on the channel side of the repair section. Filter layers were placed on the shoreward side of the cap as follows (Figure 34): (a) 2-ft-thick lower layer of 3- to 6-in. stone placed above, and shoreward of, new/existing armor stone, (b) overlayed with 9 in. of 0.1- to 0.4-in. material, and (c) covered by a layer of 500- to 4,000-lb riprap stone. Total cost of the repairs was $51,000.

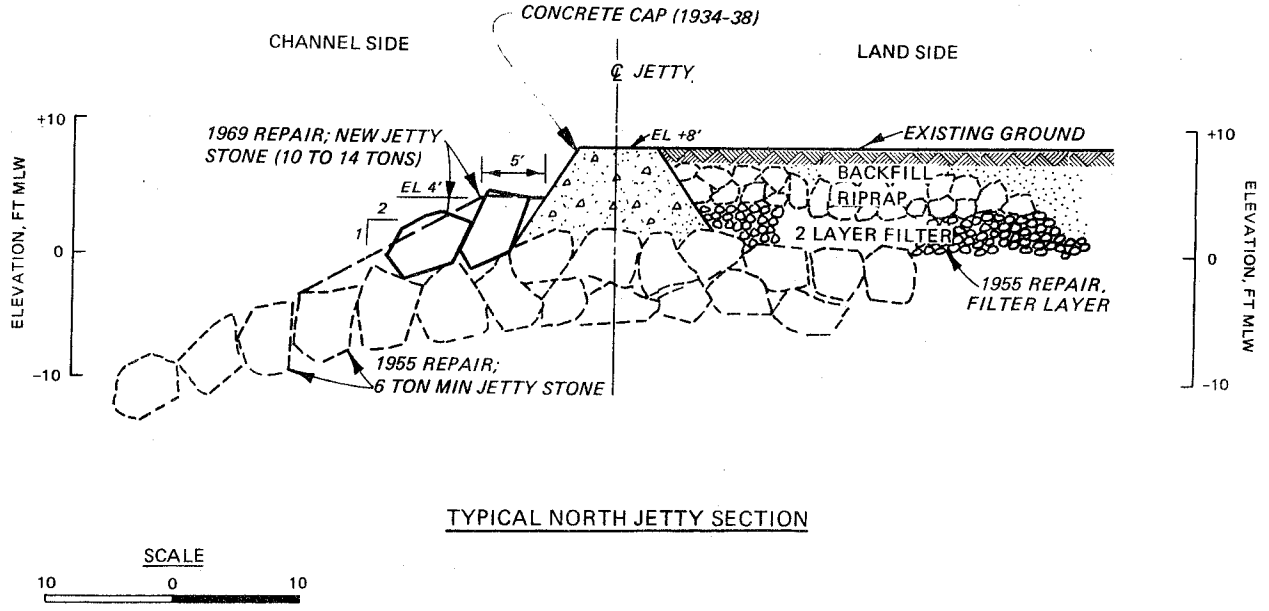
Figure 34. Palm Beach north jetty repairs of 1955 and 1969

Date(s)	Construction and Rehabilitation History
1967-1968	The harbor was deepened to 35 ft. Federal support of the sand transfer plant ended.
1969	Rehabilitation of the 550-ft seaward section of the north jetty was made with 10- to 14-ton capstone on 1V:2H-side slopes (Figure 34). A total of 2,000 tons of armor stone was placed at a cost of $83,000. A design wave height of 15 ft and a 14-sec wave period were used to select the capstone size.
1985	Present plans call for repairs to 1,300 ft of the south jetty. The jetty would be made impervious to sand motion via injection of silicate grout on the shoreward 800 ft and via a rubble filter on the seaward 500 ft. For slope protection, 5- to 10-ton stone were placed on 200 ft of the channel side (near shoreward end). The design wave height of 12.7 ft (obtained using the method outlined in Seelig and Ahrens (1980) used to compute size of cover stone to provide protection of the filter layer on the seaward end of repair). Cover stone will be 8 to 14 tons with an underlayer of 800- to 2,400-lb stone and 3- to 6-in. filter stone. The estimated first cost is $2.2 million.

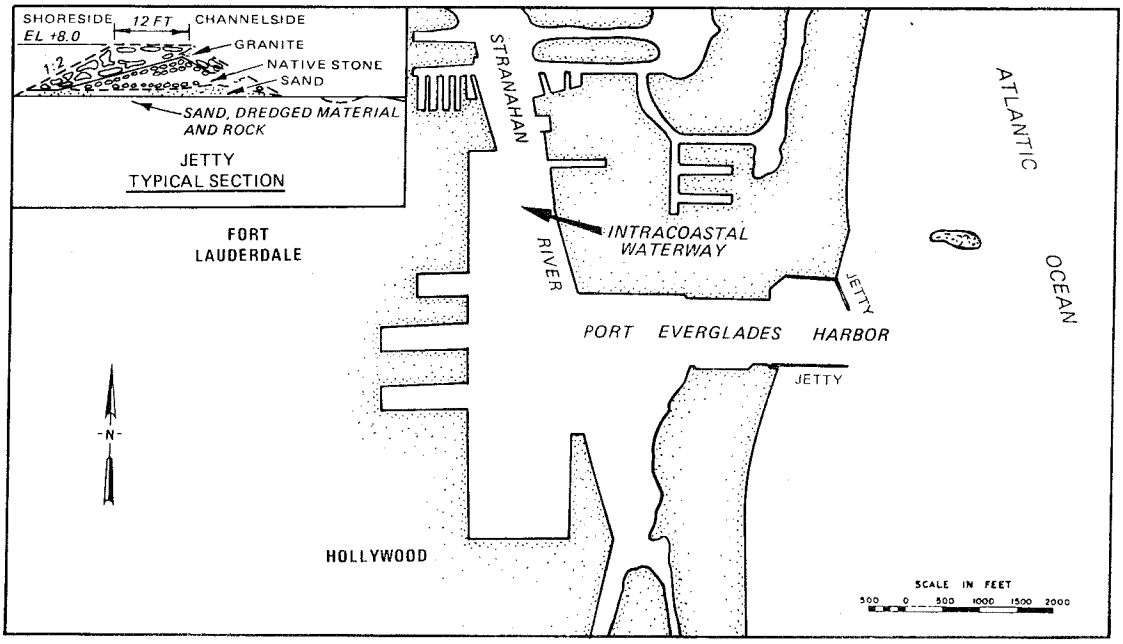
Figure 35. Port Everglades Harbor, Hollywood, Florida

1932	Repairs made to the jetties consisted of placement of 2- to 10-ton granite stone to a height of +6 ft mlw, a crest width of 12 ft, and side slopes of 1V:2H. In addition, some old stone (about 400 pieces each weighing 1,000 lb or more) was rehandled in the construction phase. Total estimated quantities of stone were 4,900 and 5,230 tons for the north and south jetties, respectively. Total cost of the repair was $49,400.
1935	A field survey showed approximate lengths of 1,250 and 1,000 ft for the north and south jetties, respectively. Centerline elevations on the north jetty range from +10 to +5 ft mlw over the shoreward (old) 500 ft and from +4 to +8 ft mlw over the seaward (repaired) 750 ft. Centerline elevations on the south jetty range from +9 to +7.5 ft mlw over the shoreward (old) 300 ft and from +9 to +4 over the seaward 700 ft. The outer 100 ft of each jetty appeared to have subsided 1 to 2 ft from the design elevation of +6 ft mlw.

1939	The jetty survey showed no major changes in centerline elevations. The north jetty elevations were +12 to +8 ft mlw from 0 (shoreward end) to 300 ft, +8 to +4 ft mlw from 300 to 1,200 ft, and +6 to +3 ft mlw from 1,200 to 1,250 ft (seaward end). On the south jetty the elevations were +9 to +6 ft mlw from 0 (shoreward end) to 220 ft, +10 to +7 ft mlw from 220 to 830 ft, and +7 to +3 ft mlw from 830 to 1,000 ft (seaward end).
1940	Repairs to jetties consisted of raising the seaward portions, straightening the seaward end of the south jetty, and placement of a special head section. The repaired lengths were 1,280 and 980 for

Date(s)	Construction and Rehabilitation History
1940 (Cont)	the north and south jetties, respectively. The outer 990 ft and 450 ft of the north and south jetties were brought up to +8 ft mlw with a 12-ft crest and 1V:2H side slopes (Figure 35, inset). The head section of each jetty had a +15-ft mlw crest elevation, a 24-ft-diam crest, and 1V:2H side slopes radiating away from the crown. A total of 18,900 tons of 4- to 12-ton granite stone was placed. (Other work consisted of placing 750 tons of 25- to 150-lb chinking stone and handling of 1,200 pieces of old stone.) Total cost of the repairs was $142,700.
1978-1979	As part of harbor deepening improvements, the seaward 200 ft of the north jetty was realigned parallel to the entrance channel (Figure 35). The realignment allowed the channel width between the jetties to be increased from 300 to 450 ft. The estimated realignment cost was $75,000.

1984-1985	The inner ends of the jetties were repaired by rebuilding the armor stone layer with new and existing stone. To allow the jetties to be used as fishing piers, void spaces were chinked with smaller stone, and a layer of asphalt was piled on the crown. Prior to the repairs, the inner ends were in very poor condition with numerous void spaces while the remaining parts of the jetties were considered to be in satisfactory condition.

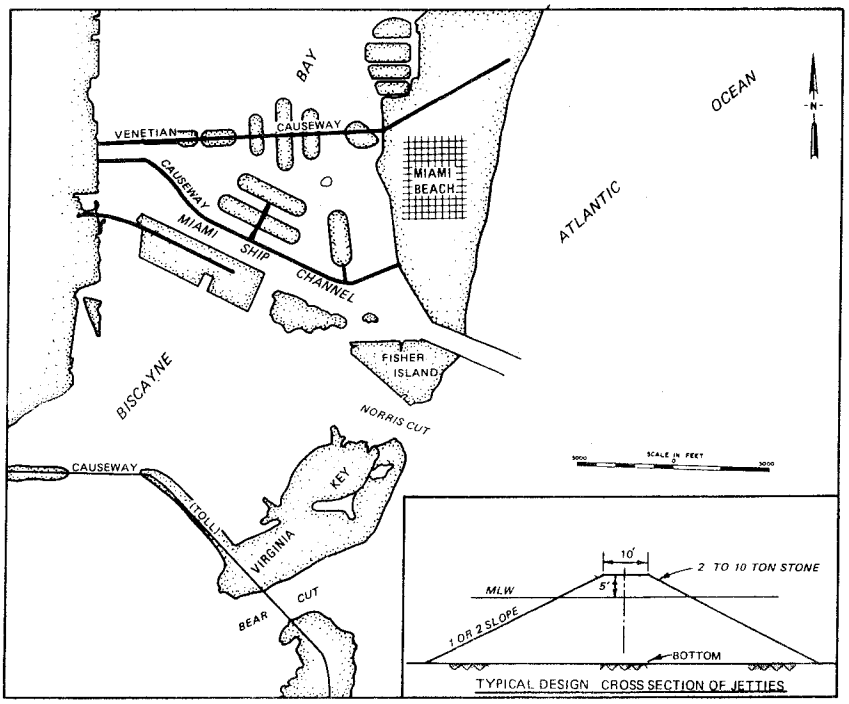
Figure 37. Miami Harbor, Florida

1985	Presently a 38-ft-deep by 400-ft-wide channel is maintained between the jetties. Except for the sand-tightened portion (1983), the jetties have not been repaired since 1934 and, although in poor condition, are still functioning properly.

Date(s)	Construction and Rehabilitation History
1904-1926	North and south jetties (Figure 37) 2,300 and 2,200 ft long, respectively, and 1,000 ft apart, were constructed to provide channel protection.
1927	Repairs were made to the north jetty and revetment. The jetty section was rebuilt to original dimensions with an elevation of +6 ft mlw, a crest width of 10 ft, and the side slopes were 1V:1.5H below mlw and 1V:1H above mlw. A total of 3,450 tons of granite was placed on the inner 700 ft of the jetty, and approximately 100 tons was recovered and used over the same section. Total cost of the repair was $30,600. These repairs were required because the hurricane of September 1926 (passed over Miami) which resulted in several jetty breaches extending below mlw.
1928	The north and south jetties were extended seaward 1,350 and 600 ft, respectively. The jetty section consisted of a 5-ft crest width at +5 ft mlw with 1V:2H side slopes above mlw and 1V:1.5H below mlw. A total of 9,500 tons of Florida limestone was used as core stone and 37,300 tons of granite as capstone. Total cost of the extensions was $208,000. A December survey of the original jetties (excluding the extensions) showed crest elevations ranging from +4 to -2 ft mlw. Approximately 100 ft of the old seaward ends were below mlw.

1929	The jetties and north revetment were repaired. A total of 1,600 ft of the north jetty, 700 ft from its inner end, and 2,200 ft of the south jetty (exclusive of the 1928 extension) was repaired with granite stone to a crest width of 10 ft, an elevation of +5 ft mlw, and 1V:1H side slopes. Stone weighing 13,800 and 18,900 tons was used on the north and south jetties, respectively. The total cost of jetty repairs was $181,000.
1931-1932	Both jetties were surveyed in 1931 and 1932. Centerline elevations for the north jetty were from +9.5 to +4 ft mlw on the inner 2,300 ft and from -3 to +4.5 ft mlw on the outer 1,350 ft. (This section was damaged by storm waves during the survey period.) Centerline elevations for the south jetty varied from +4 to +8 ft mlw.
1933-1934	Based on the previous survey of the jetties, repairs were made to bring the jetties up to the design section. The crest width was 10 ft, the crest elevation was +5 ft mlw, the side slopes were 1V:2H, and the granite stone varied from 2 to 10 tons. Several sections on the north jetty, totaling 2,100 ft, were repaired and a
