REPAIR, EVALUATION, MAINTENANCE AND REHABILITATION RESEARCH PROGRAM

TECHNICAL REPORT REMR-CO-3

CASE HISTORIES OF CORPS BREAKWATER AND JETTY STRUCTURES

Report 2
SOUTH ATLANTIC DIVISION

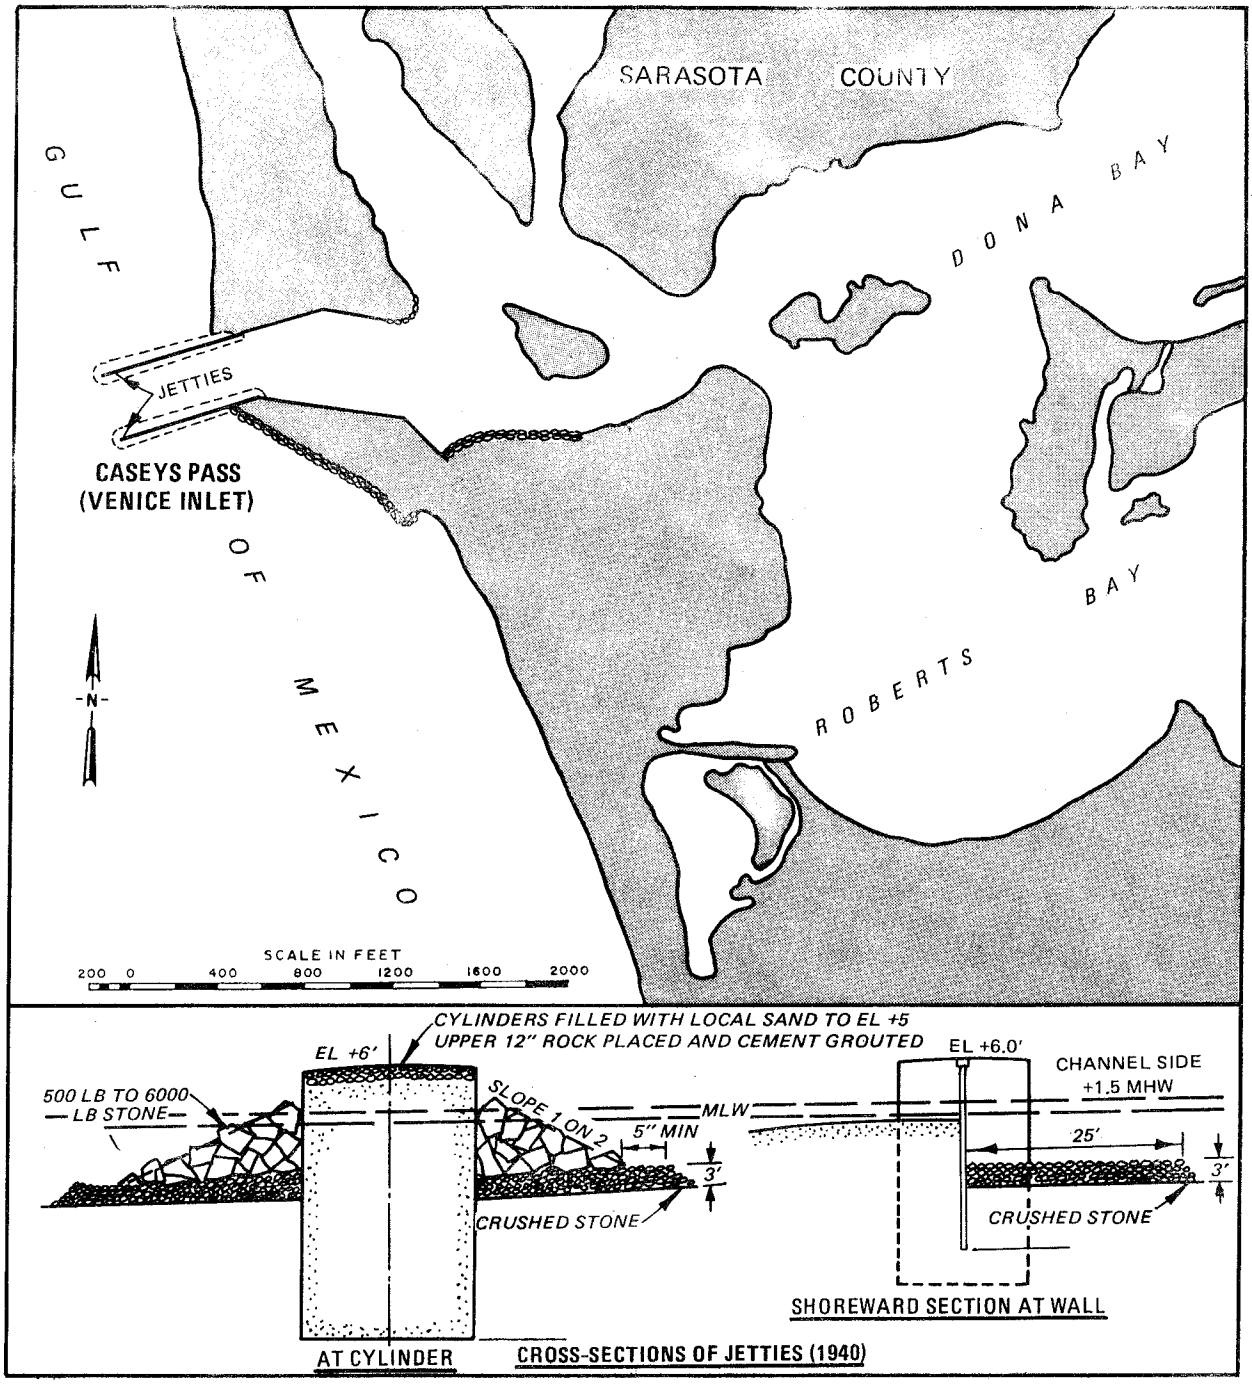
Figure 39. Casey's Pass, Florida

1950-1951	Jetty surveys showed that the heads and seaward sides of the jetties needed repairs. The channel side of the north jetty needed repair because of the proximity of the channel causing scouring at the toe.
1955	Repairs were made to the seaward end of the south jetty which was in a "severely damaged" condition. A total of 650 tons of 3- to 6-ton cover stone was placed on a 2-ft-thick foundation blanket of 2- to 6-in. stone at a total cost of $6,500. Repairs were also made to the collapsed concrete caps on the 1st and 8th caisson from its seaward end. Nearly 3/4 of the first caisson was severely damaged, and 3- to 6-ton cover stone was placed to +6 ft mlw with a 10-ft crown width. The upper 4 ft of the 8th caisson was filled with stone, and the upper foot of this was capped with concrete grout.
1963	Repairs to the concrete cylinder caps and jetty stone/rock revetments were made at a cost of $30,000. At this time, the channel was dredged to a depth of -9 ft mlw. Along the exposed seaward sections, 3- to 6-ton capstone totaling 615 and 770 tons was placed on the north and south jetties, respectively, and approximately 20 capstones were reset. Several of the seaward cylinders were repaired. Their caps and sand were removed to -1 ft mlw, replaced with the broken pieces of the cap and 20- to 200-lb stone, and grouted with concrete throughout the upper 18 in. of stone.

Date(s)	Construction and Rehabilitation History
1968-1969	Visual examinations and detailed surveys showed the sheet-pile cylinders and walls to be in need of immediate repairs. Voids between the original concrete caps and the underlying sand existed in virtually all cylinders not repaired in 1963. Corrosion was the main cause of deterioration, with subsequent removal of sand from the cylinders because of wave and current action. Rehabilitation of the jetties was carried out in 1969 (Figure 40). The sheet-pile walls and cylinders (except the outer two on the north and outer one on the south) were removed down to +2 ft mlw, and the sand within the cylinders were removed to mlw. The existing concrete cap (broken into pieces less than 12 in. long) and 1- to 12-in. bedding stone were placed in the cylinders to +2 ft mlw. This was overlayed with 4- to 10-ton capstone (70 percent > 8 tons), with similar capstone placed along the connecting walls, to bring the structure to the original design elevation of +6 ft mlw with a crown width of 10 ft. Additional 4- to 10-ton capstone was placed, as needed, to bring the side slopes up to 1V:2H. On the outer 50 ft of the jetties, the side slopes were 1V:3H. Finally, asphaltic concrete was placed (Figure 40) on the jetties. This material was placed over the entire crown width down to mlw, and had 1V:1H side slopes. The design of the jetties used Hudson's formula with wave heights of 12 to 16 ft and wave periods of 7 to 9 sec.

1978	Repair to jetties consisted of resetting stone and adding 6- to 12-ton stone (75 percent > 10 ton) on the outer 200 ft of the jetties and 2- to 6-ton stone on the next 450 ft of the jetties as needed to solidify the structure.
1985	The jetties are in good condition except for their head sections which are in need of some repair.

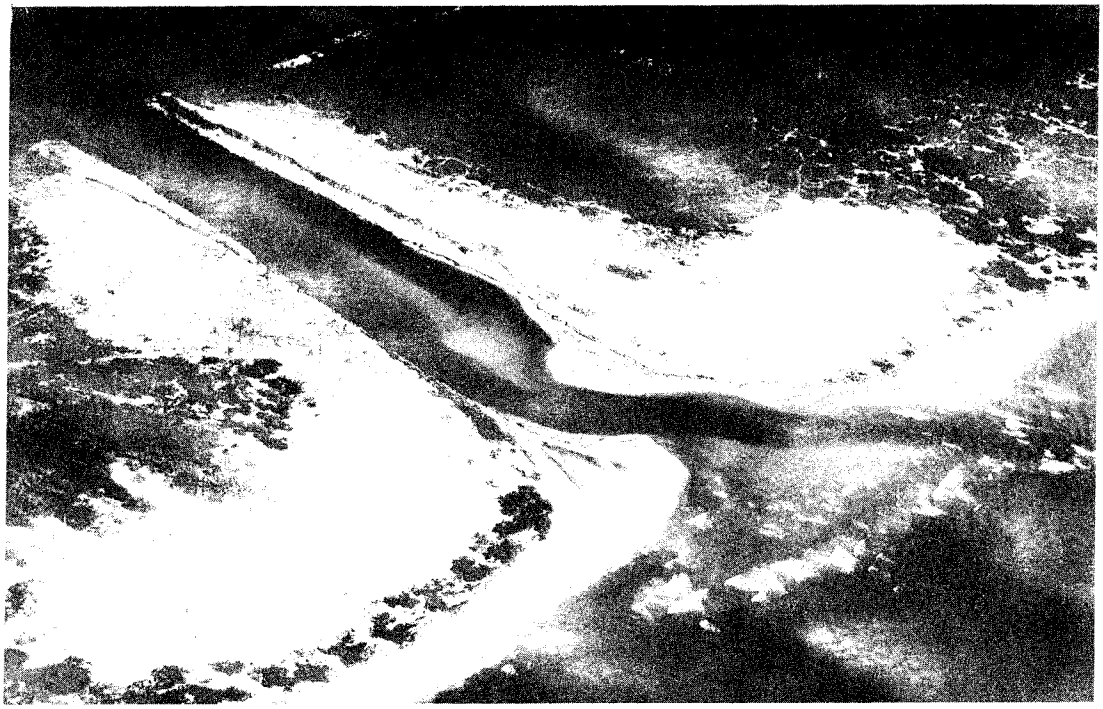
Date(s)	Construction and Rehabilitation History
1954-1957	In 1954, local interests cut a channel through St. George Island to provide a direct route to the Gulf from Apalachicola (Figure 43). In April 1957 the Corps completed the existing projects with the construction of two rubble-mound jetties on the Gulf and dredged the channel to a depth of 10 ft (Figure 43, inset). The east and west jetties, 900 and 1,030 ft long, respectively, and spaced 400 ft apart, were built out to the -10 ft mlw contour. Approximately 70 ft of the landward end of each jetty flared away from the channel. The design cross section (Figure 43, inset) had a crest width of 14 ft, a crest elevation of +6 ft mlw, and 1V:1.5H side slopes. On the seaward end of each jetty the side slopes changed to 1V:2H via a 100-ft-long transition section. Minimum cover stone sizes were 6 and 10 tons on the trunk and head/transition sections, respectively. The core stone weighed from 25 lb to 2 tons, and the 2- to 2.5-ft-thick foundation blanket used 15- to 200-lb stone. The stone size was selected using Hudson's slope stability formula, a maximum wave height of 13.7 ft, and a +6 ft mlw storm surge level. Figures 44a and 44b are photographs of the jetties taken before and shortly after the completion. "Keyhole" erosion on the landward side of the jetties (the jetties and the crescentic erosion yielding the silhouette of a giant keyhole) can be seen in the postconstruction photograph (44b).

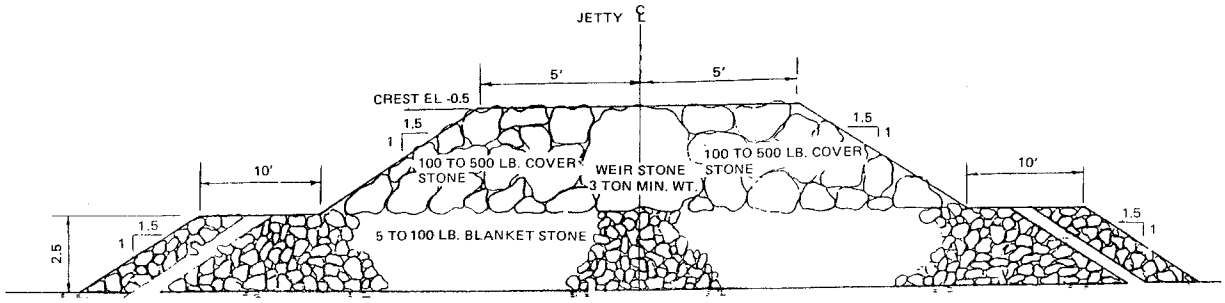
Figure 55. Design cross section of 1970 modification to the weir section of the west jetty at East Pass

Date(s)	Construction and Rehabilitation History
1982 (Cont)	providing for insufficient impounding capacity. Shoaling in the vicinity of the weir apparently resulted from inadequate maintenance of the deposition basin, which had only been dredged once (287,000 cu yd removed in 1972). The report recommended closing the weir section of the west jetty since the net littoral drift was, in fact, from east to west to reduce the shoaling in the inner channel areas caused by westward littoral drift passing through the weir section.
1985	The weir section of the west jetty was modified with the placement of a rubble-mound trunk section identical to the trunk section used in the original design (except that the blanket stone was to have a minimum thickness of 1 ft directly over the sheet piles and 2.5 ft thick elsewhere as called for in the original design). Estimated volumes of blanket, core, and cover stone were 5,300, 1,500, and 4,600 cu yd, respectively. At present, toe stability problems exist and have been documented with video footage of scour along the toe of the east jetty. Otherwise, the jetties are in good condition.
