The REMR Bulletin

News from the Repair, Evaluation, Maintenance,
and Rehabilitation Research Program

DEC 1987

Concrete Rehabilitation at Lock and Dam No. 20, Mississippi River

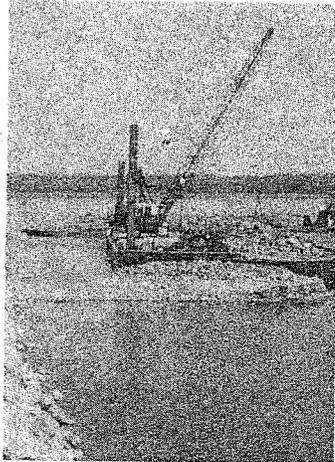
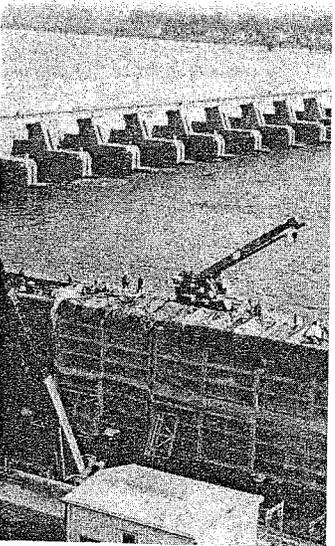
Lock and Dam No. 20 dewatered for rehabilitation

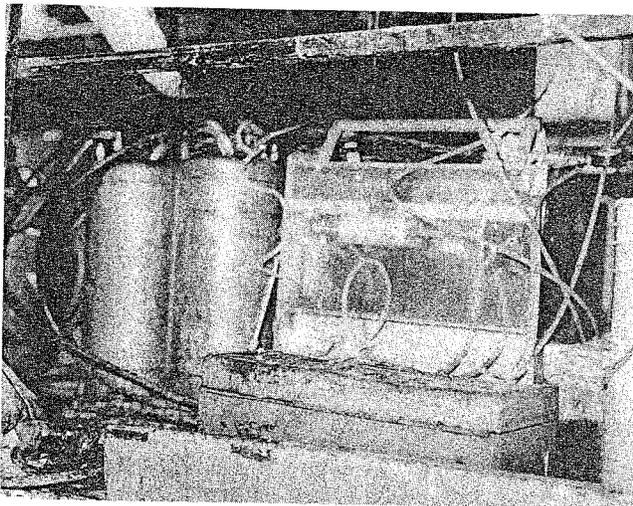
Figure 1. Injection pump, two 5-gallon reservoirs, and plastic tubes to connect the pump to the injection ports

Equipment necessary for this type of repair, which can fit on a four-man scissors lift, consists of the injection pump, two 5-gallon reservoirs for the LV epoxy, and plastic tubes to connect the pump to the injection ports (Figure 1).
