News from the Repair, Evaluation, Maintenance,
and Rehabilitation Research Program

Volume 10, Number 2

June 1993

Coastal structure inspection in wake of Hurricane Iniki

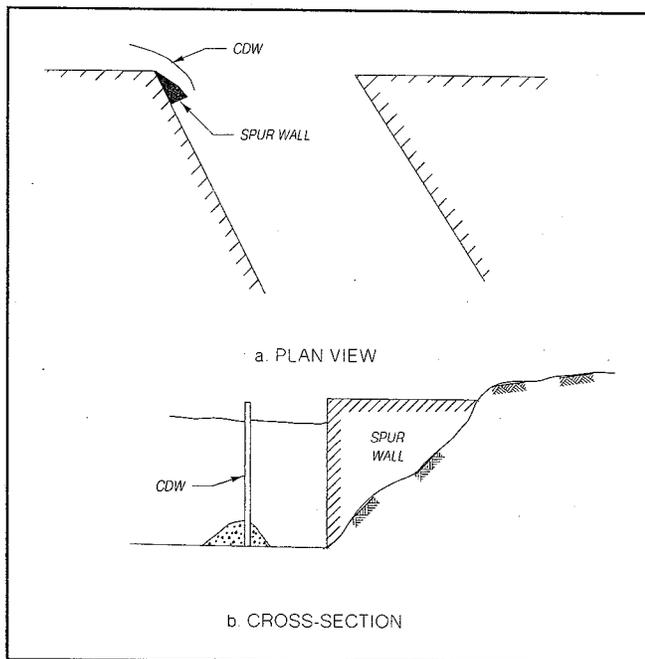
vertical-walled addition to the existing upstream entrance corner will usually be required to complement the CDW. This spur wall is considered a part of the overall CDW structure (Figure 1).

Figure 1. Plan and cross-sectional CDW schematics.

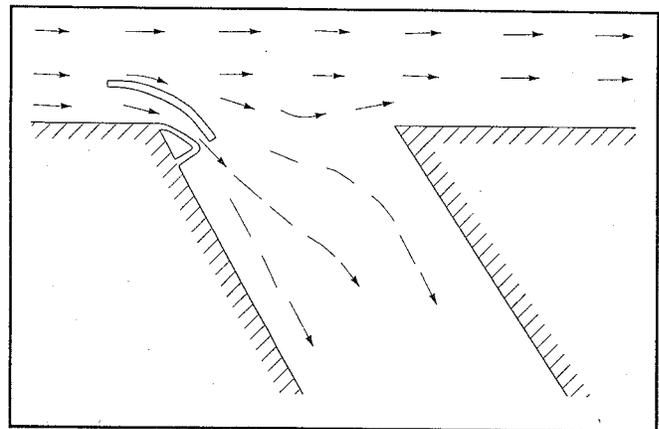
The current deflector structure modifies flow patterns, breaking down or preventing the formation of eddies. It captures flow entering the branch channel and directs it parallel with the direction of the branch channel (Figure 2). Vortex currents can be prevented at a channel branch if a smooth transition is provided for the incoming flow velocity

Figure 2. CDW operating principle.
