US Army Corps
of Engineers

TECHNICAL REPORT REMR-CS-4

REPAIR OF WATERSTOP FAILURES: CASE HISTORIES

Final Report

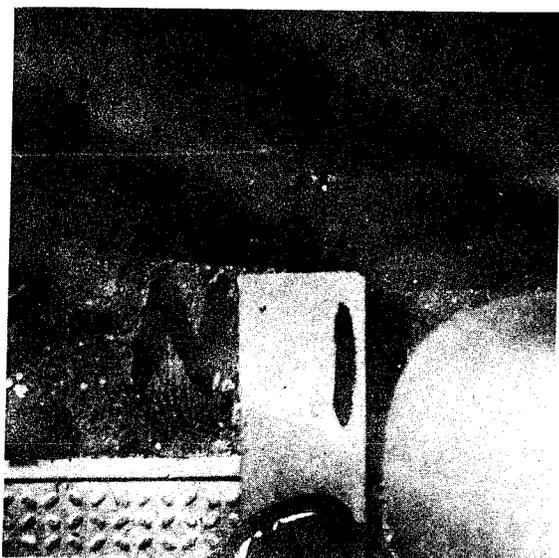
Figure 3. Movement between east gate bay monolith and adjacent monoliths as viewed from top of lock wall, November 1973, Algiers Lock

17. The joints between lock chamber monoliths and those between approach monoliths appeared to be in good condition with no unusual openings or offsets when inspected in 1973. However, joints between the gate bay monoliths and adjacent monoliths showed visual evidence of considerable movement (Figures 3 and 4). Also, there were indications that considerable water passed through the joints between the west gate bay monolith and adjacent chamber monoliths during the recent high water (Figure 5). Gate bay joint movements as measured in October 1973 are shown in Figures 6 and 7. No joint repairs were considered necessary at the time; however, repairs during the next scheduled dewatering in 1978 were anticipated.

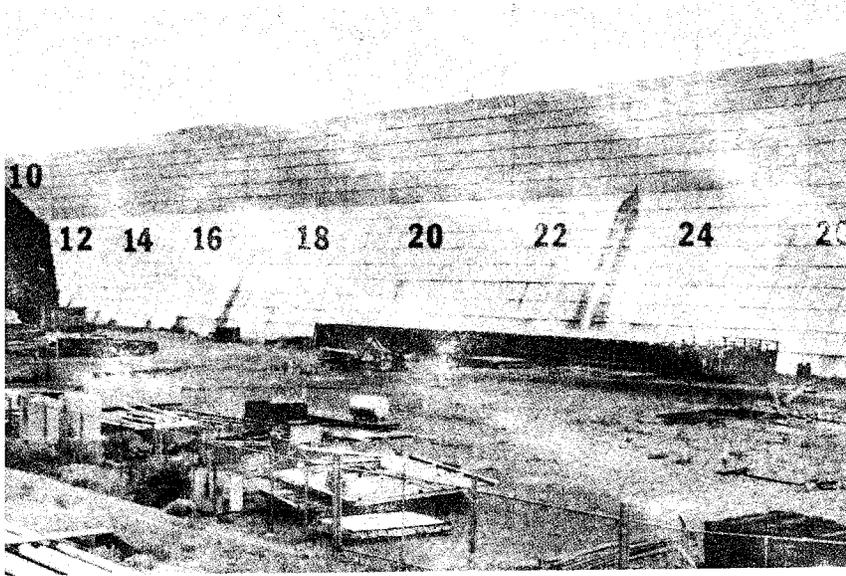
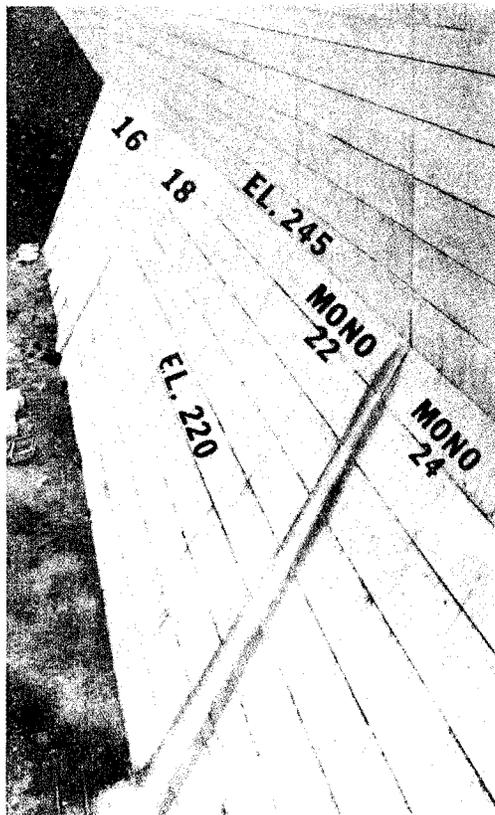
Figure 28. Landside lockwall leakage, John Day Lock, October 1972

84. In October 1972, leakage was noted at monolith joints 10/12, 12/14, 16/18, 22/24, 24/26, and 28/30 for the landside lock wall and at 21/23, 23/25, 25/27, and 27/29 for the riverside wall. All except monolith joints 10/12, 12/14, and 22/24 had been repaired in May 1971. Leakage from the landside lock wall with the lock full of water is shown in Figure 28. Leakage apparently entered the landward backfill and some subsidence was reported.

Leakage from monoliths 16/18 and 22/24 appeared on the surface of the back side of the wall at elevations 220 and 245 ft, respectively. Measured deflections in excess of 1/2 in. were reported for individual lock monoliths (Figure 29).

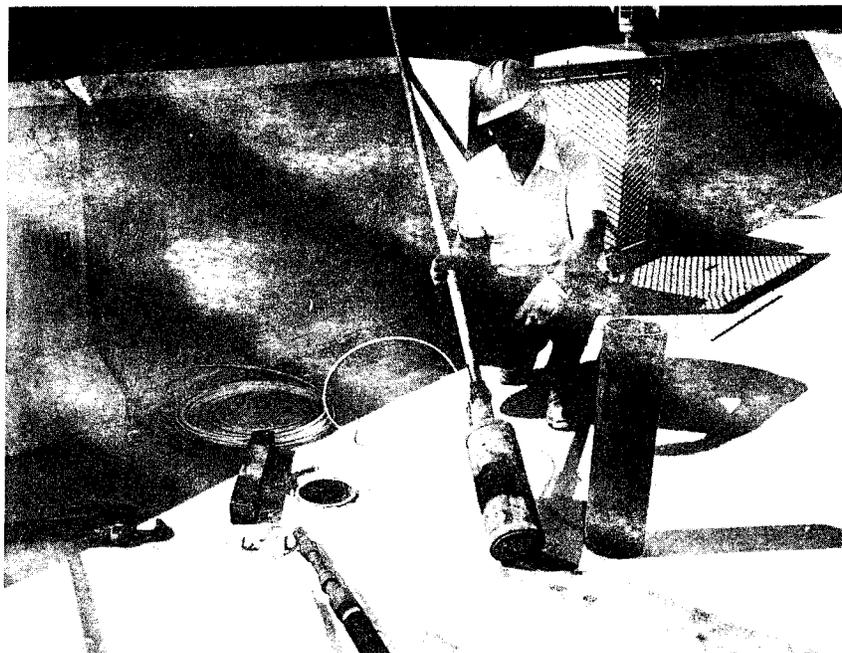
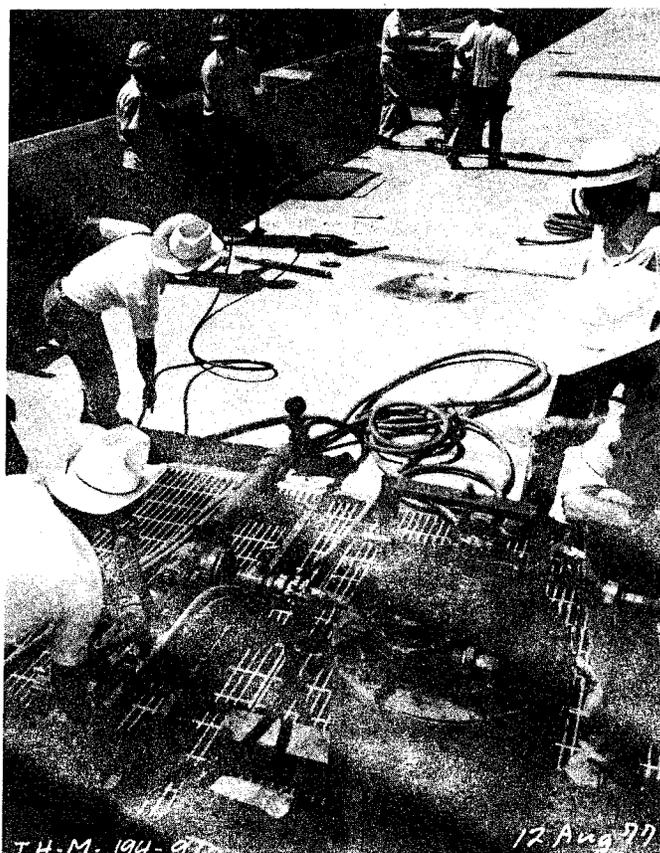
Figure 38. TACSS grouting equipment, Ice Harbor Lock

106. The Takenaka Aqua-Reactive Chemical Soil Stabilization (TACSS) System T-035NF was used at monolith joint 8/10 to grout a 6-in.-diameter vertical hole, 160 ft deep, drilled 4 ft from the lock face. The materials were furnished by TJK, Inc. and Associates of North Hollywood, California, and the grouting equipment was furnished by Continental Drilling of Seattle, Washington. The original proposal was to use 40 gal of TACSS T-020NF and 4 gal of C-852 Accelerator. This material was chosen after reading the literature provided by the manufacturer, Dainippon Ink and Chemicals, Inc., Japan. However, based on the recommendation of the supplier, TACSS T-035NF was substituted. The equipment used included a diesel engine-powered air compressor, air-powered injection pump, a 48-gal mixing tank with air-powered agitator, about 200 ft of 1/2-in. inside diameter plastic tubing, and a 6-in.-diameter packer. Photographs of the equipment are shown in Figure 38.

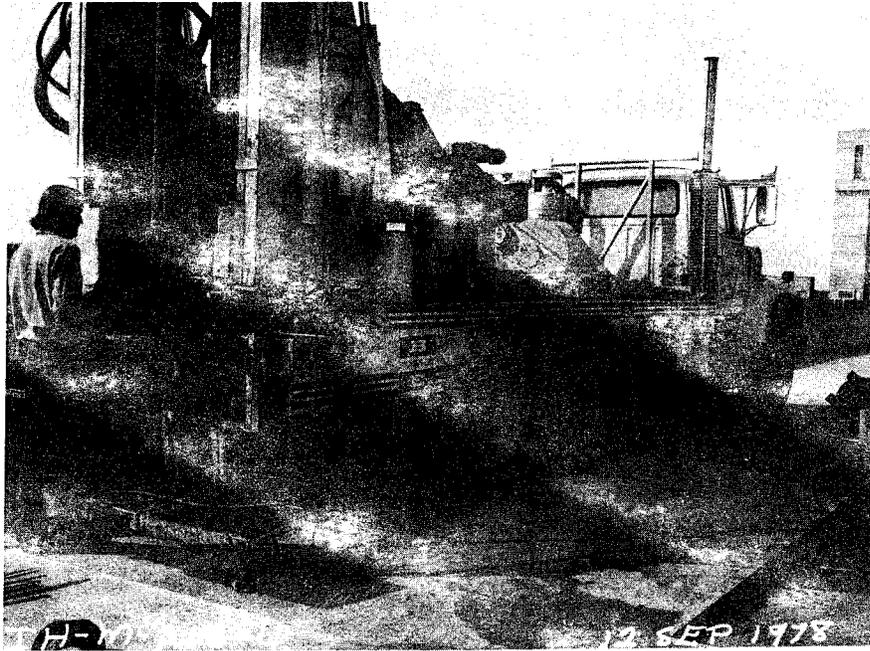
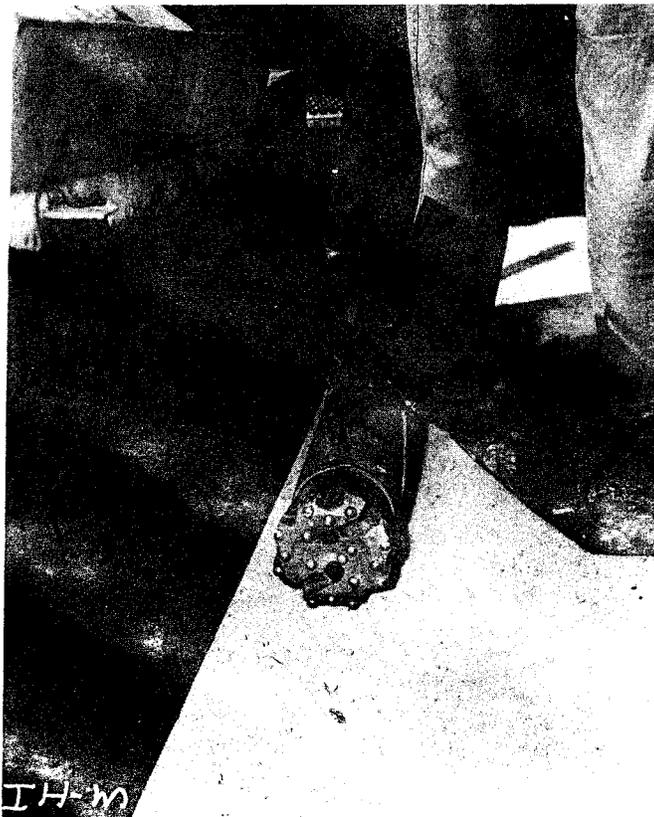
Figure 49. Equipment used to drill holes along monolith joints for remedial waterstops, Ice Harbor Lock

into bedrock (Figure 49). The drill holes were filled with an impermeable flexible chemical grout. Greatly decreased flow of water into the landside fill from the navigation lock joints was attributed to the waterstop repair. Visible contraction joints showed no sign of leakage when inspected in November 1980. Lock monolith displacements, as measured by extensometers, remained unchanged from the previous inspection in 1977.

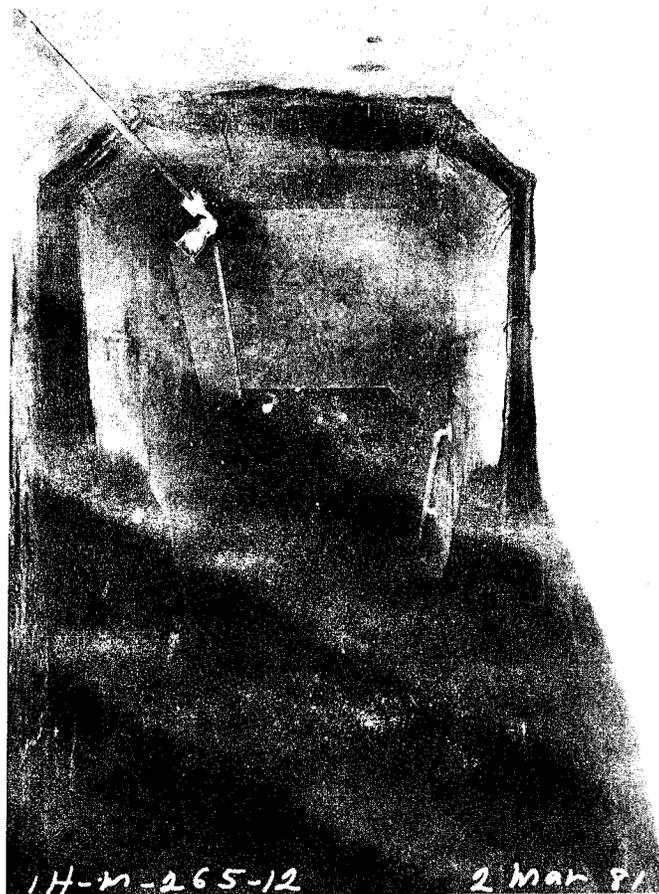
129. The crack in monolith 8 of the south nonoverflow was previously investigated with drill holes. The crack extends through the dam from the upstream face to the downstream face. An array of EX-holes was drilled from the elevation 355 ft drainage gallery to intersect the crack at a point 5 ft from the upstream face on 10-ft vertical centers. These holes were to intercept the water leaking into the crack and channel it away. The flows proved to be so great that the holes and crack were chemically grouted using AM-9 as part of the 1978 grouting contract. The leakage was stopped but a year later

the crack began leaking again. Leakage in March 1981 was as shown in Figure 51.

Figure 51. Monolith 8 crack as viewed from the drainage gallery, Ice Harbor Dam

132. Additional holes were drilled to intersect the crack in monolith 8 on 5-ft centers and the previously grouted holes on 10-ft centers were flushed. Holes above elevation 363 ft produced water when cleaned or drilled to the crack; whereas, holes below this elevation produced little or no water. Holes at the lower elevations were extended or relocated and still no water was seen. This indicated that the crack was wider or more open at the top than at the bottom, which is not uncommon in the cracking of large monoliths. Chemical grouting was done using Q-Seal, an acrylamide grout marketed by Ques Corporation that is essentially identical to AM-9. It was hoped that a higher consistency grout mixture could be used to prevent further extrusion of grout from the crack. However, the "heavier" grout could not be pumped into the small crack openings so a highly concentrated grout mixture was used without mineral filler.

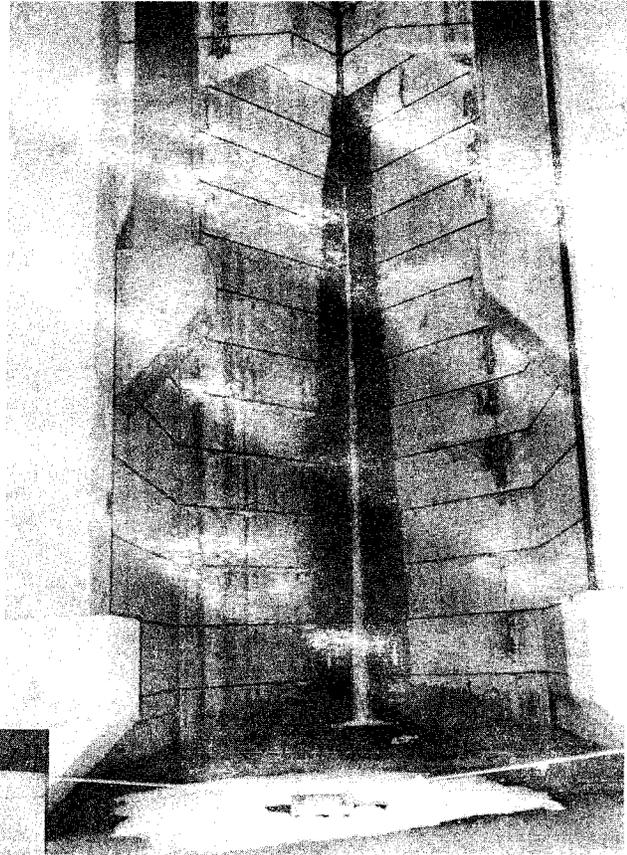
Figure 65. Monolith joint 10/12 leakage before and after repair, Little Goose Lock

152. Based on the Ice Harbor and Little Goose trial repairs, the drill hole with elastic filler method was selected to reestablish monolith joint waterstops at Little Goose Lock. Repairs were accomplished under contract in 1978 by drilling a 6-in.-diameter vertical hole along the joints from the deck to about 5 ft into bedrock and then filling the holes with AM-9 chemical grout to create a cast-in-place waterstop. This repair stopped an estimated 95 percent of the leakage. Leakage at selected joints before and after repair is shown in Figures 65 and 66.

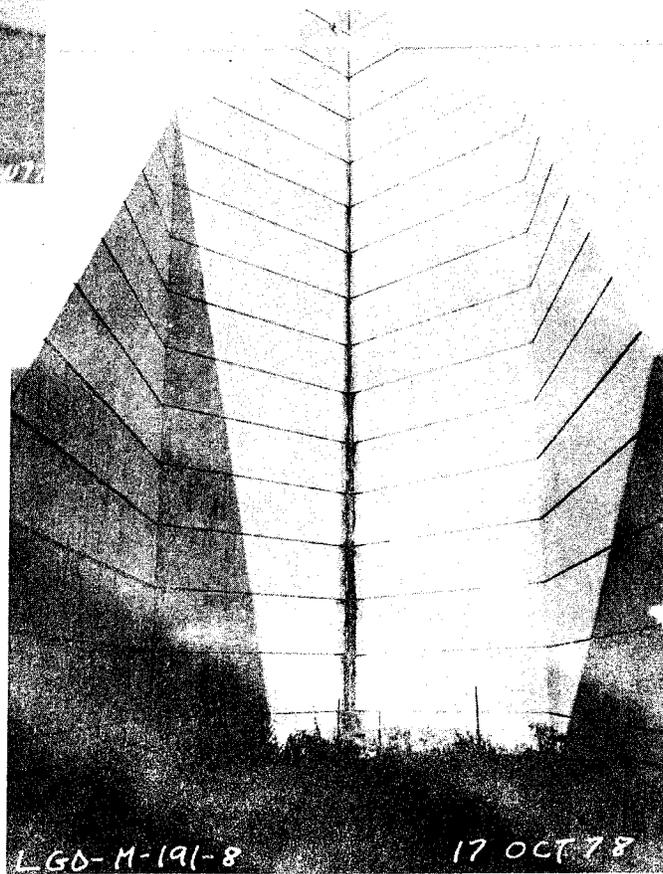
Figure 66. Monolith joint 11/13 leakage before and after repair, Little Goose Lock

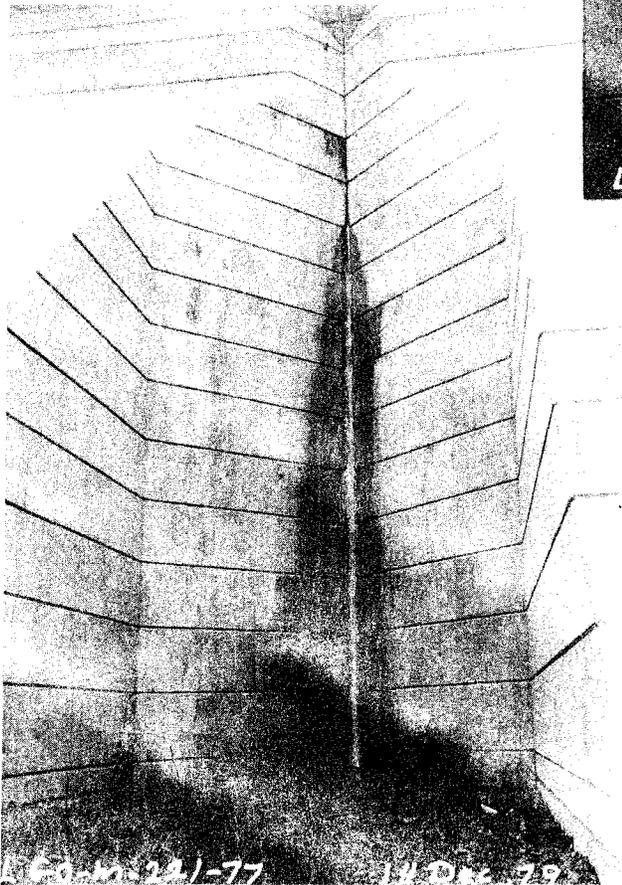
153. Based on an inspection in August 1979, it was reported that several monolith joints exhibited small amounts of leakage (Figure 67) and would probably require regrouting in the future. It was suggested that one of the advantages of this repair system is that regrouting could be done easily and economically by an experienced chemical grouting crew. Other observations reported during this inspection included:

Figure 67. Monolith joint leakage, Little Goose Lock, December 1979

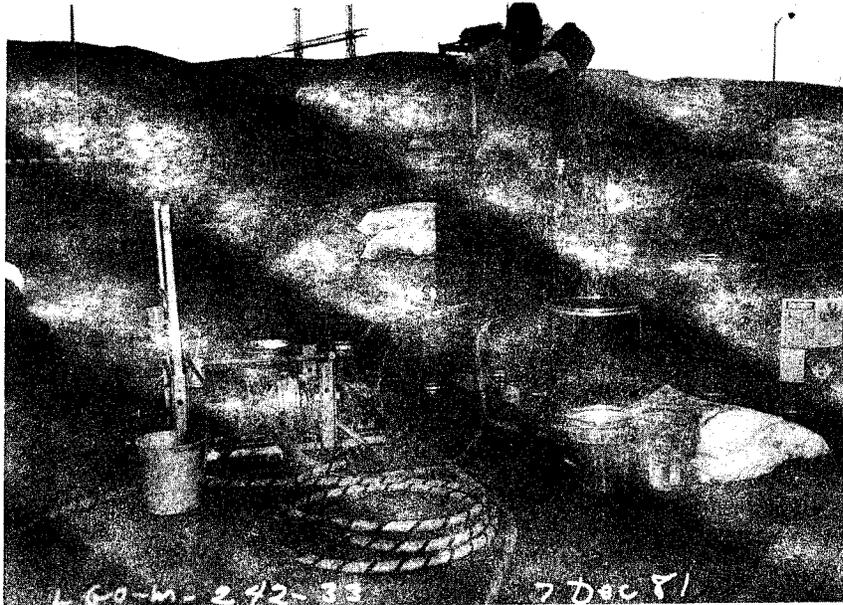
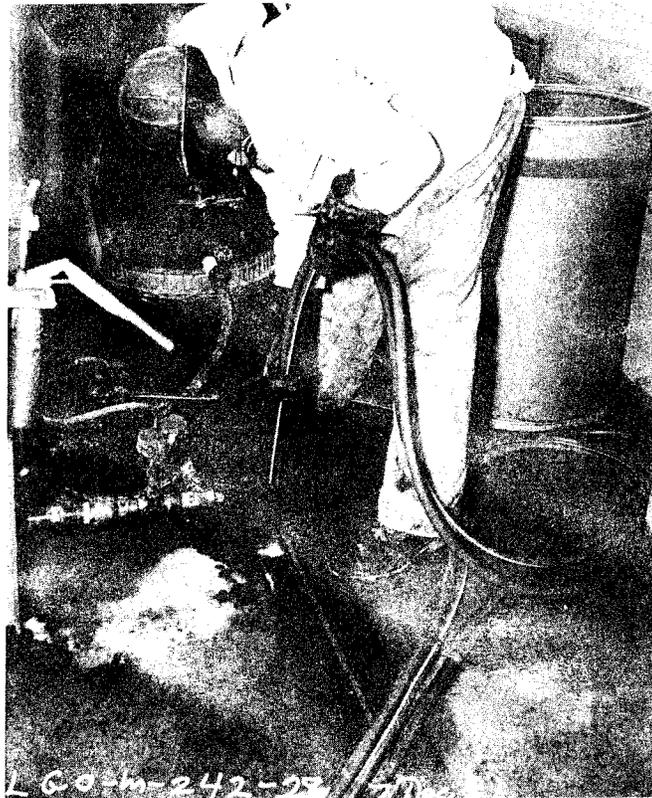
Figure 69. Acrylamide grouting operations, Little Goose Lock

157. Drill holes along monolith joints 15/17, 22/24, and 24/26 were flushed and filled with approximately 300, 350, and 250 gal of acrylamide grout, respectively. Photographs of the grouting operation are shown in Figure 69. At one point, the grout line stuck in the monolith joint 24/26 hole

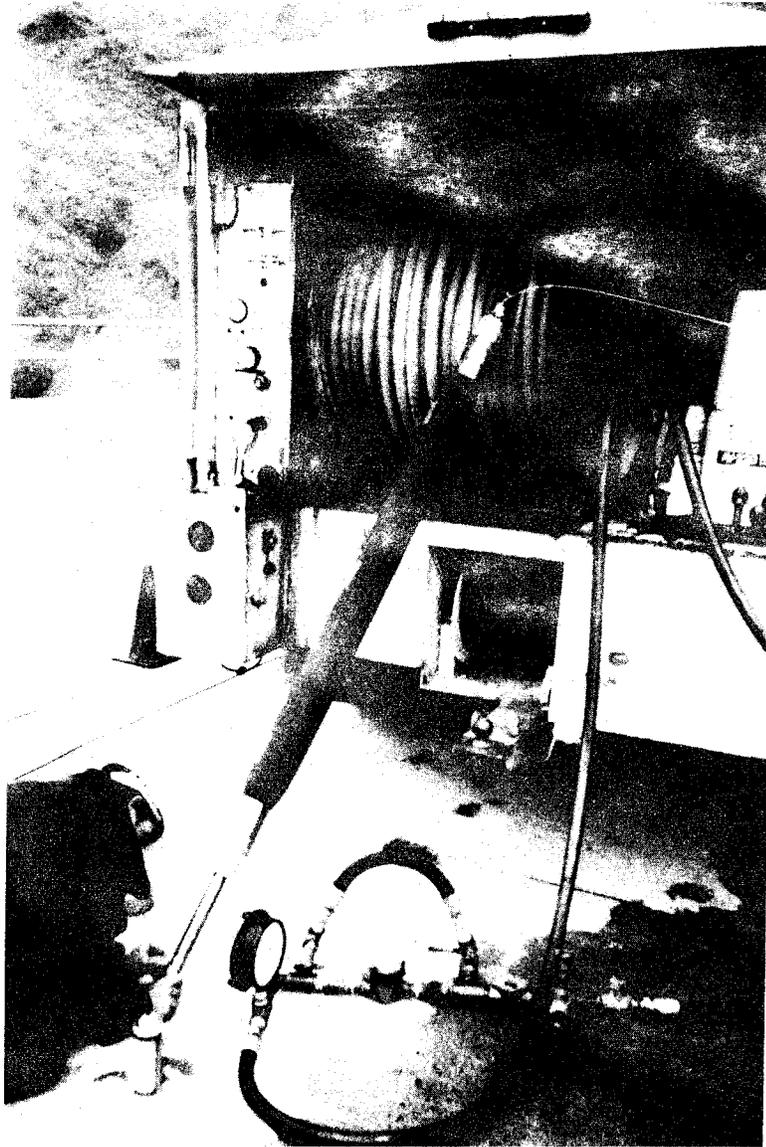
187. The bottom 10 ft of each hole was subjected to flow and pressure tests (Figure 84) to determine whether the joint was capable of evacuating water at depth. All three holes exhibited high leakage rates with packer settings approximately 10 ft above the bottom of the hole. Therefore, it was decided that tests need not be performed at higher elevations since the bottom

Figure 84. Flow and pressure test apparatus,
Pine Flat Dam

was permeable. Later video inspection indicated the holes had very rough walls in the areas where the packer was set. It is likely that much of the pressure and flow test losses were past the packer. This together with the fact that the packer can easily be circumvented through an open monolith joint make these test results suspect.

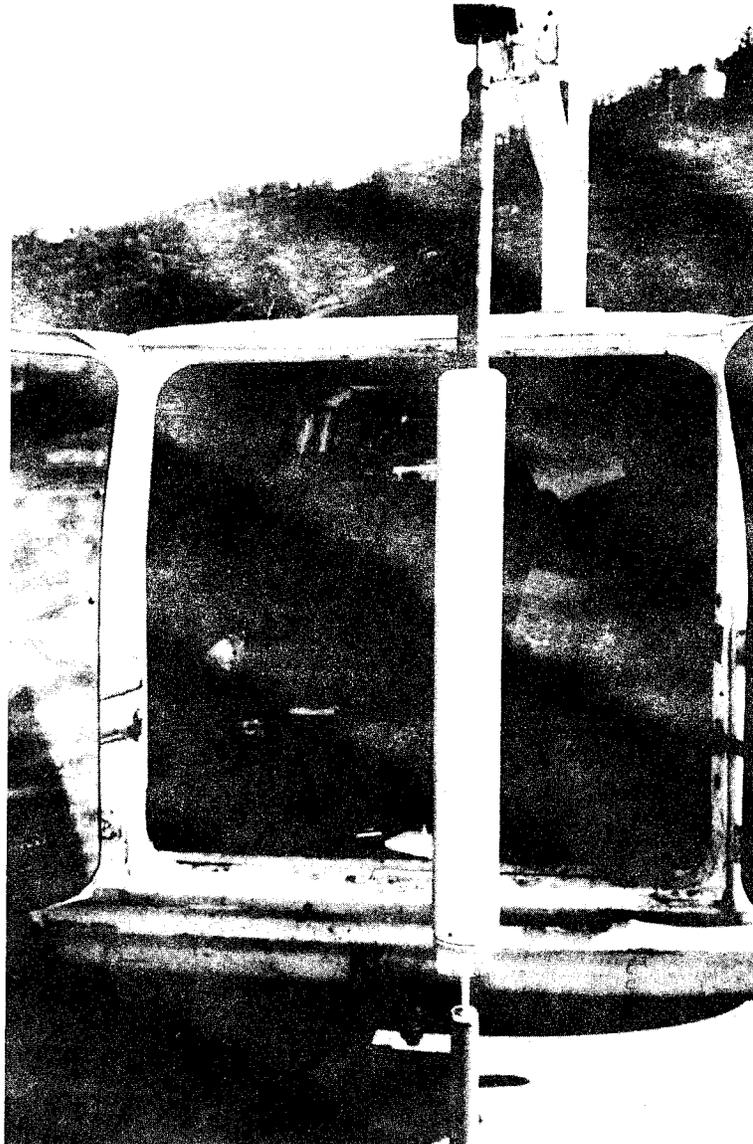
Figure 85. Closed circuit television camera for drill hole inspection, Pine Flat Dam

surface roughness of the holes. All inspections were recorded on videotape and written logs were maintained. These inspections indicated that the walls were quite rough with each hole containing large percentages of its length where there had been losses of cement paste and aggregate. The rounded surfaces of aggregate were very visible in many locations, and in several locations the stones were exposing subrounded points. The loss of material had resulted in several rather large cavities within the concrete. In addition, each hole contained rock pockets which appeared to be areas of honeycombed concrete. Hole 29/30 in particular exhibited this condition on each side of

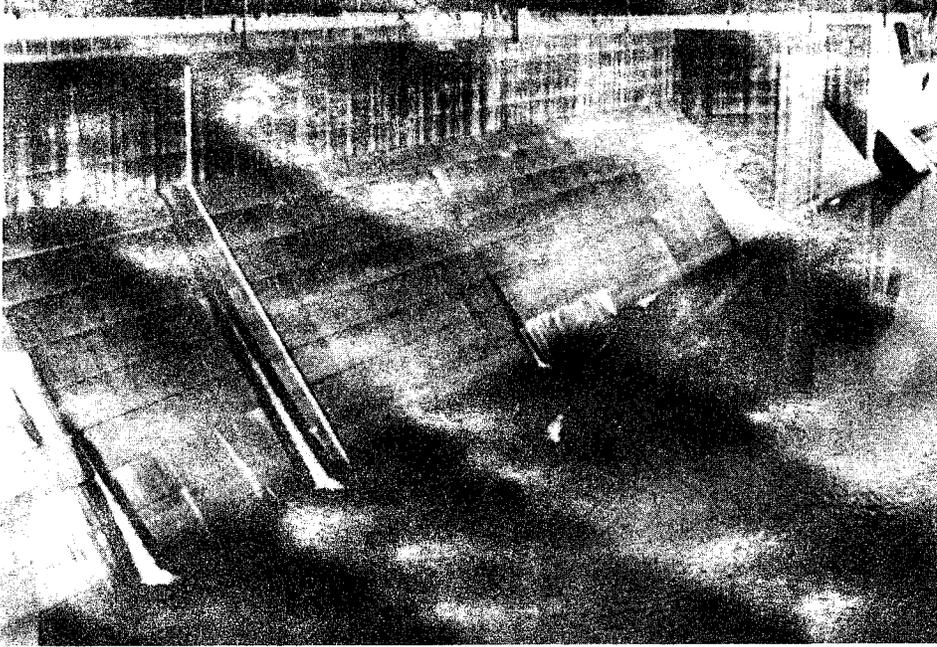
Figure 113. Leakage through monolith joints with lock chamber at upper pool level

209. The Dardanelle Lock had six vertical monolith joints that had been leaking since 1975. The leakage only occurred during cold wintertime conditions. They were first investigated in January 1977 when the leakage had increased significantly (Figures 113 and 114). Observation and dye tests proved that water from the lock chamber, both at low and full chamber, was passing through the monolith joints. Defective copper waterstops were the probable cause of the leakage. Visual leakage existed at river wall monolith joints R7/8, R8/9, R10/11, R13/14, R18/19, and land wall joint L21/22. Monolith joints R18/19 and L21/22 are located at the lower miter sill and leakage through these joints entered the lock wall grouting galleries and then to the lower miter sill cross-over gallery where sump pumps are located. Total inflow during full lock chamber (wintertime) increased from 75 gal/min in January 1977 to 382.2 gal/min in January 1981. The sump pumps were taxed to the maximum and were modified several times to handle the high inflow.

a. View of riverward lockwall taken from dam looking downstream

b. Close-up of largest leakage

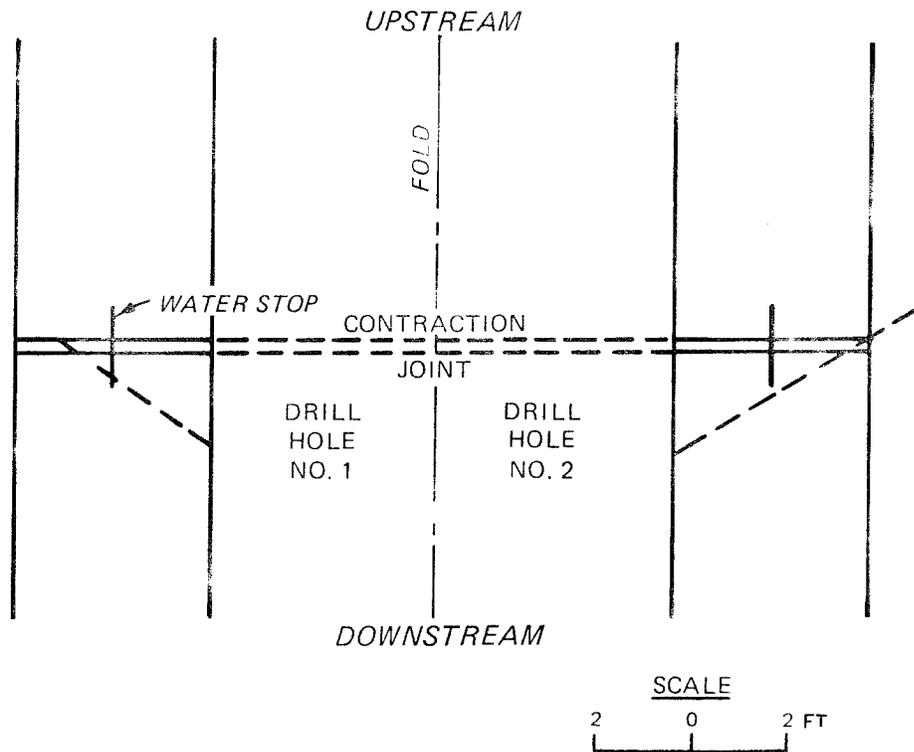
235. US Army Corps of Engineers crews began mobilizing on Monday, 1 June, and were ready to enter the conduit at the beginning of shift on 3 June. Two holes were drilled, as shown in Figure 123 and 124, and the conduit was made ready for the grouting contractor. Measured flow from the drill holes was 12.5 and 8 gal/min for holes 1 and 2, respectively. Flow through the leak with both drill holes flowing was estimated at 2.5 gal/min.

Figure 124. Section through grout holes 1 and 2, Applegate Dam

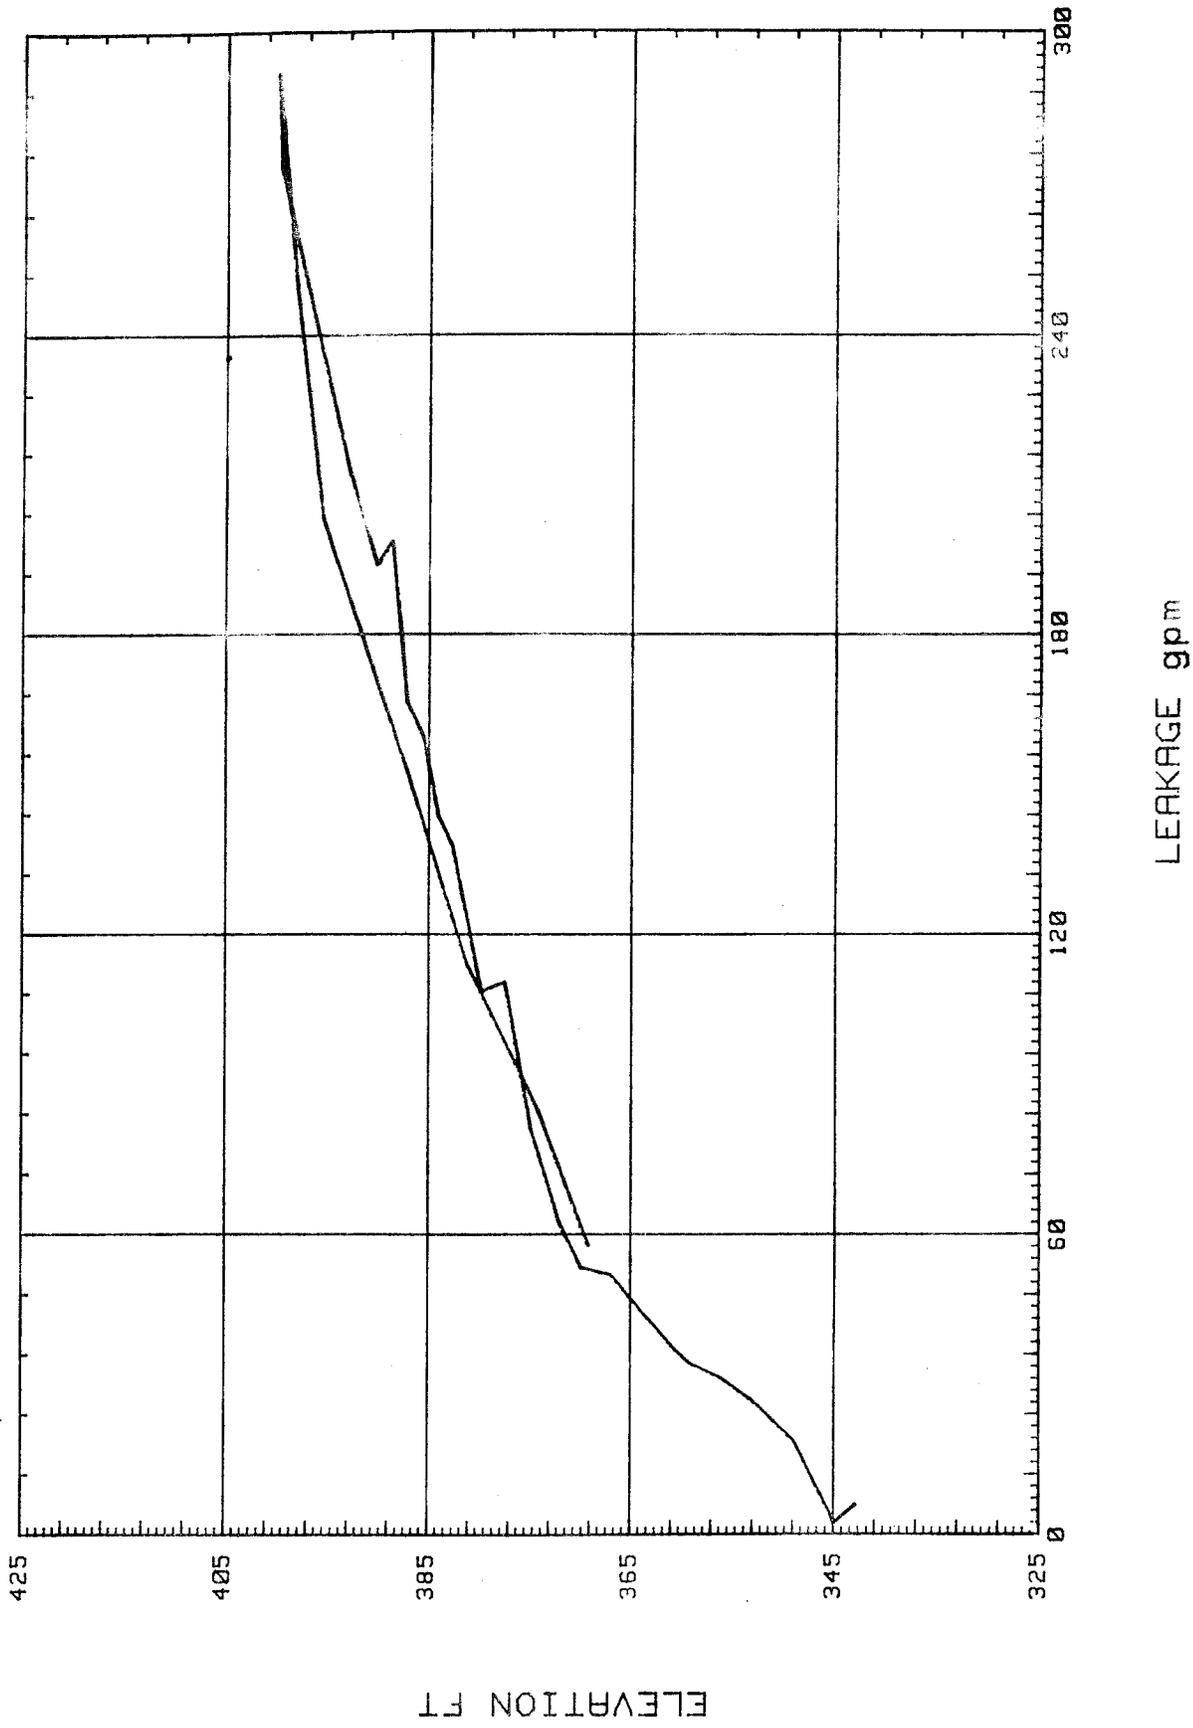
270. After test repairs on the five joints were completed, the pool was again raised to elevation 400 ft to evaluate the effectiveness of the repair. The sluice gates were closed on 6 June 1983 when the lake was at elevation 342.1 ft. As the lake level began to rise, leakage was measured at approximately 5-ft intervals until the lake reached elevation 400 ft on 10 June. The sluices were opened 11 June, and the lake was allowed to fall. The monitoring process continued through 15 June, as the lake stabilized at elevation 360 ft, with results as shown in Figure 136.

Figure 136. Leakage measurements, Richard B. Russell Dam, 6-15 June 1983

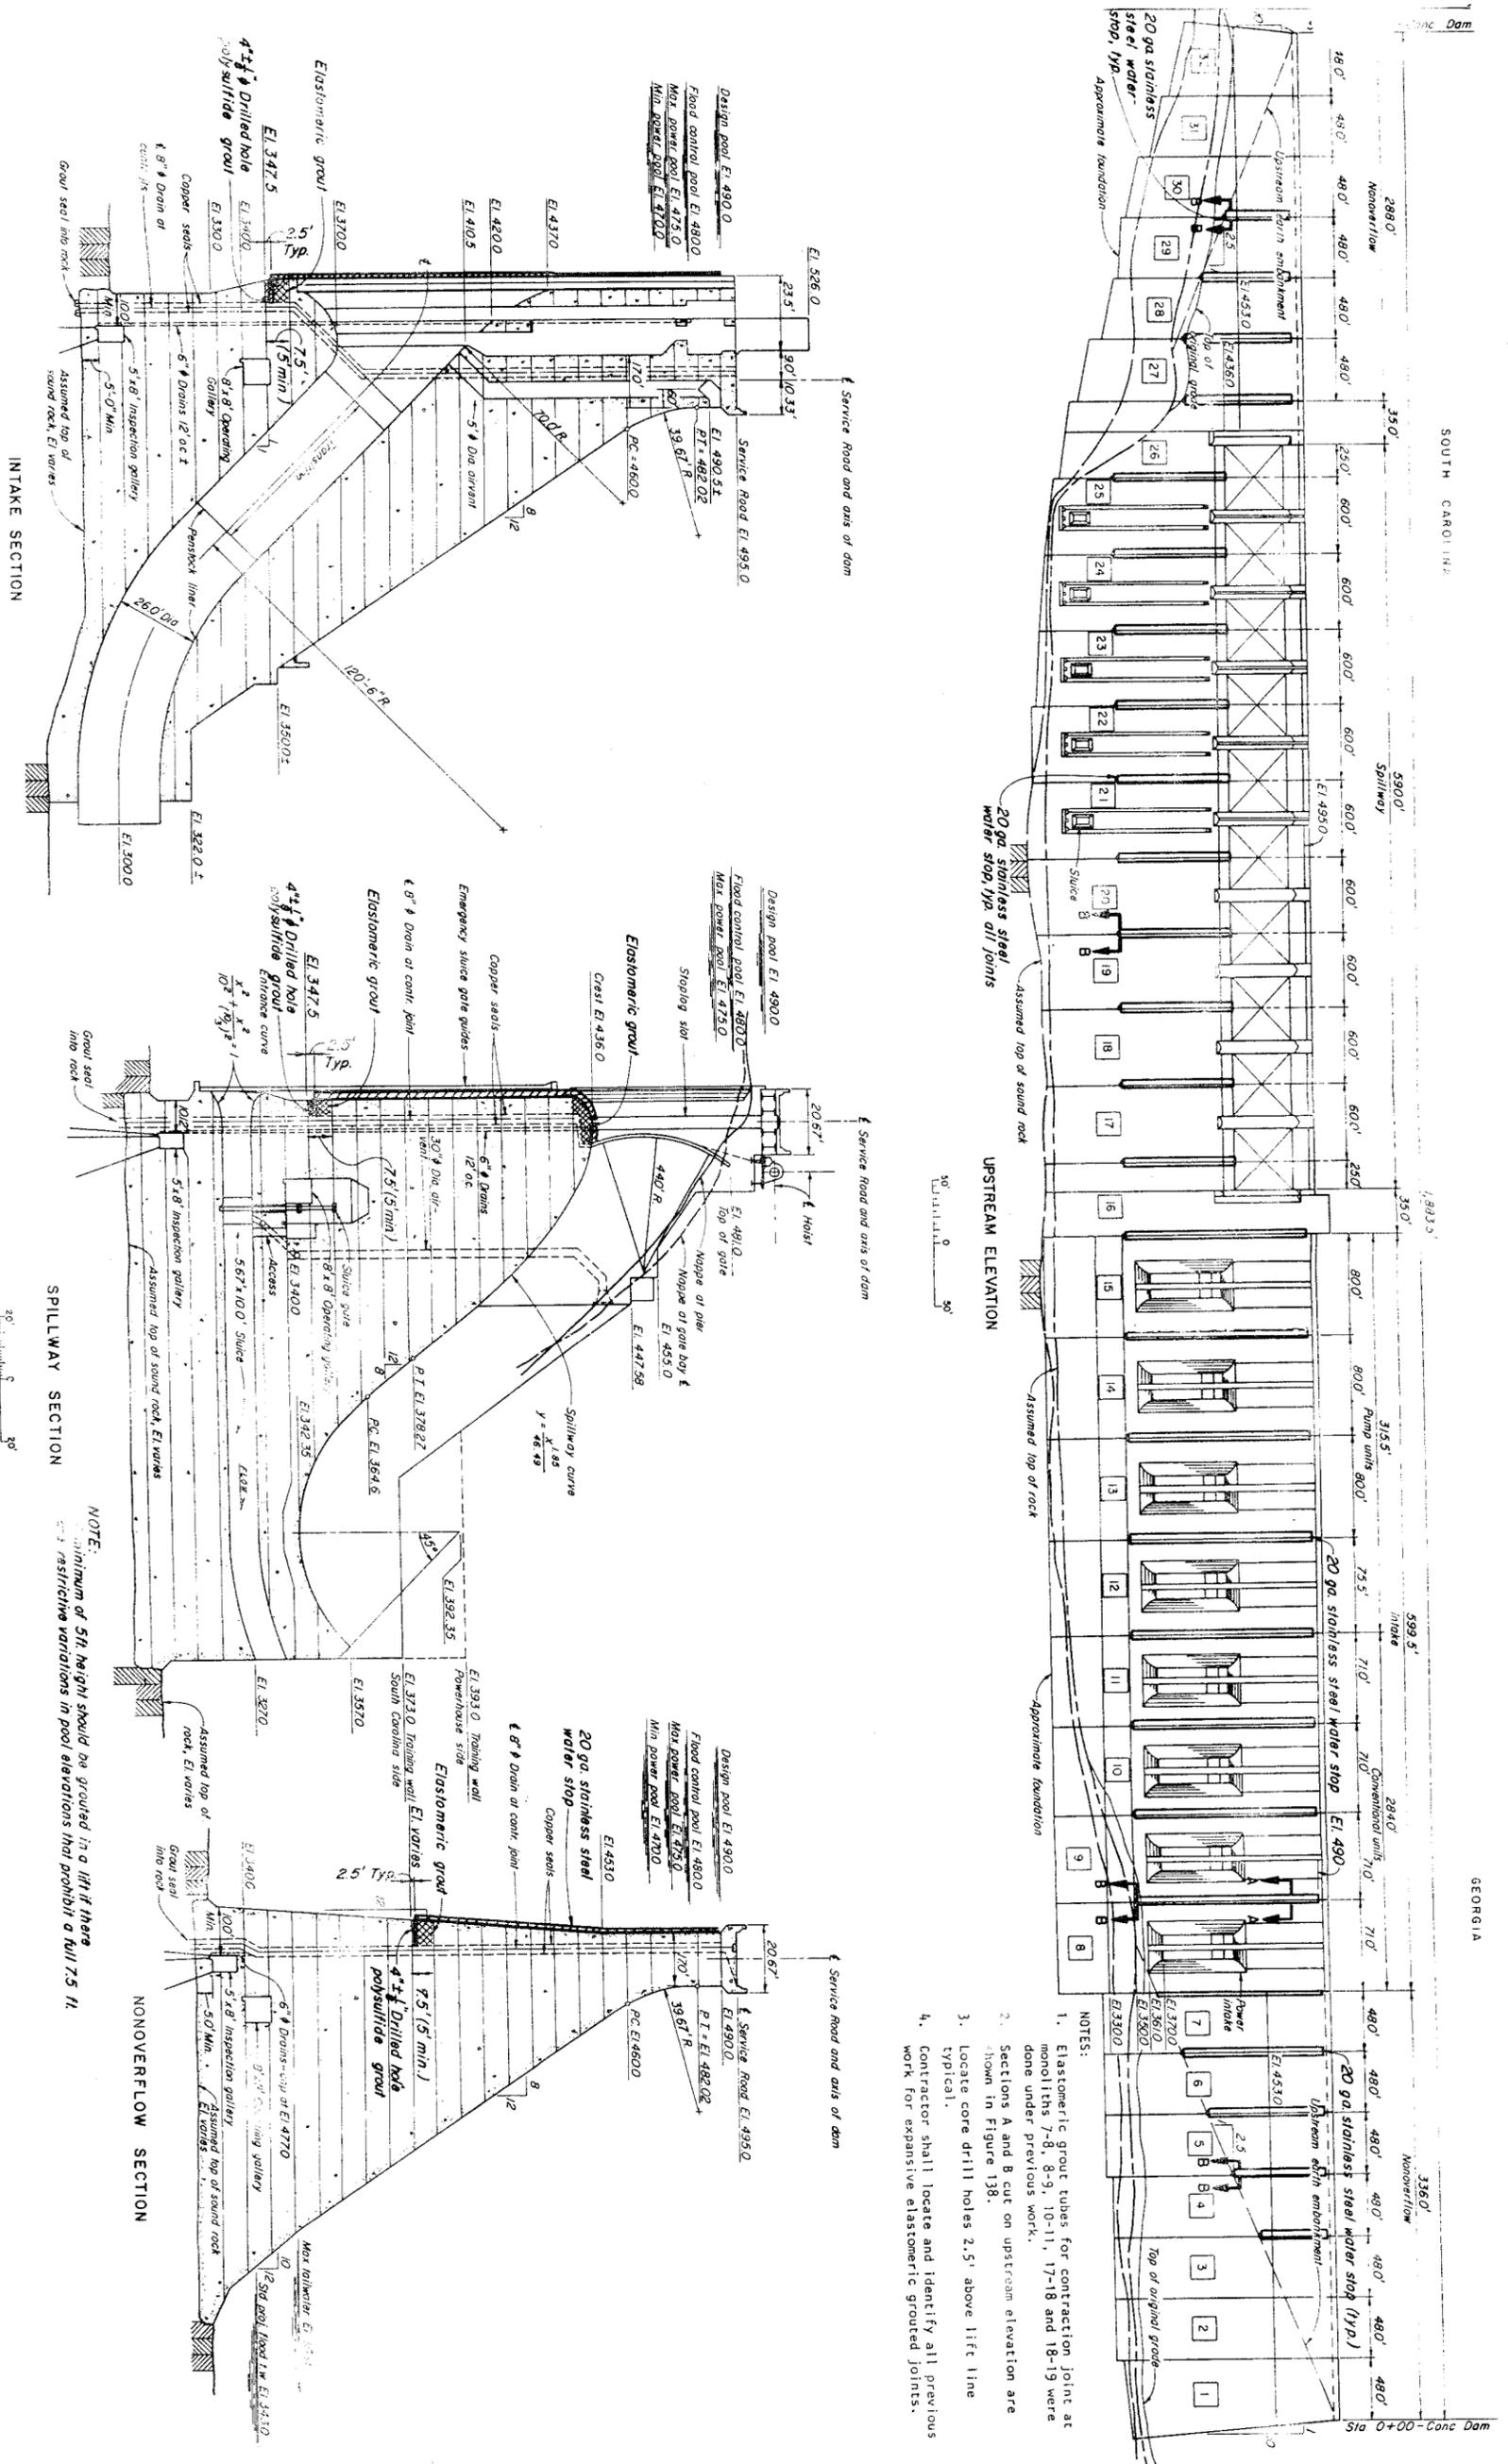
Figure 137. Phase I elastomeric grouting of contracting joints, Richard P. Russell Dam

273. Plans and details of the Phase I repairs are shown in Figures 137 and 138. Phase I repair procedures, refinements of the methods used in the initial repair, were as follows:

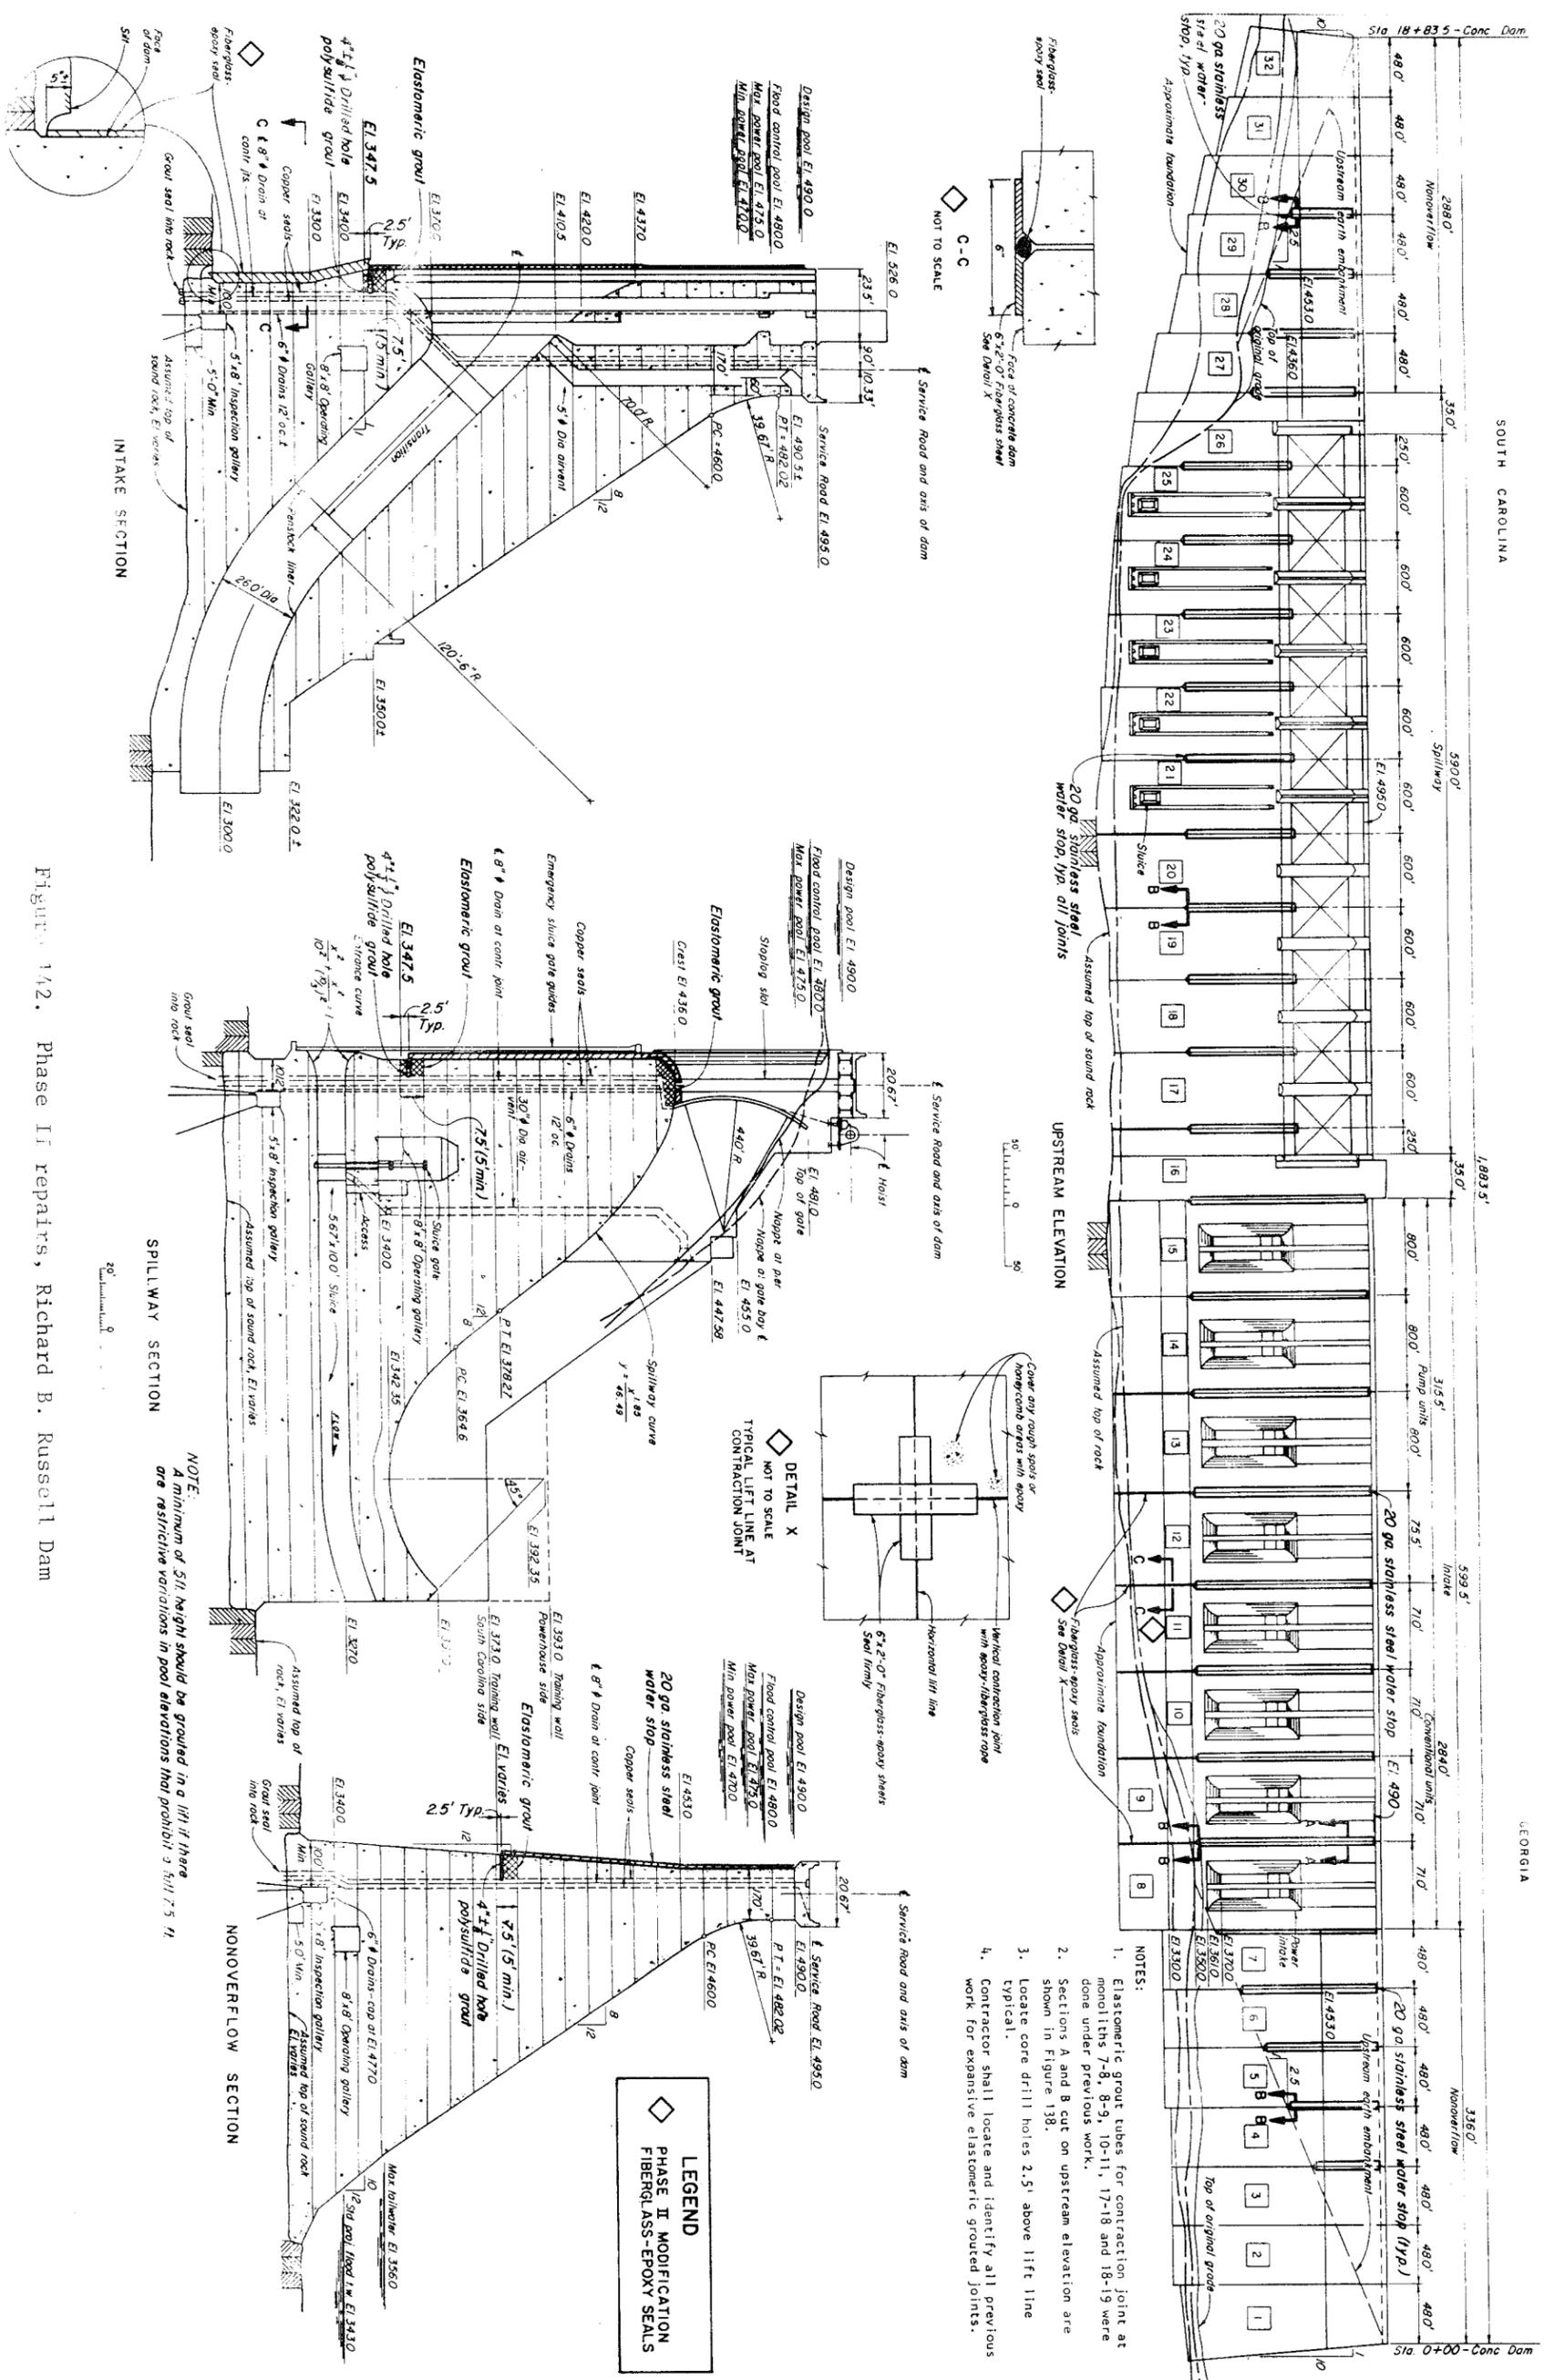
Figure 142. Phase II repairs, Richard B. Russell Dam

280. Interior grouting was considered the most effective way to control the leakage at contraction joint 4/5 and face drain 15F. Face drain 15F was plugged with grout injected through a packer. Corrective work at joint 4/5 consisted of drilling holes beside the drain and angling them into the suspect leakage path. Expansive elastomeric grout was injected into the suspect honeycomb areas adjacent to joint 4/5. This grouting was effective in stopping the contraction joint leakage and also reducing leakage into an adjacent face drain. This procedure was successful at joint 4/5 primarily because the elevation at which high leakage occurred was midway up the inspection gallery wall. Face drain 24C, which leaked at over a 100 gal/min in October 1983, was successfully sealed as follows: Power plant personnel placed the emergency bulkhead at the adjoining sluiceway to perform a dye test. With bulkhead placement in the sluiceway, leakage to 24C stopped. Subsequent investigation of the sluiceway uncovered four or five honeycomb areas in the ceiling around the door. These problem roofs were also grouted. The expansive grout was a hydrophilic polyurethane foam, CG 5600, manufactured by the 3M Company.
