US Army Corps
of Engineers

TECHNICAL REPORT REMR-CS-4

REPAIR OF WATERSTOP FAILURES: CASE HISTORIES

Final Report

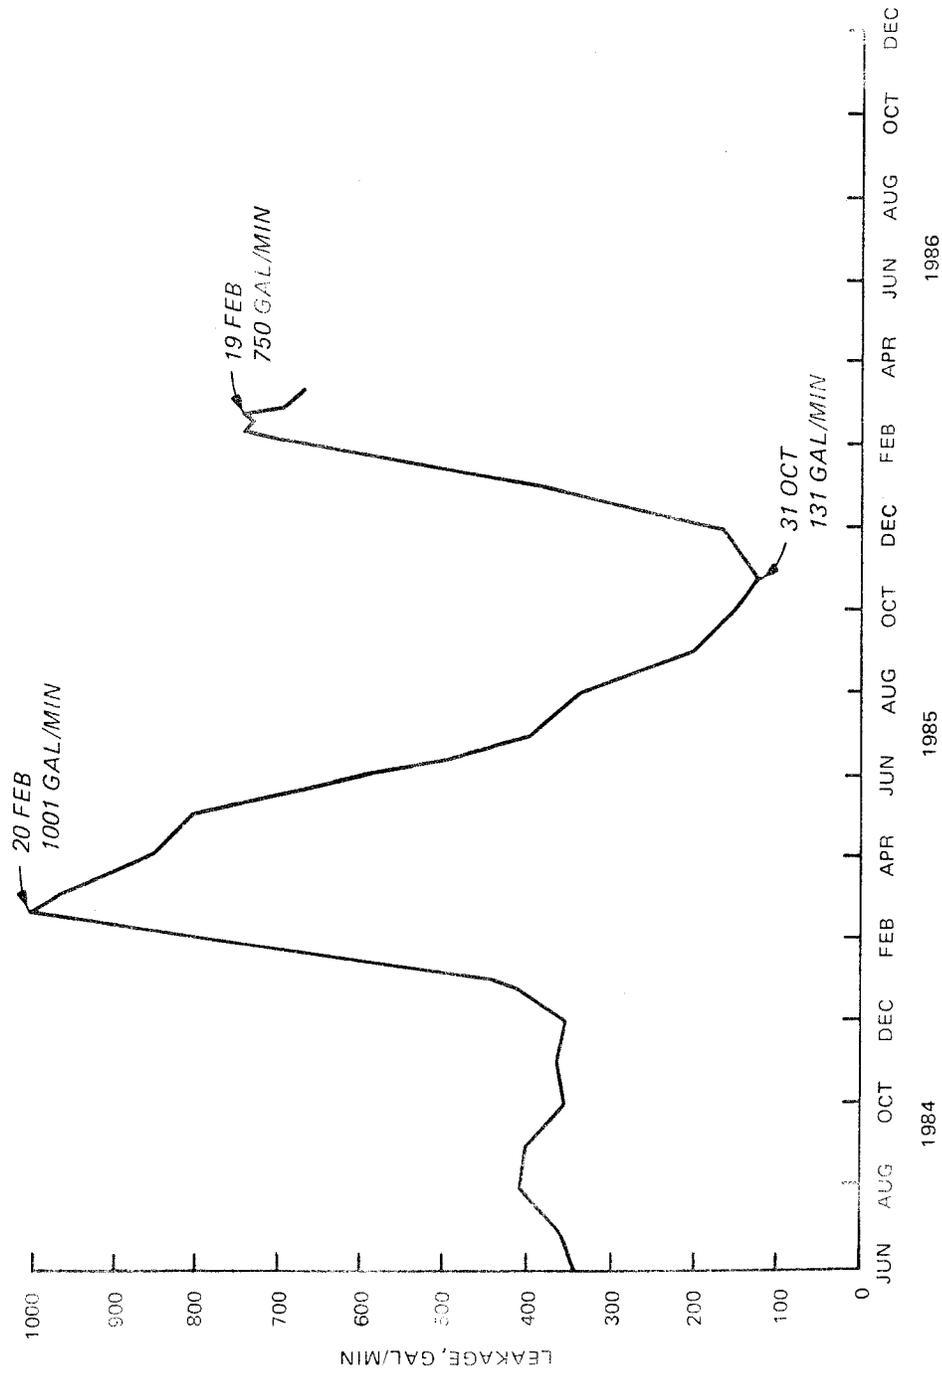
repairs, a maximum leakage of 1,001 gal/min was recorded on February 20, 1985 followed by a steady decline to 131 gal/min on October 31, 1985 (Figure 143). In 1986, the maximum leakage of 750 gal/min was recorded on February 19. Continued measurements and observations are planned through another winter cycle. Based on experience at other dams, it is believed that the formation of calcium carbonate will further reduce the leakage.

Figure 143. Results of leakage measurements, Richard B. Russell Dam

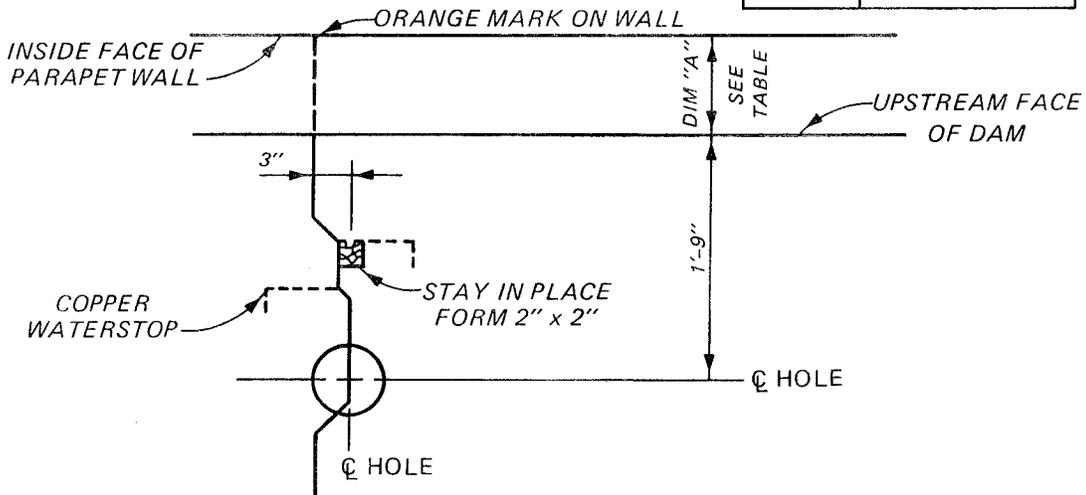
291. Construction Drilling, Inc. (CDI), the drilling subcontractor, began mobilizing on 3 April 1984. The mobilization took about a day and a half because numerous patches in the roadway had to be planked and bridged over, a requirement of the Missouri State Highway Department. CDI used an Acker track-mounted drilling rig with many modifications specifically for drilling with a down-the-hole hammer. Drilling was accomplished with a 6-in. down-the-hole hammer, a type of rotary/percussion drilling equipment. The head of the hammer pounds as it rotates. At 150 psi, the hammer is operating at approximately 1,000 blows/min. This rate varied as the air pressure at the hammer changed due to depth and frictional losses. In addition to the down-the-hole hammer, a 6-in. core barrel was used to obtain concrete core to verify joint location in the borehole. Drill hole locations are shown in Figure 147.

Figure 147. Drill hole locations, Bagnell Dam

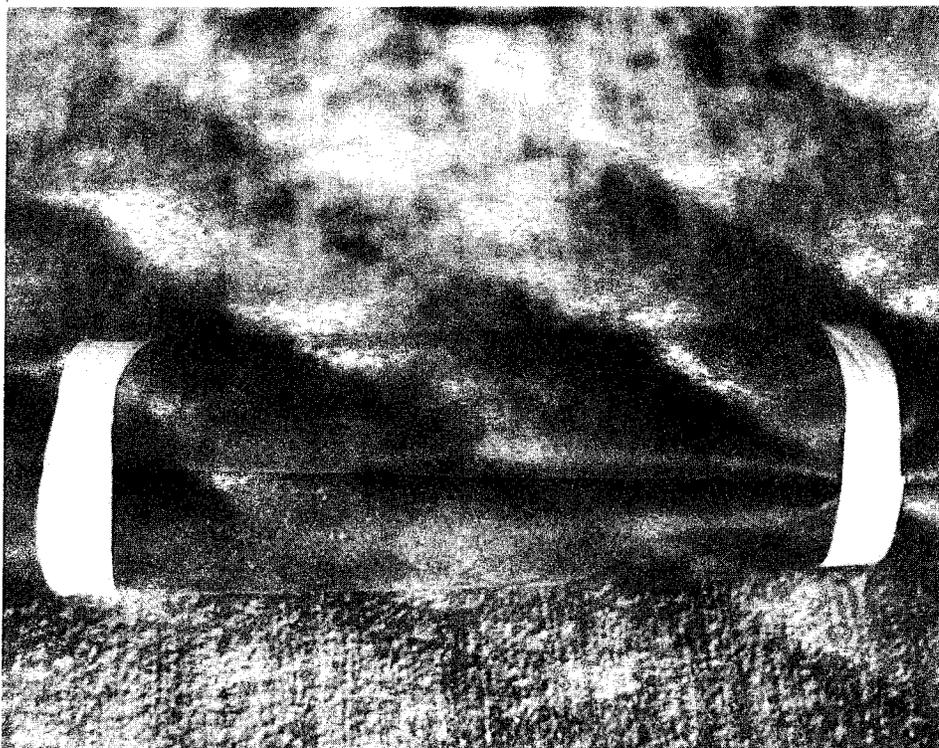
Figure 153. Composite sleeve ready for installation, Bagnell Dam

diameter and secured with masking tape bands spaced at approximately 12 in. on center (Figure 153).

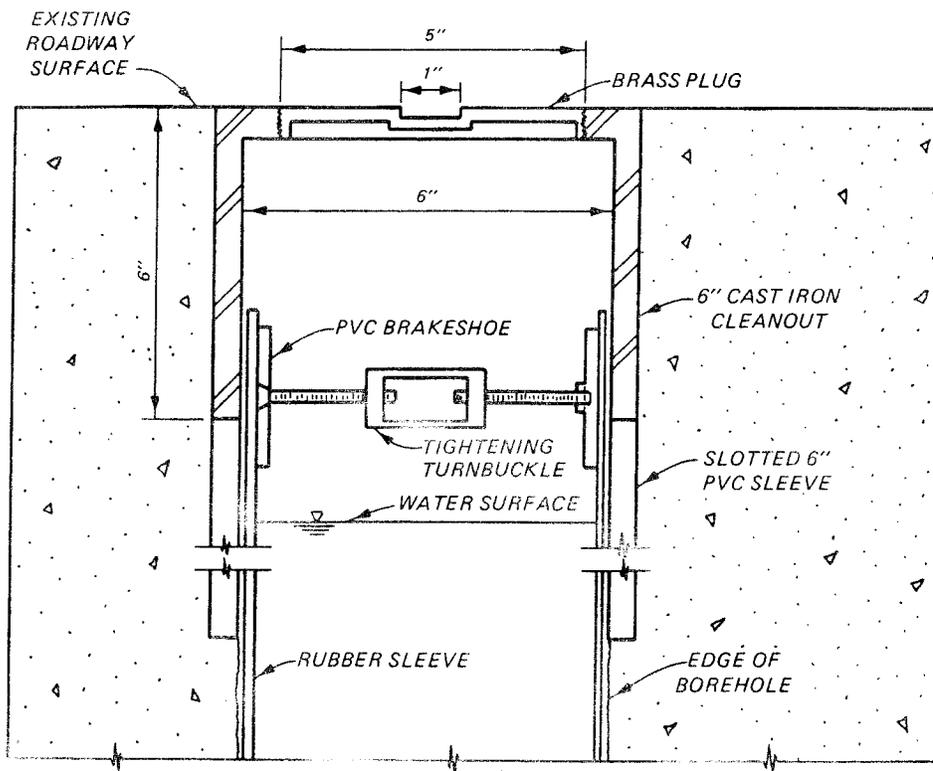
Figure 155. Section through top connection, Bagnell Dam

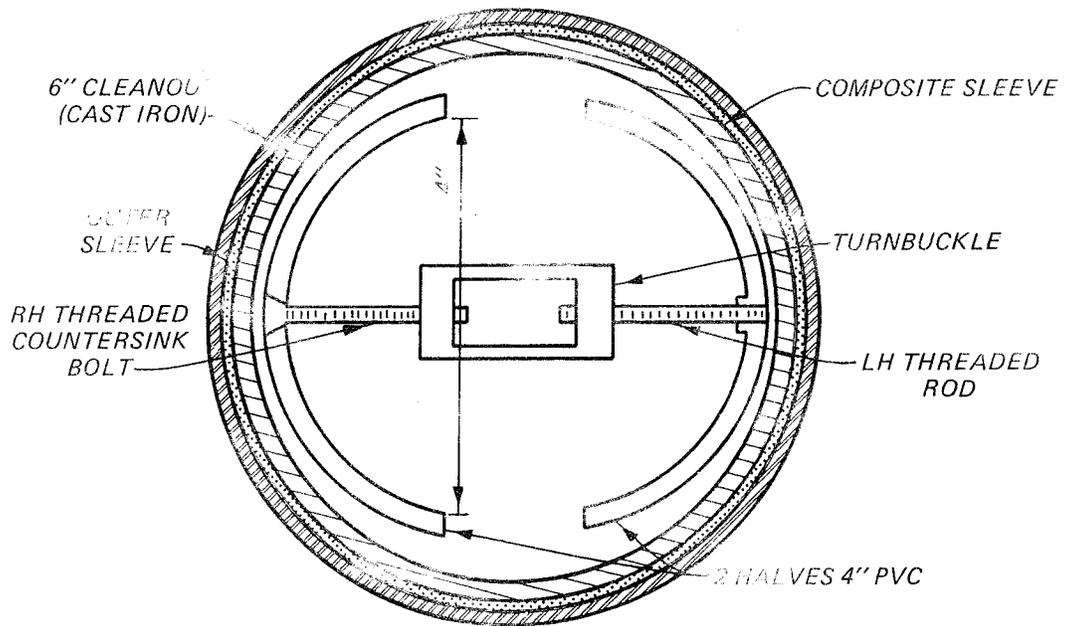
Figure 156. Plan view of top connection, Bagnell Dam

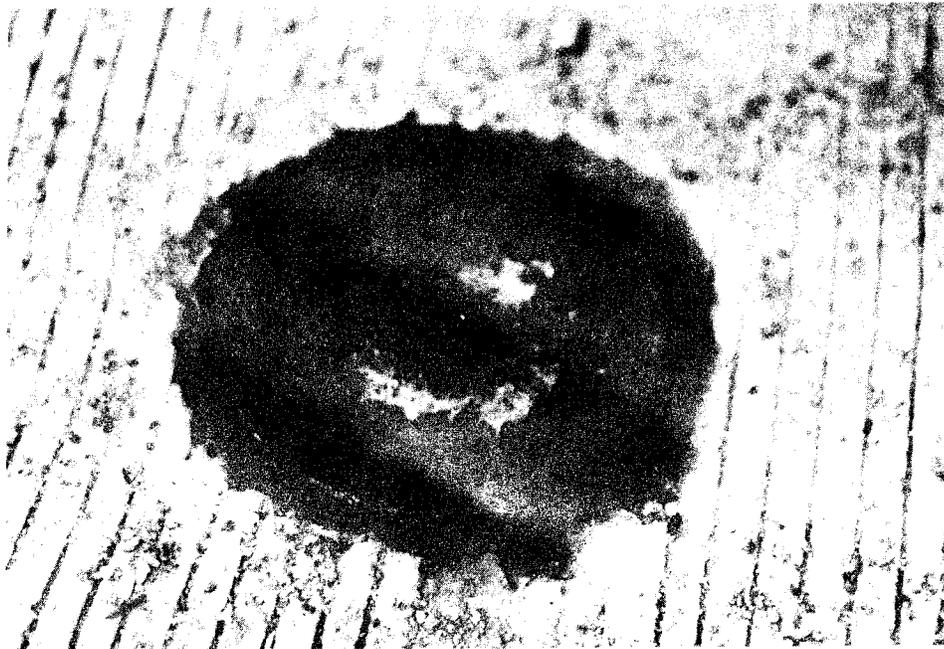
Figure 157. Cast iron cleanout with brass plug, Bagnell Dam

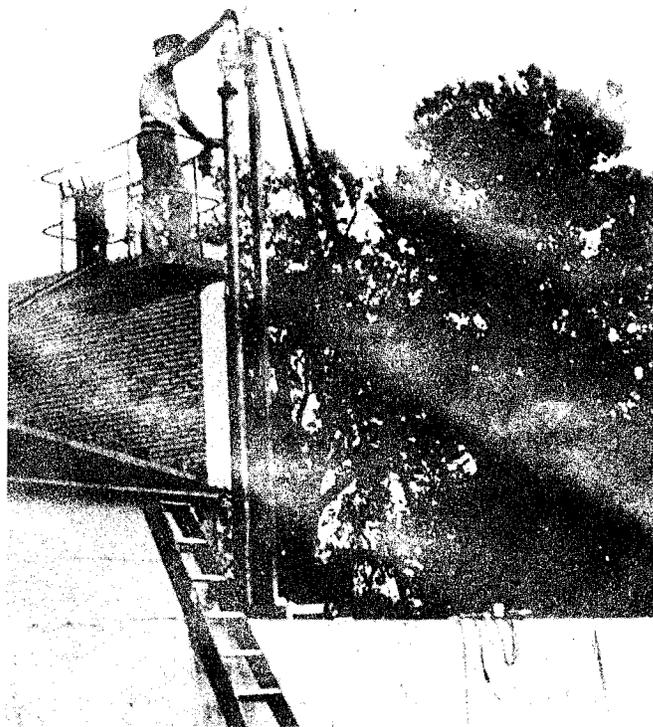
Figure 161. Drilling through existing waterstop, Caruthersville Floodwall

311. The 8-hp air drill was mounted on a 15-ft-high mast that was anchored to the top of the floodwall. Operators had to work from a manlift (Figure 161). Asphalt in the joint filler tended to gum up the drill bit and cause it to jam also. To minimize this, the drillers used a mild soap solution to lubricate the bit. The drill bit still jammed up, however. When this happened, operators had to remove the bit; but when they did this, the concrete and joint filler also often came out. The steel plate remained embedded in the concrete at the bottom of the hole. To keep the plate from flopping around and locking up inside the tube when drilling was resumed, they filled the cored portion of the hole with low-strength grout and then redrilled the entire hole. Because of bit jams, some holes took 7 to 10 days to drill and others took only 1-1/2 days. Dixie Construction Products, Atlanta, Georgia, was the drilling contractor.
