**REPAIR, EVALUATION, MAINTENANCE, AND
REHABILITATION RESEARCH PROGRAM**

TECHNICAL REPORT REMR-CS-6

**IN SITU REPAIR OF DETERIORATED
CONCRETE IN HYDRAULIC STRUCTURES:
FEASIBILITY STUDIES**

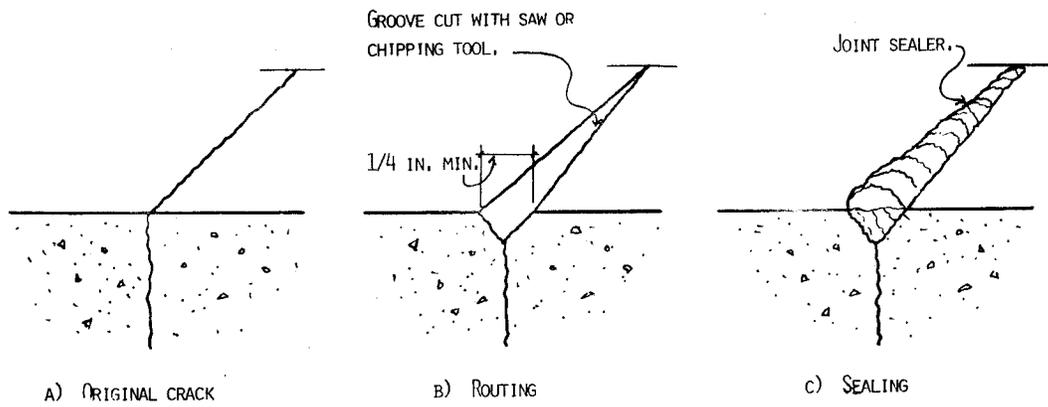
The technique simply entails enlarging the crack along its exposed face and filling and sealing it with a suitable joint sealant (Figure 4). Choice of the sealant depends on how tight or permanent the seal must be. Epoxy compounds are most commonly used, although hot-poured joint sealants have been used when watertightness is not required and appearance of the repair is unimportant. Urethanes, which remain flexible through large temperature variations, have been used successfully in cracks up to 0.75 in. in width.

Figure 4. Repair of crack by routing and sealing (ACI Committee 224, 1984).

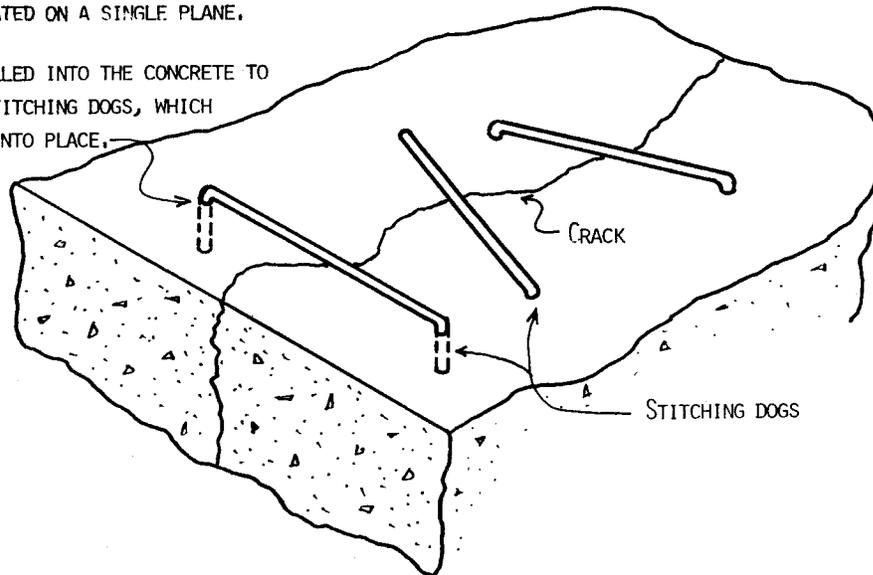
3. Stitching. This technique involves drilling holes on both sides of the crack and grouting in U-shaped reinforcing bars (stitching dogs) that span the crack (Figure 5). A non-shrink grout or an epoxy resin is normally used to anchor the legs of the bars. Stitching is generally used when it is necessary to reestablish tensile strength across major cracks. Stitching does tend to stiffen the area being repaired, which may accentuate the overall stiffness of the structure and cause cracks to develop elsewhere. It is, therefore, generally necessary to strengthen the adjacent sections using external reinforcement.

NOTE VARIABLE LENGTH, LOCATION AND ORIENTATION OF DOGS SO THAT TENSION ACROSS CRACK IS DISTRIBUTED IN THE CONCRETE RATHER THAN CONCENTRATED ON A SINGLE PLANE.

HOLES ARE DRILLED INTO THE CONCRETE TO RECEIVE THE STITCHING DOGS, WHICH ARE CEMENTED INTO PLACE.

Figure 5. Repair of crack by stitching (ACI Committee 224, 1984).

Stitching will not close a crack but can be used to prevent it from propagating further. If water is a problem, the crack should be made water tight before it is stitched to protect the bars from corrosion.

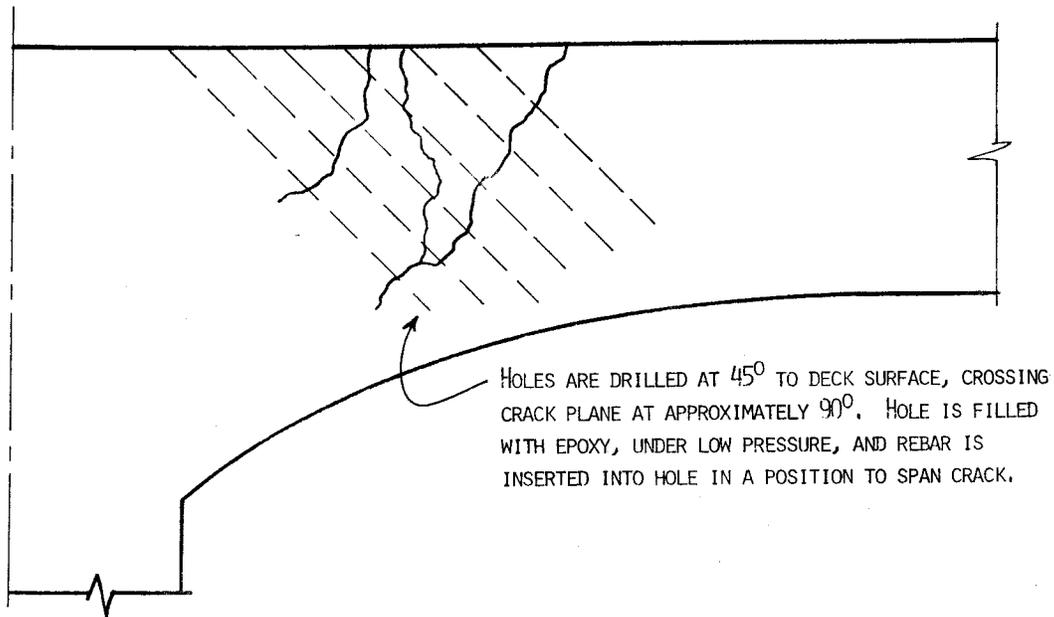
Post-reinforcement is a technique developed by the Kansas Department of Transportation to repair cracked structural bridge concrete. The method consists of sealing the surface of the crack, drilling holes at 45° to the deck surface, and crossing the crack plane at approximately 90°, filling the hole and crack plane with epoxy pumped under low pressure, and placing a reinforcing bar into the drilled hole in a position to span the crack (Figure 6). The epoxy bonds the bar to the walls of the hole; it fills the crack plane, thereby rebonding the cracked concrete surfaces in one monolithic form and reinforcing the section.

Figure 6. Repair of crack by post reinforcement.

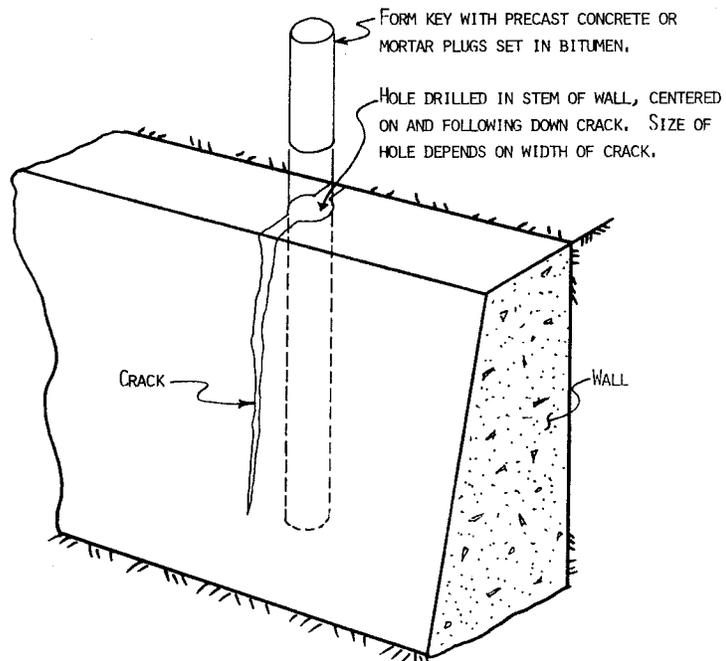
5. Drilling and Grouting. This technique is useful for repairing vertical cracks which are reasonably straight and are accessible at one end of the crack such as in retaining walls. It consists of drilling a hole, usually 2 to 3 in. in diameter, down the length of the crack and grouting it in to form a key (Figure 7). The grout key prevents transverse movement of the concrete adjacent to the crack and will also reduce heavy leakage through the crack. If watertightness is essential and structural load transfer is not, the drilled hole is filled with a resilient material in place of the grout.

Figure 7. Repair of crack by drilling and plugging (ACI Committee 224, 1984).

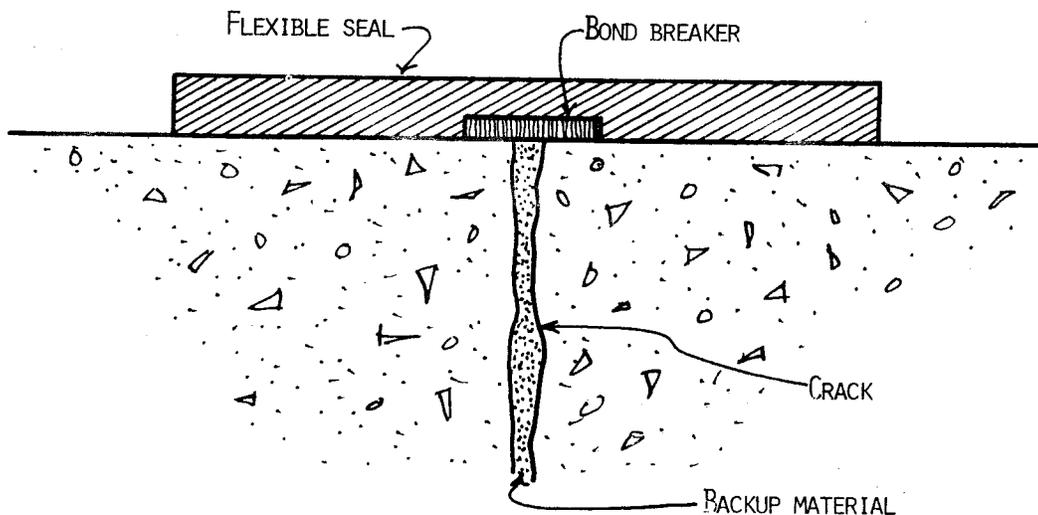
Figure 8. Repair of crack using a flexible seal (ACI Committee 224, 1984).

6. Flexible Sealing. Active cracks can be sealed by routing them out and filling them with a suitable flexible sealant. This technique is applicable where appearance is unimportant and in areas where the cracks are not subject to traffic or mechanical abuse. The repairs are made by routing out a slot or groove along the length of the crack of sufficient width and shape to accommodate the expected movement. The slot is then filled with a backing material, covered with a bond breaker, and finally sealed with the flexible joint sealant (Figure 8).

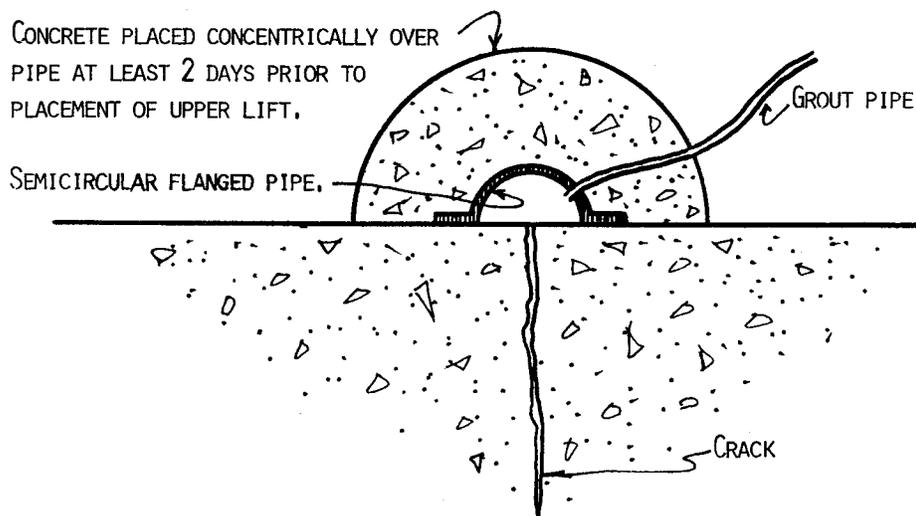
9. Crack Arrest. This technique is commonly used to prevent reflective cracking into new concrete which is being placed over existing concrete. The technique, in general, arrests the cracking by blocking it and spreading the tensile stresses causing the cracking over a larger area. One technique consists of placing semicircular sections of steel pipe over the crack and then covering the pipe with concrete to anchor it in place. After this concrete cap has set, the new concrete is placed over the cap. The steel pipe is later filled with grout to complete the structural continuity of the member (Figure 9).

Figure 9. Repair of crack using the crack arrest method (ACI Committee 224, 1984).
